# BOILER SYSTEM FAILURES

## *Analysis & Diagnostics Manual*

### EXAMPLES OF ISSUES IN SPECIFIC BOILER SYSTEM COMPONENTS

Metallurgy  
Volume 2.0 | Boiler Systems

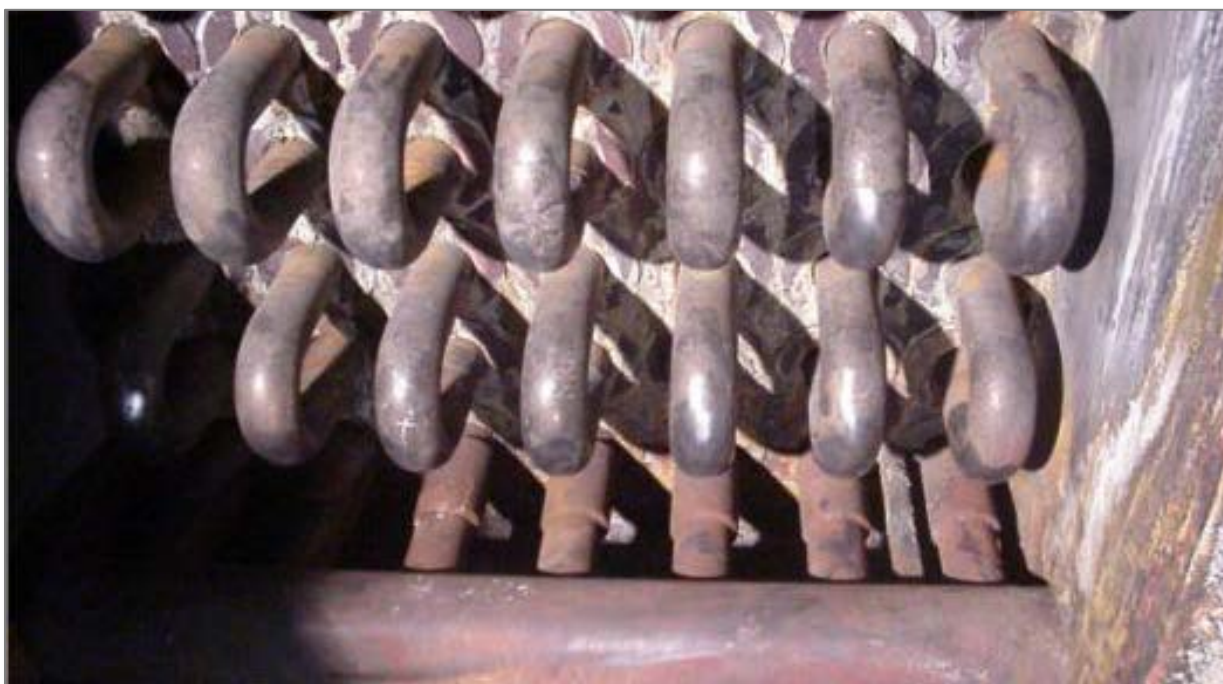
Return bends outside of gas passage.  
*External surfaces prone to corrosion if not protected from moisture*

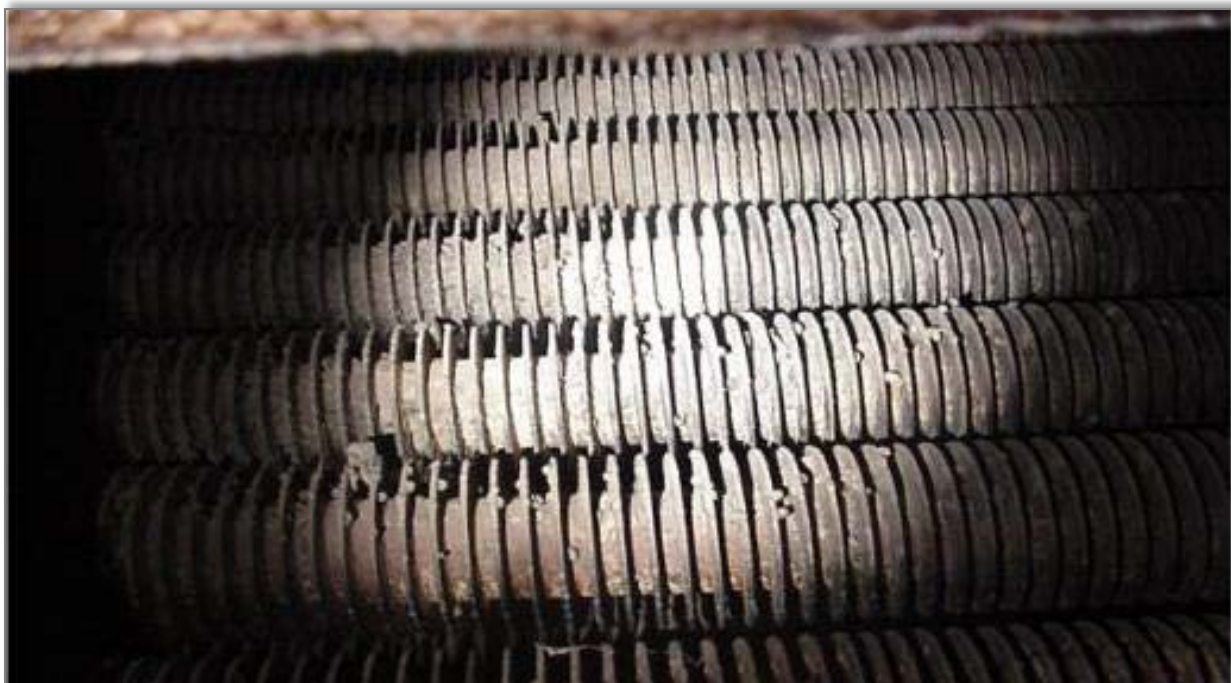
Top view of finned economizer tubes

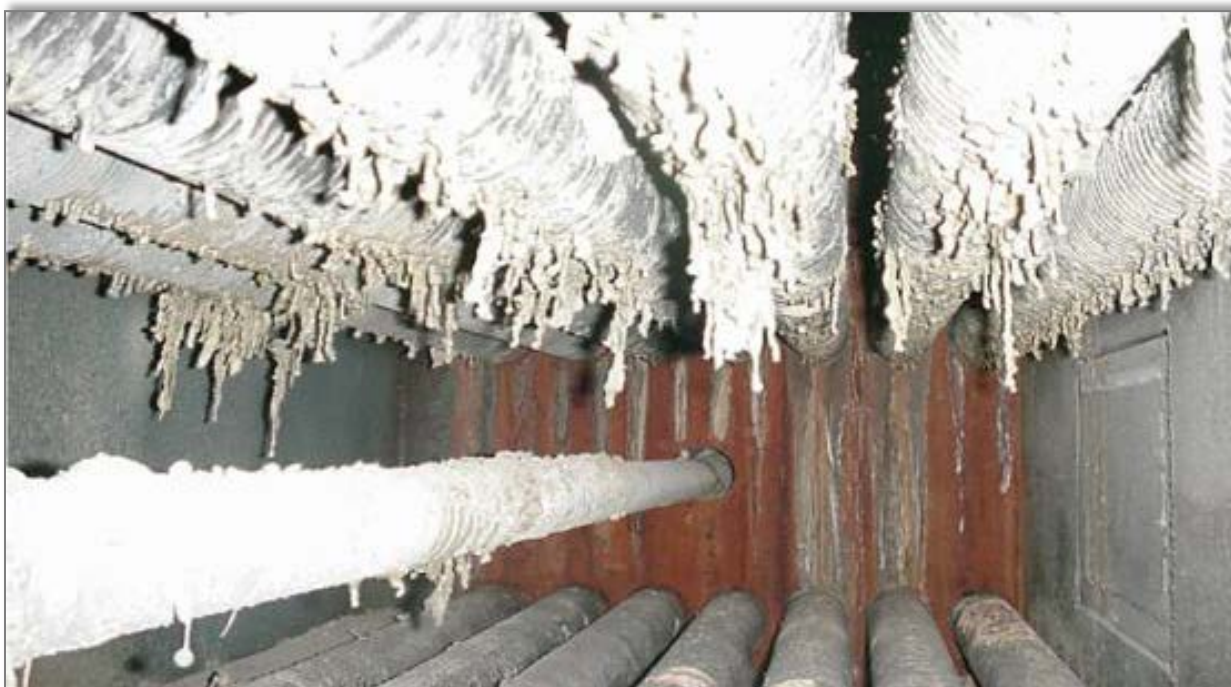
Section of fouled, finned economizer tubes

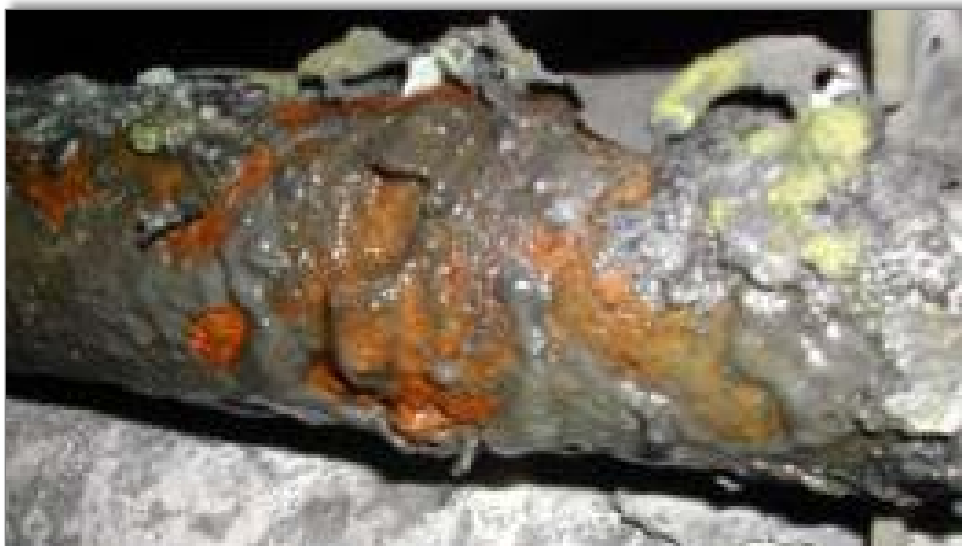
External deposits containing sulfur compounds—  
*from burning high sulfur oil*

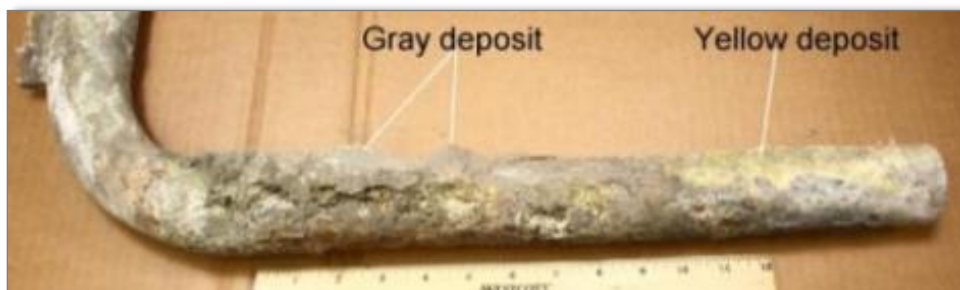
Bare economizer tube sections before cleaning

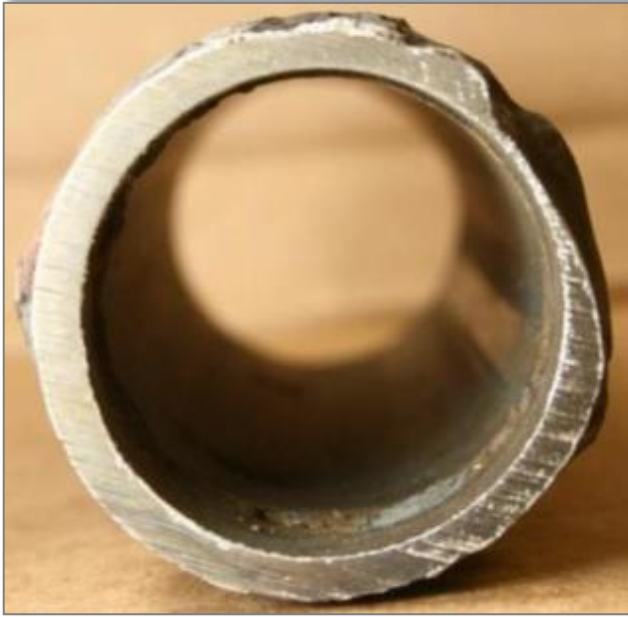
Economizer tube cross section after cleaning, showing surface metal loss due to burning high sulfur #6 oil. Sulfuric acid forms on the tube surface when operating below the  $\text{H}_2\text{SO}_4$  dew point, ~ 267 °F.

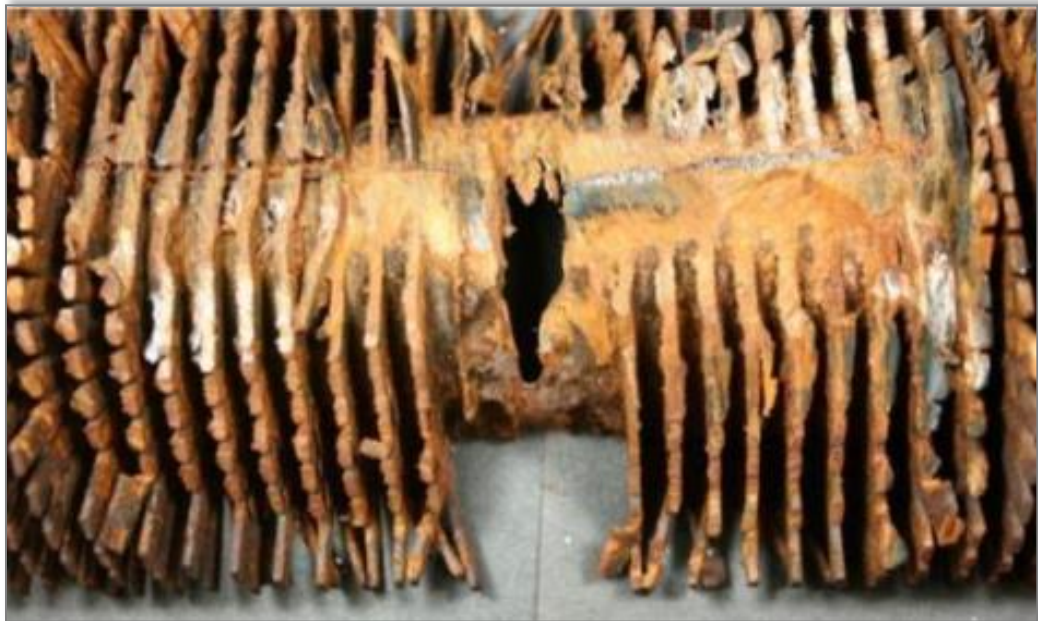
Finned economizer tube failure

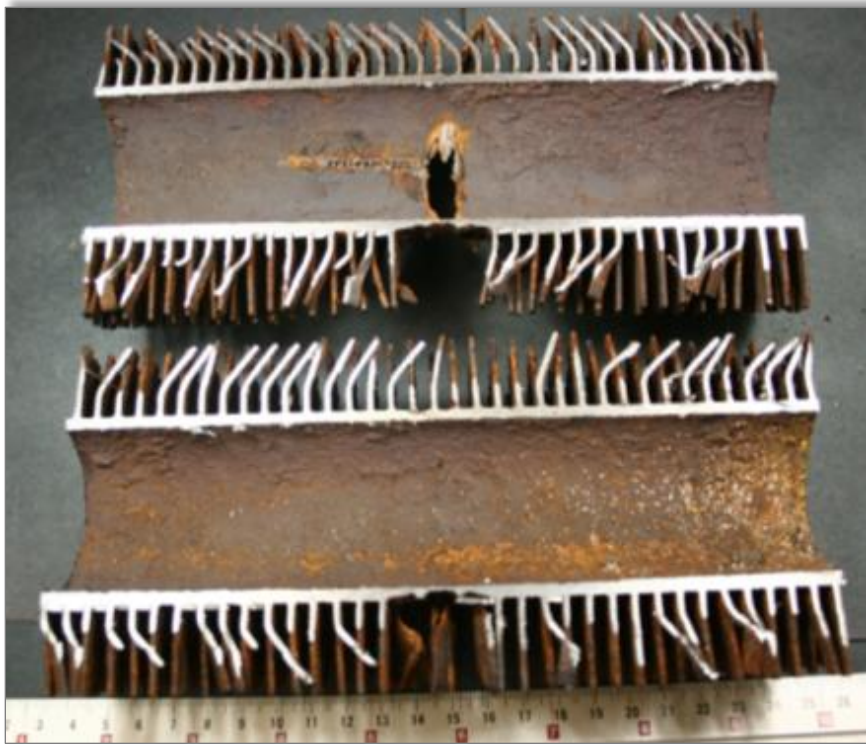
Tube removed and split longitudinally, before cleaning

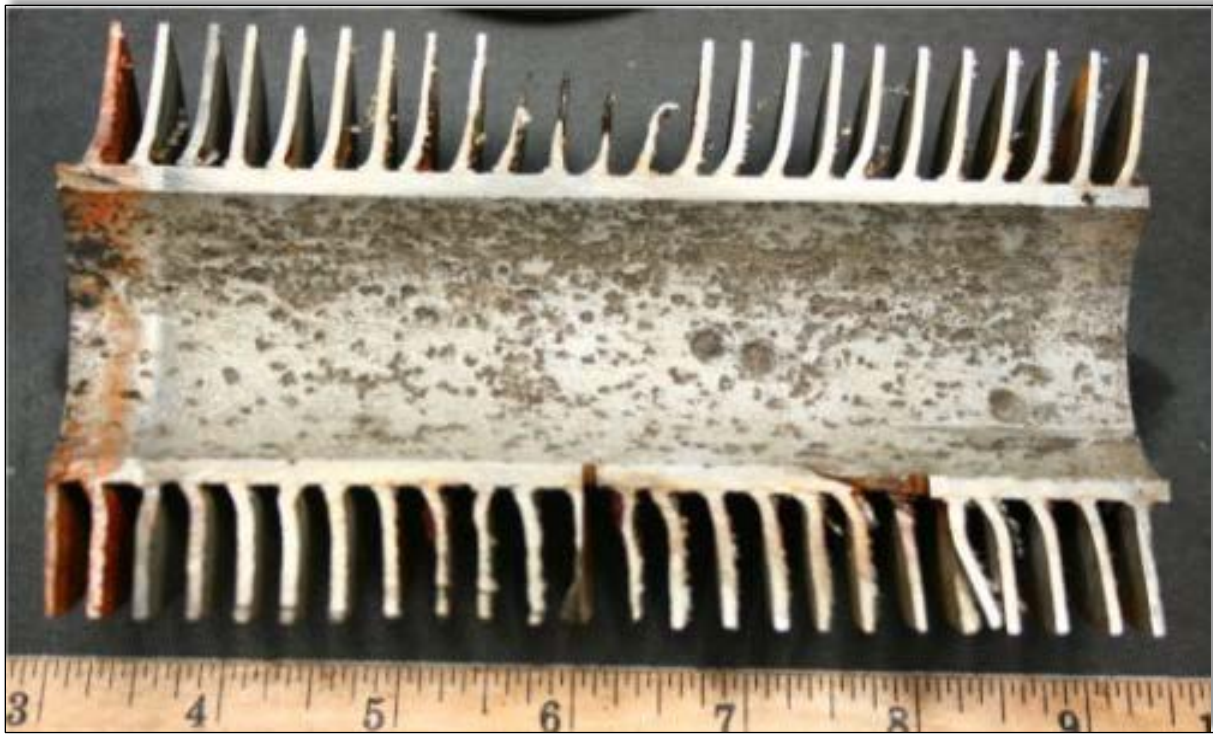
Tube section, cleaned in dilute inhibited hydrochloric acid  
*Oxygen pitting evident after cleaning*

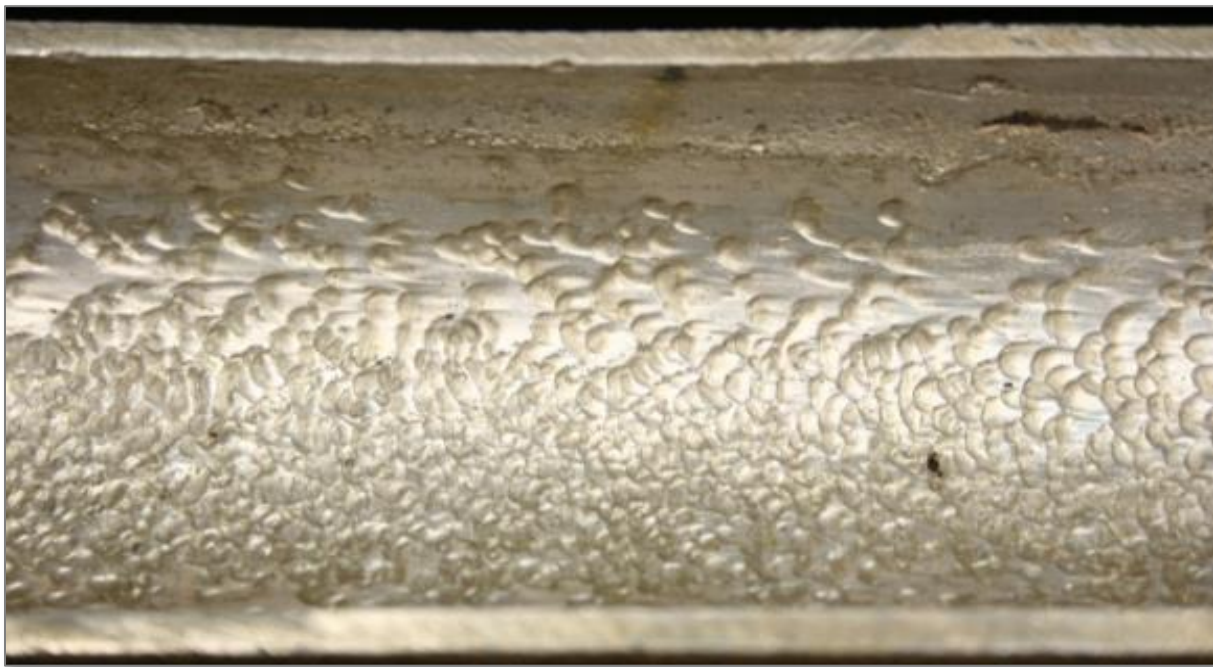
FAC in an economizer tube

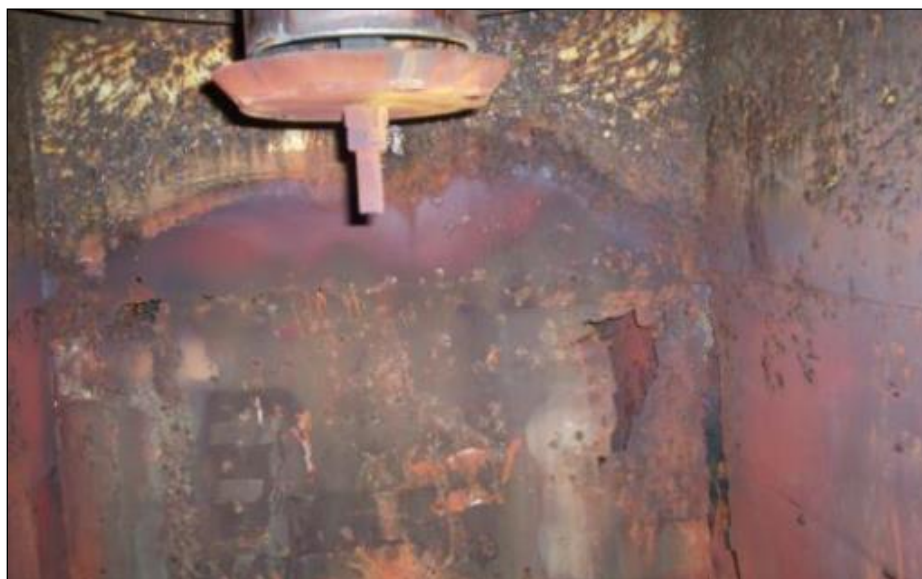
Deaerator spray zone corrosion on SS shell due to high chlorides

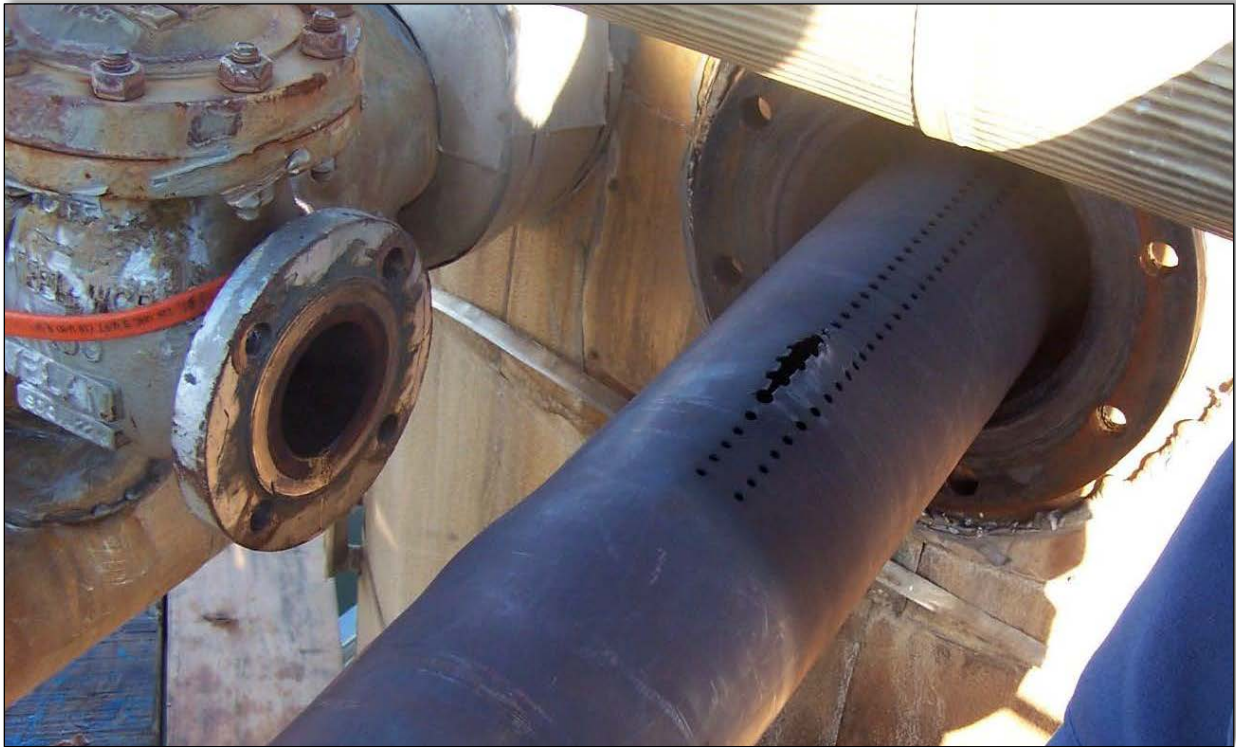
Deaerator inlet header spray pipe failure

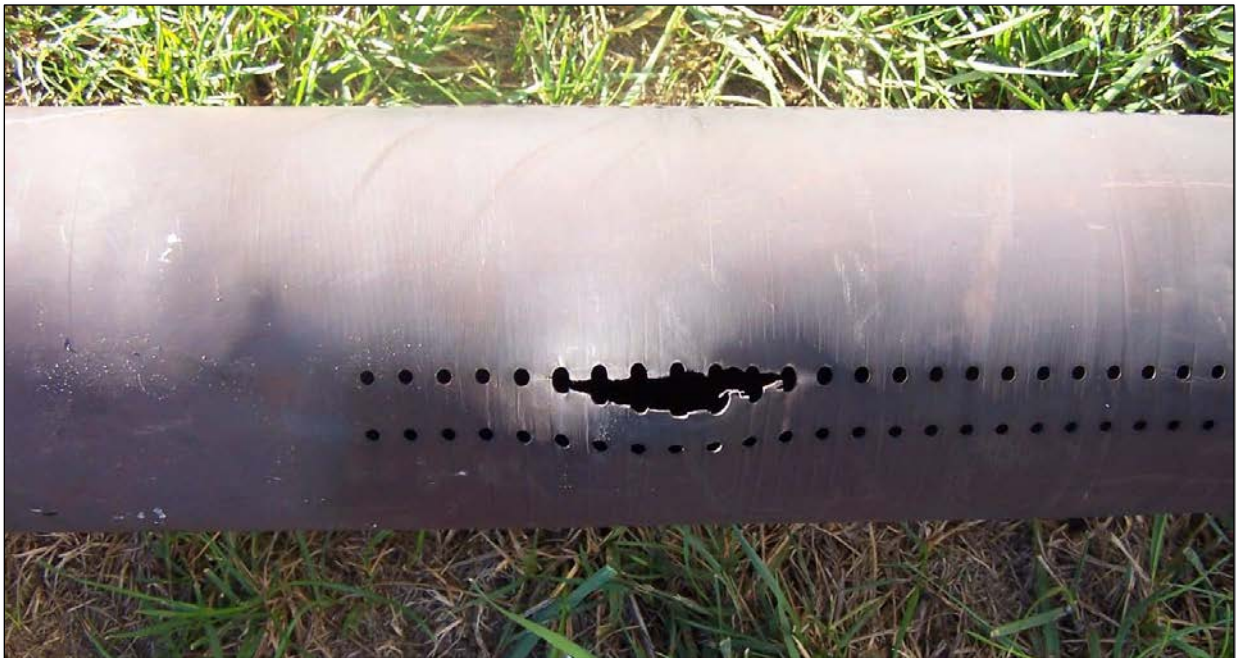
Deaerator inlet header spray pipe failure

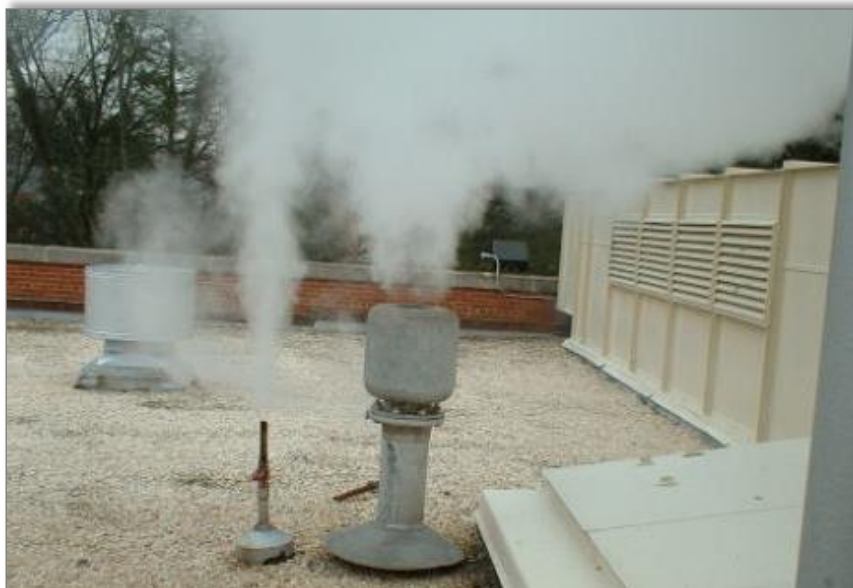
Extreme, excessive deaerator venting: Standard vent line and 4" bypass line flowing at very high rates. Root cause was the deaerator steam supply PRV stuck open, over pressurizing the system and lifting the multiport bypass relief valve. Result: 24,000 lbs. per hour of steam being wasted to atmosphere

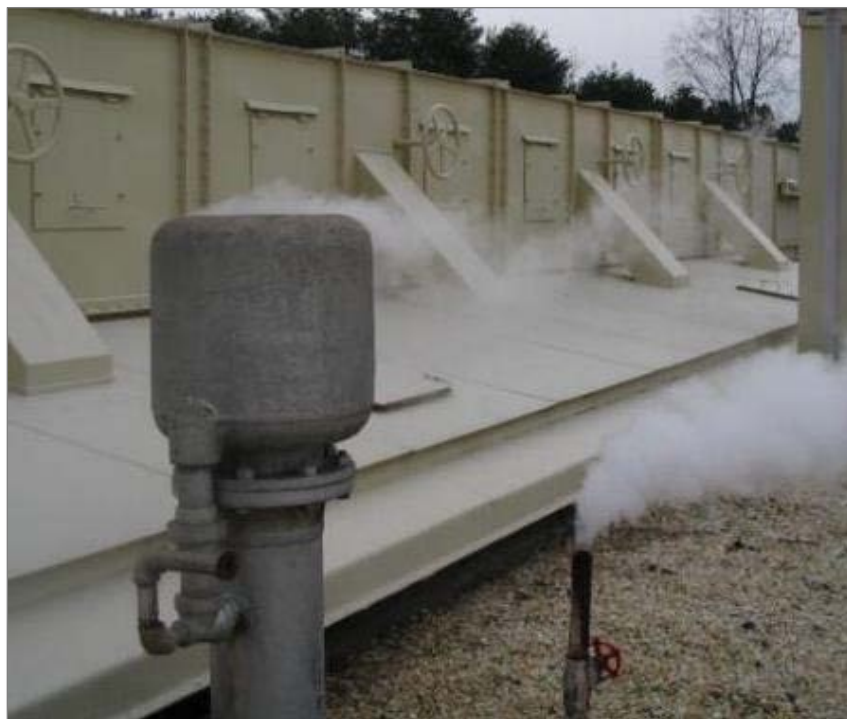
Normal venting: 4 inch bypass valve off and more normal vent line flow after replacing the pressure reducing valve

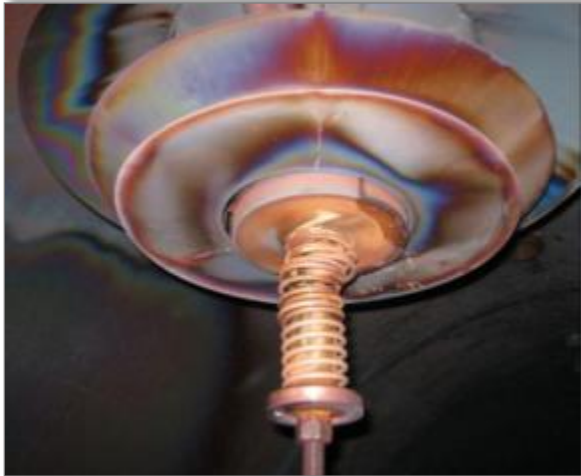
Deaerator spray valve spring failure

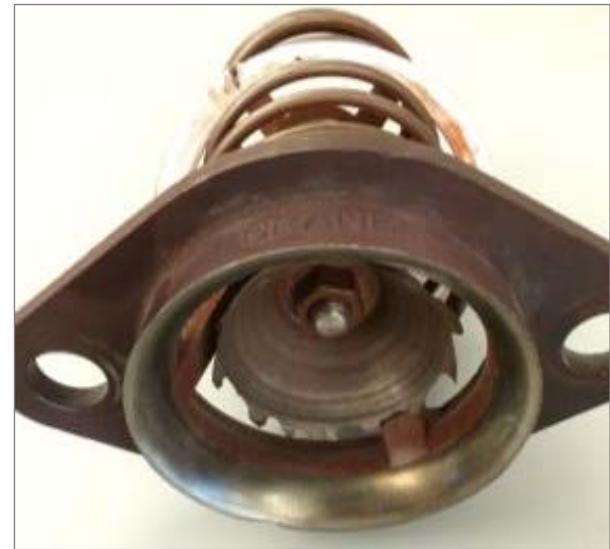
Mechanically damaged deaerator spray valve

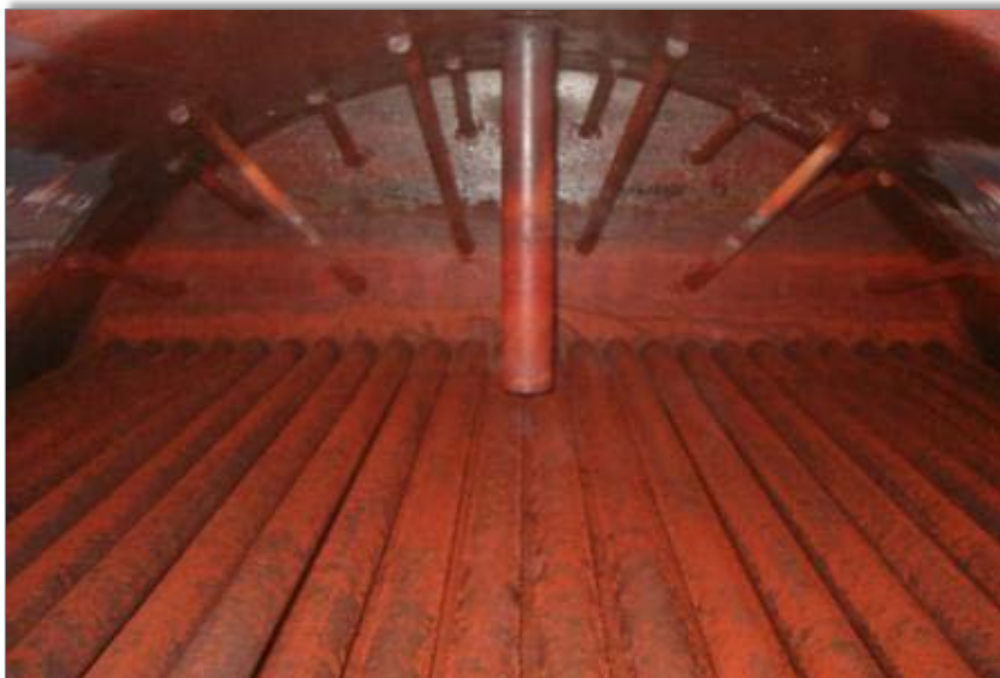
Tubes showing surface iron deposits and flash rusting

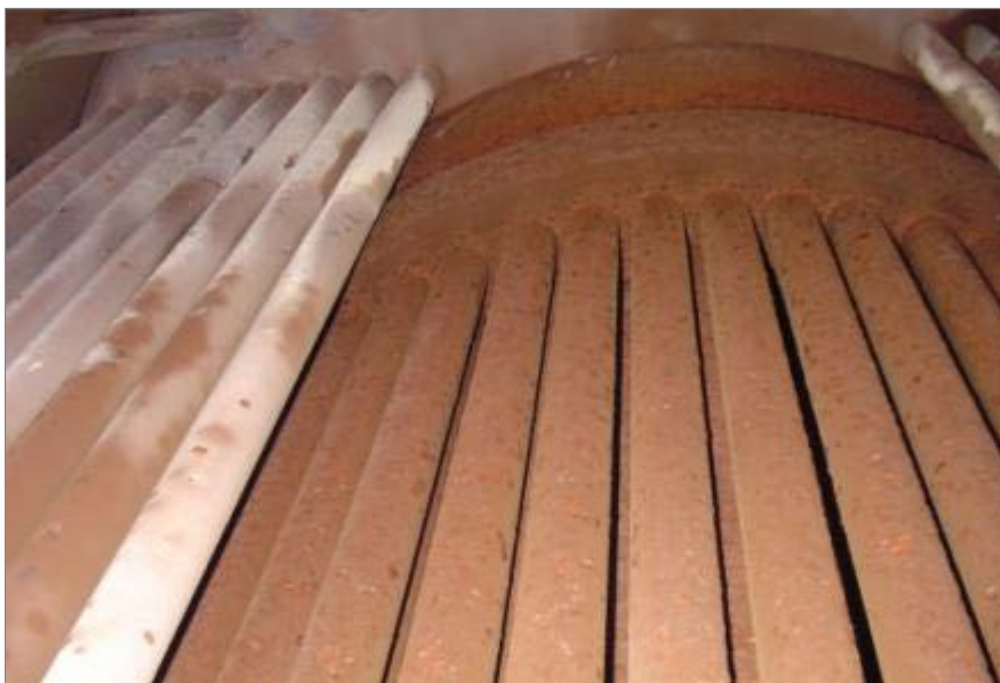
Tubes viewed from man-way, white deposits from evaporation to dryness

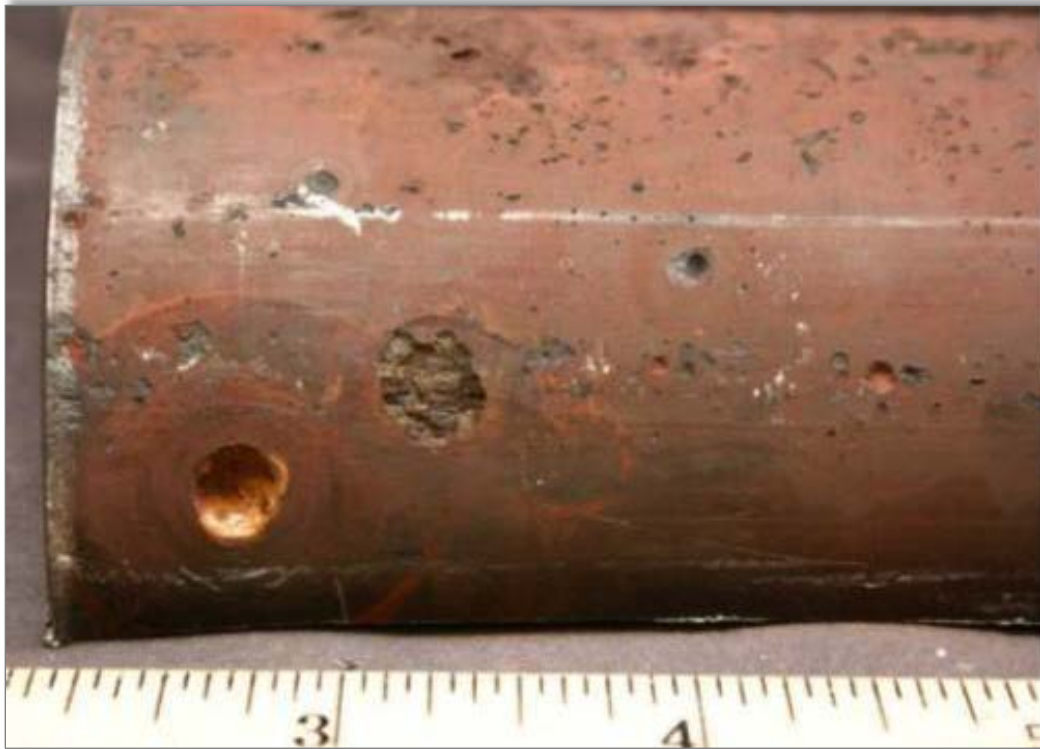
Oxygen pitting, before cleaning

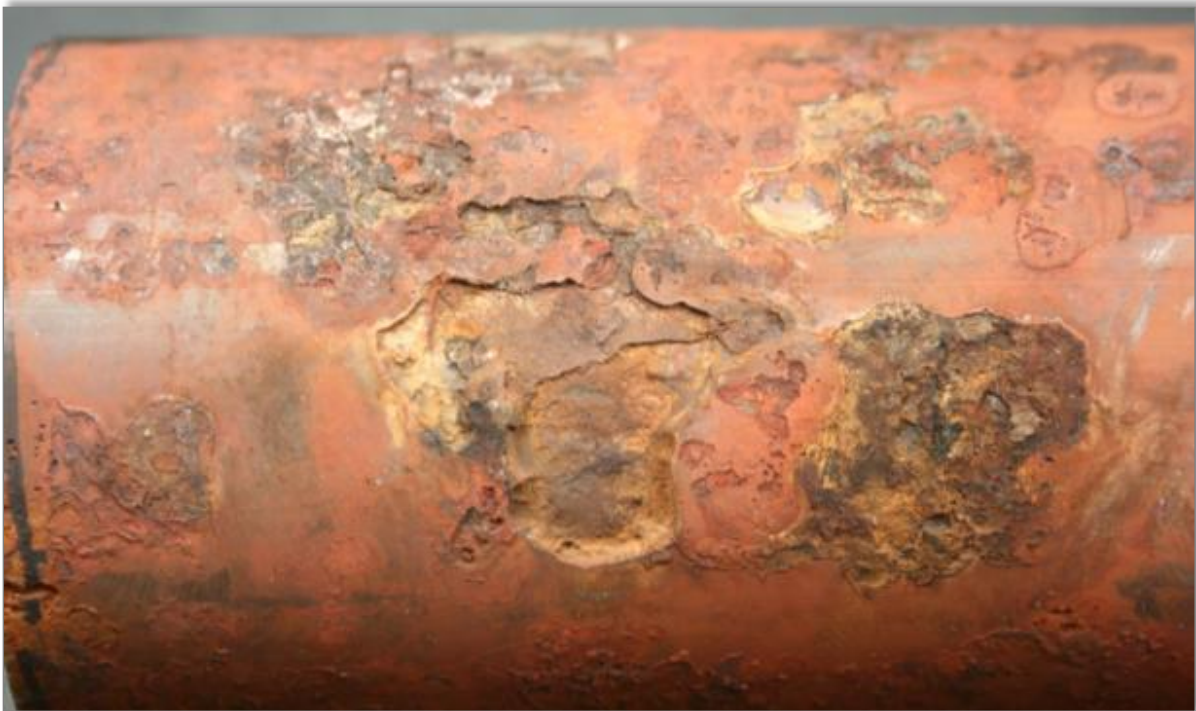
Oxygen pitting before cleaning – resulting from oxygen intrusion during offline storage

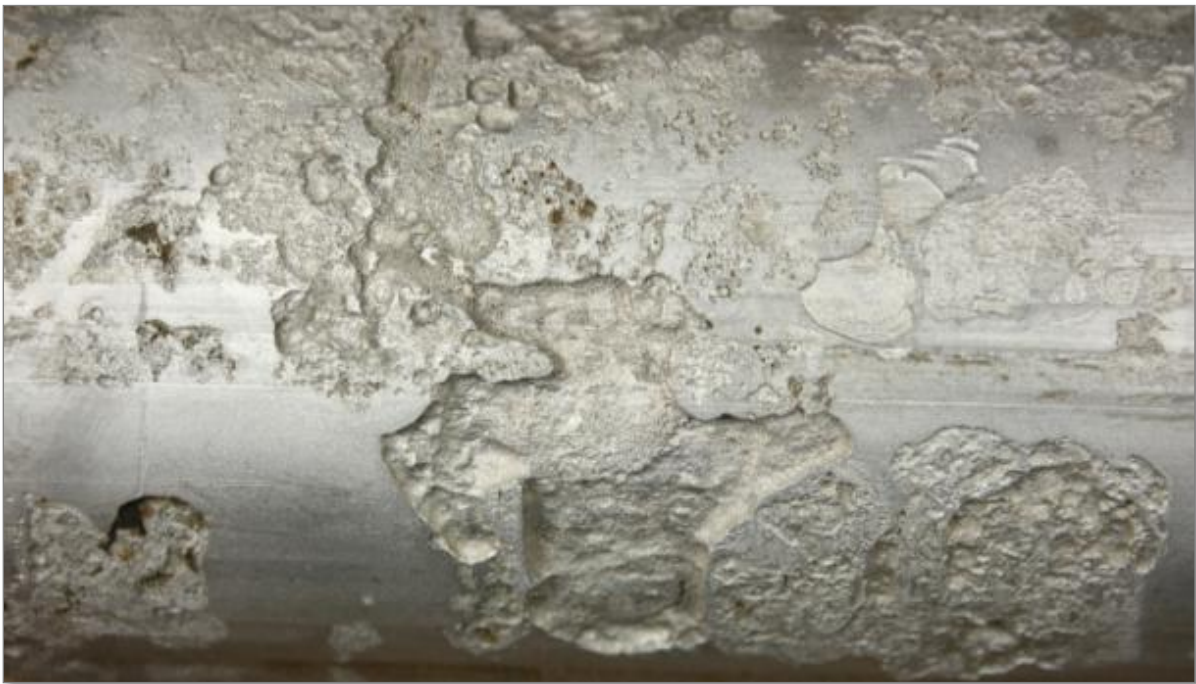
Oxygen pitting after cleaning

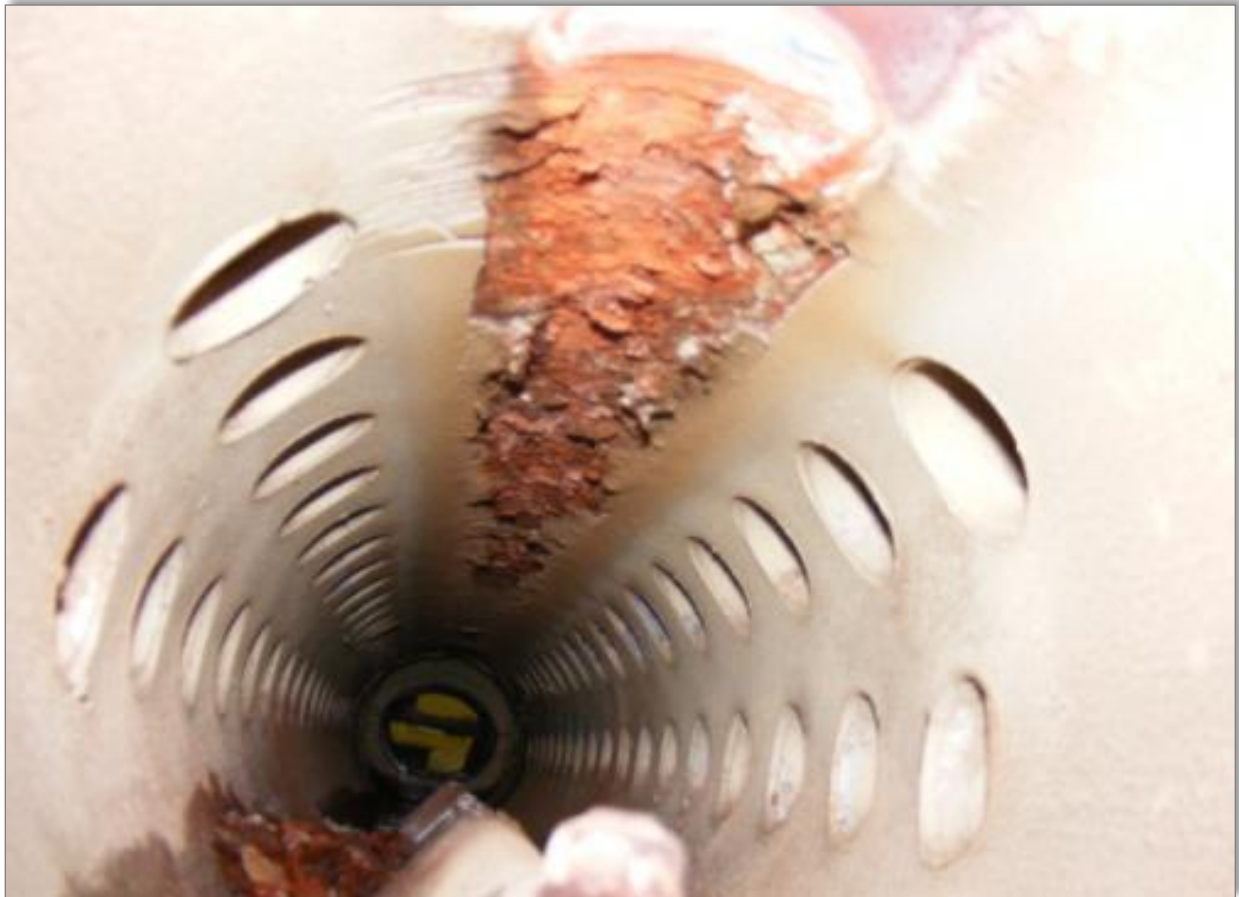
Overhead deposits due to external protective refractory loss allowed furnace gases to penetrate to top of the header and cause steam blanketing and concentration of boiler water, localized corrosion and evaporation to dryness on internal header surface.

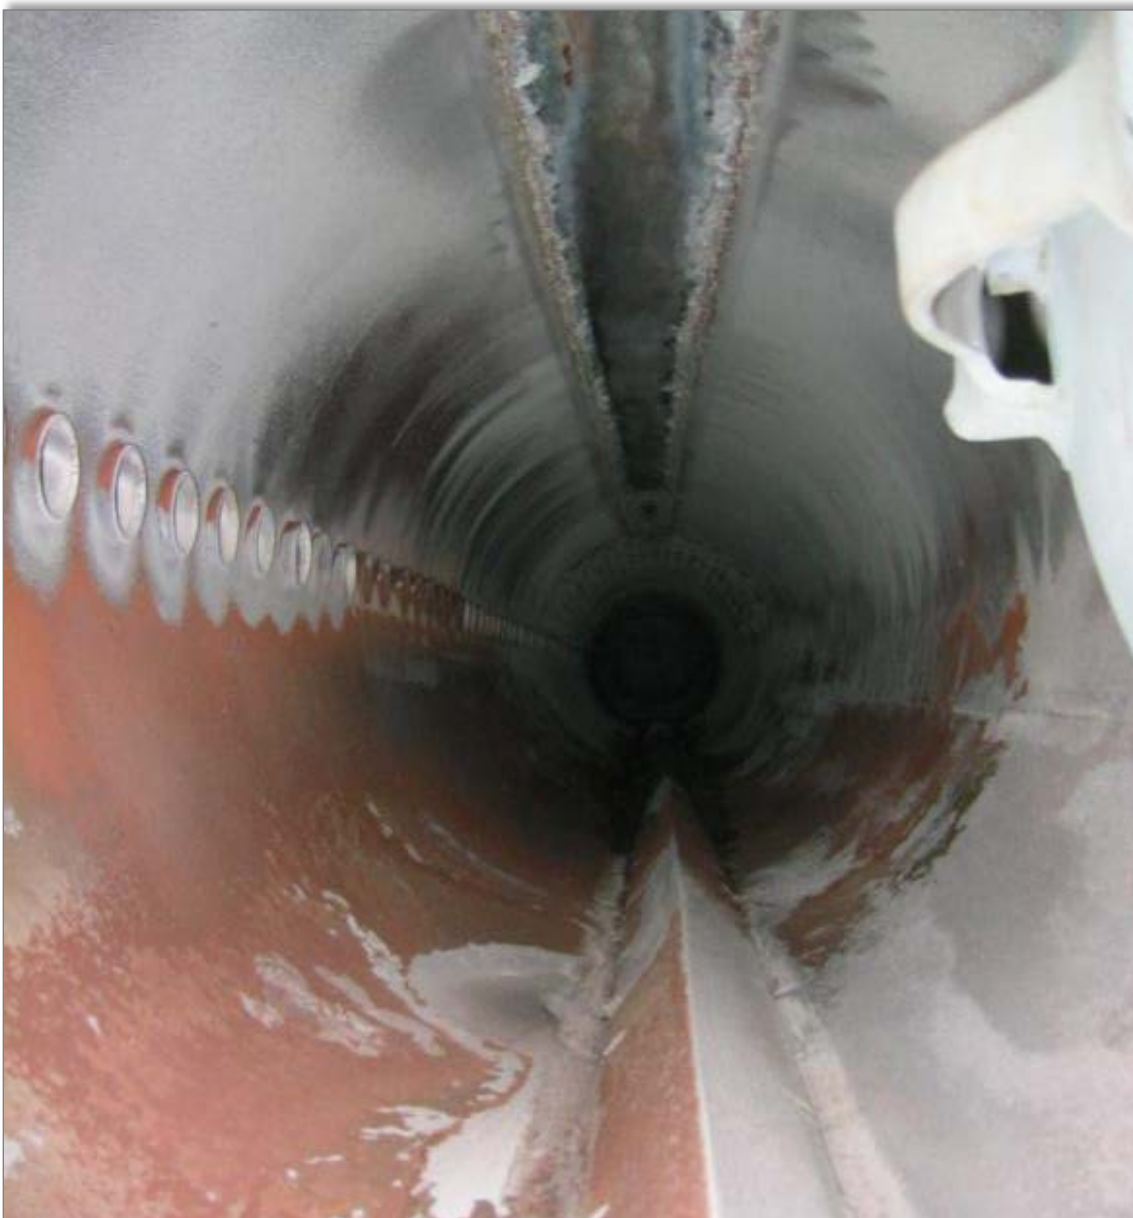
Deposits formed in the top of the drum due to refractory brick deterioration on the furnace floor above allowing hot combustion gases to penetrate through to top of the mud drum and cause steam blanketing and concentration of boiler water, localized corrosion and evaporation to dryness on internal drum surface. Deposits sloughed from tubes have accumulated at the bottom of the drum, partially blocking the inverted blowdown channel ports.

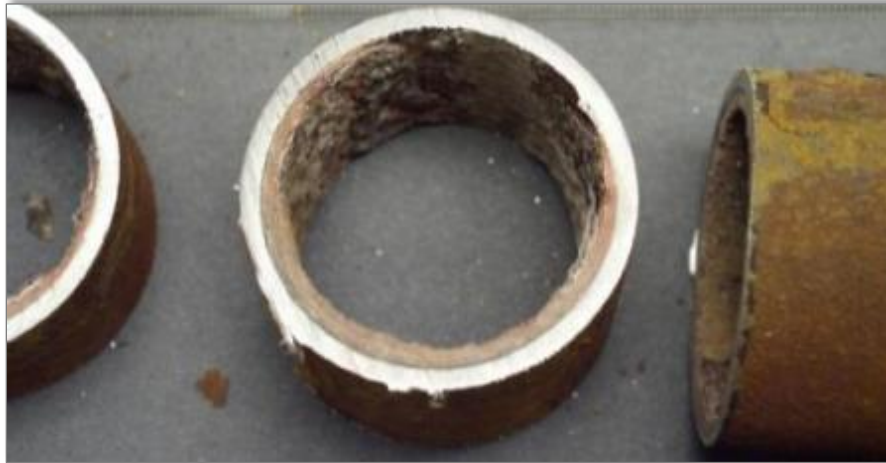
Boiler tube with iron and silica scale

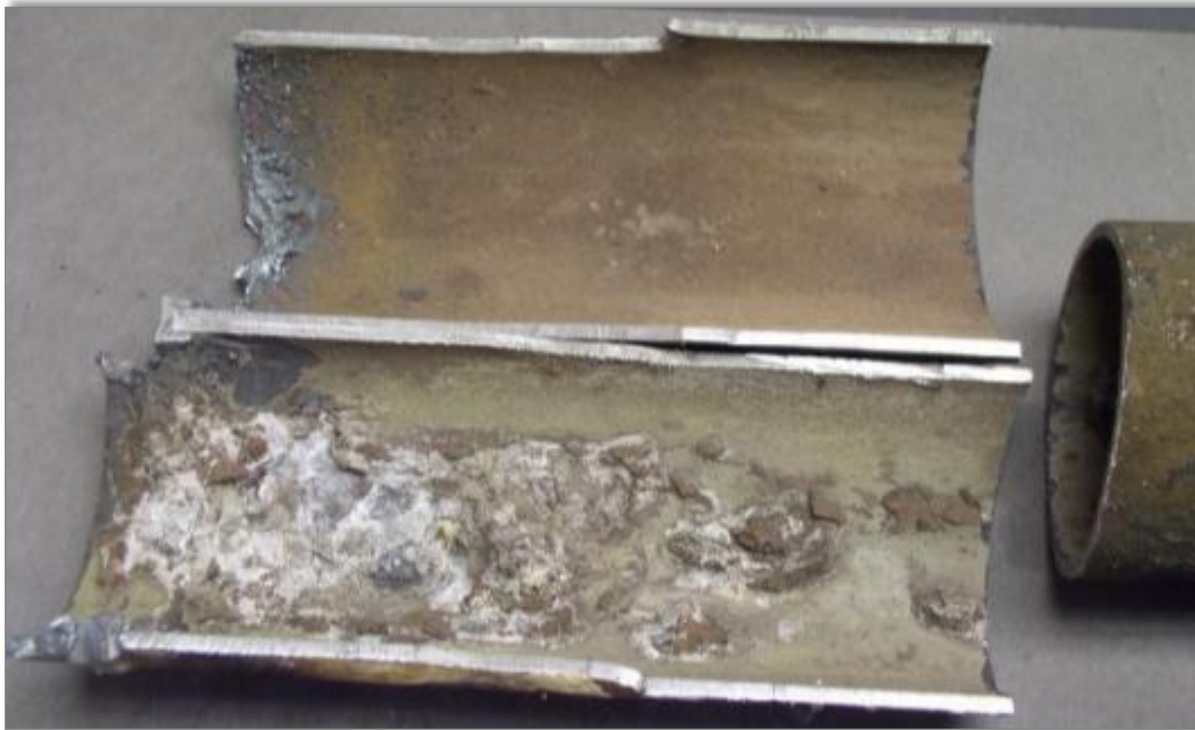
Inclined overhead boiler tube – deposits on the inside (bottom) surface facing the furnace

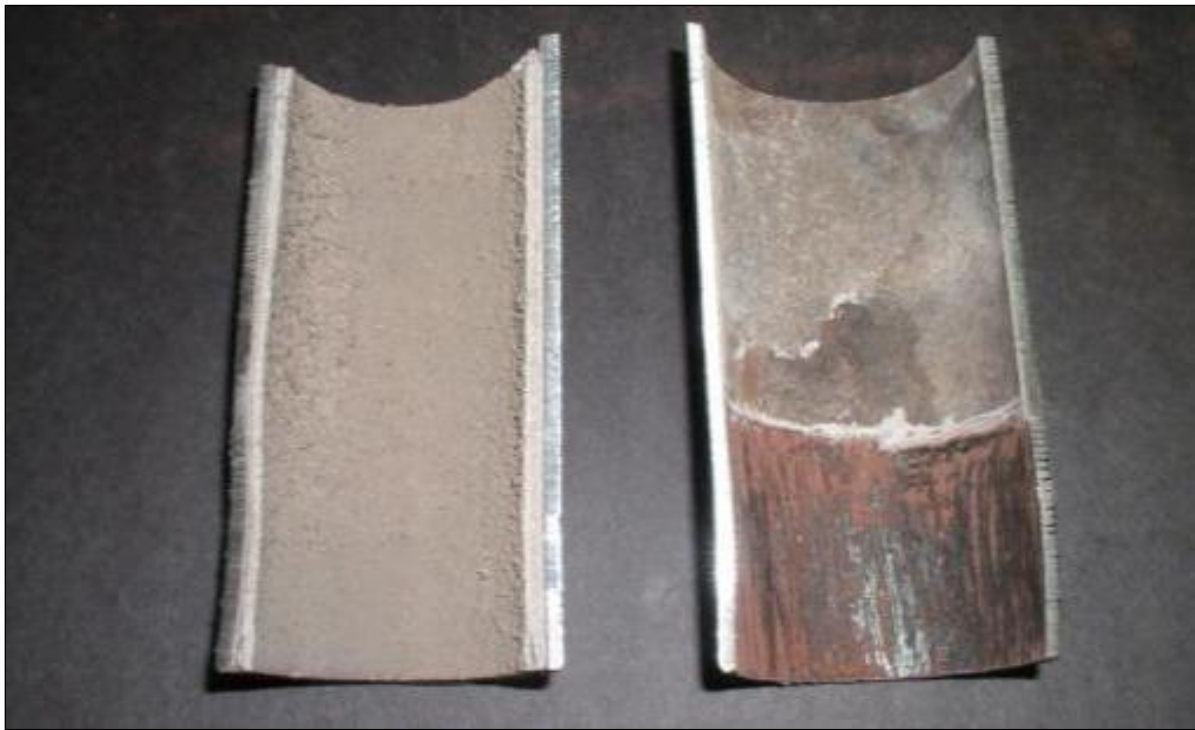
Tube mineral scale removed for deposit weight density determination. Scrape and weigh method vs. glass bead blasting

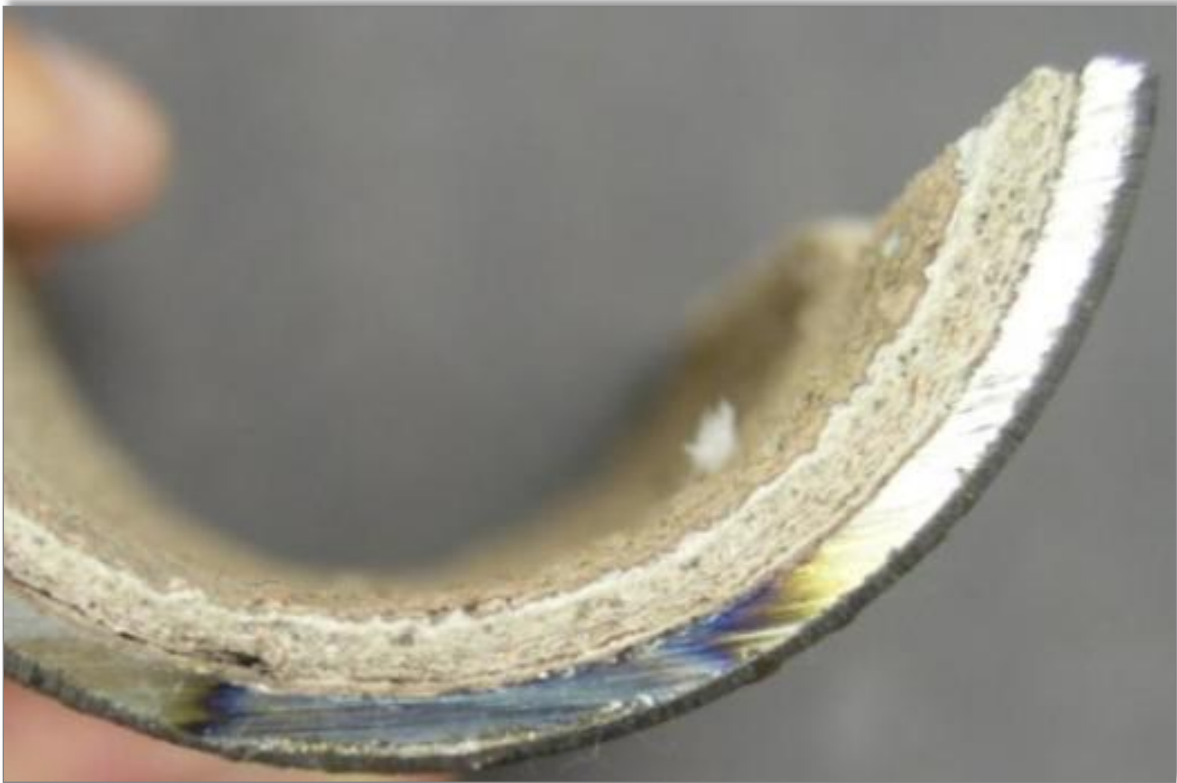
Tube scale layering due to multiple feedwater hardness excursions

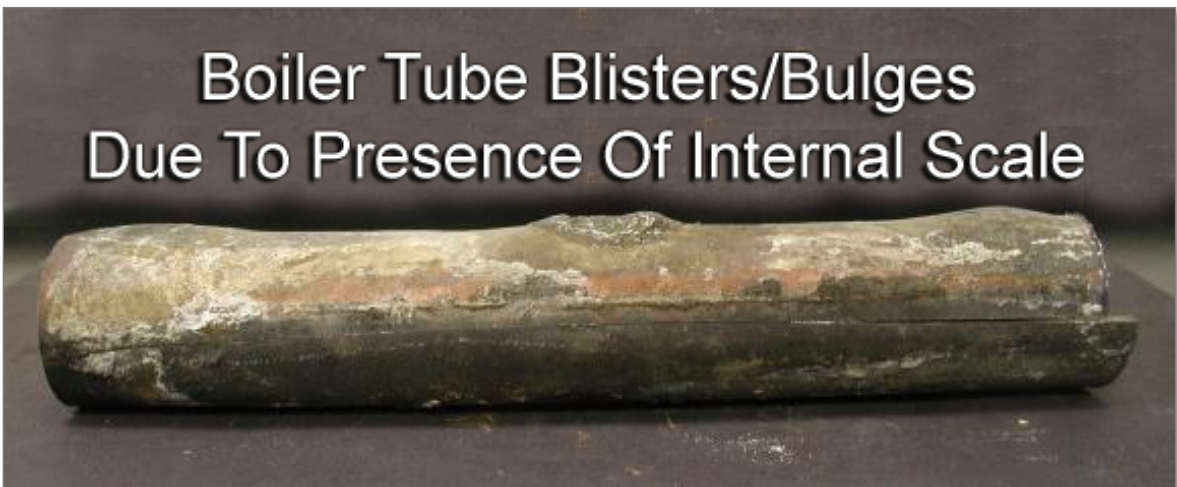
Internal surface scale restricted thru-wall heat transfer causing the tube metal to overheat, bulge, and ultimately fail.

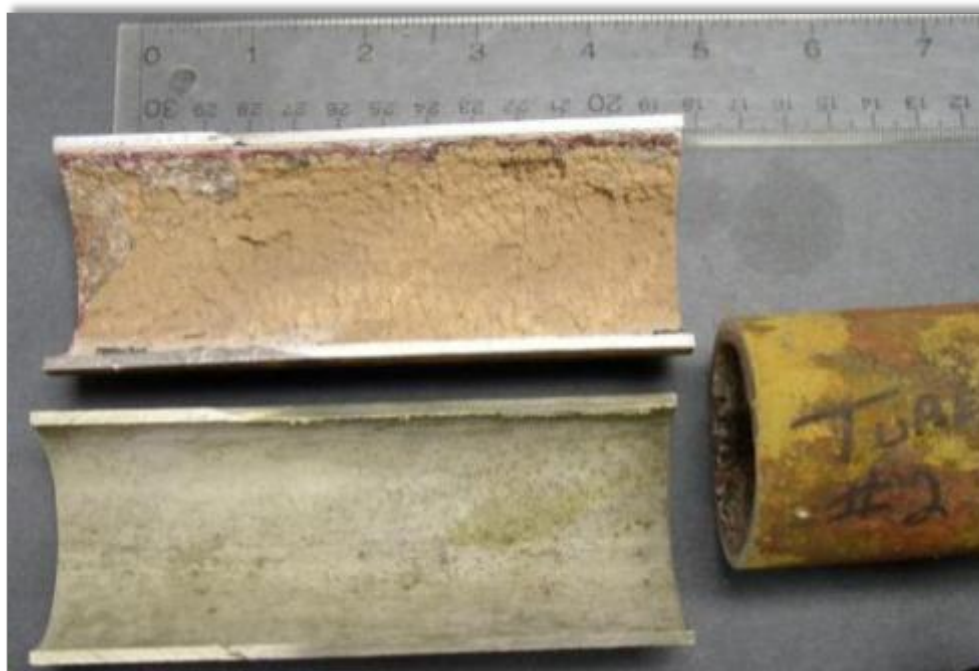
Tube with as-received (top) and as-cleaned (bottom) sections

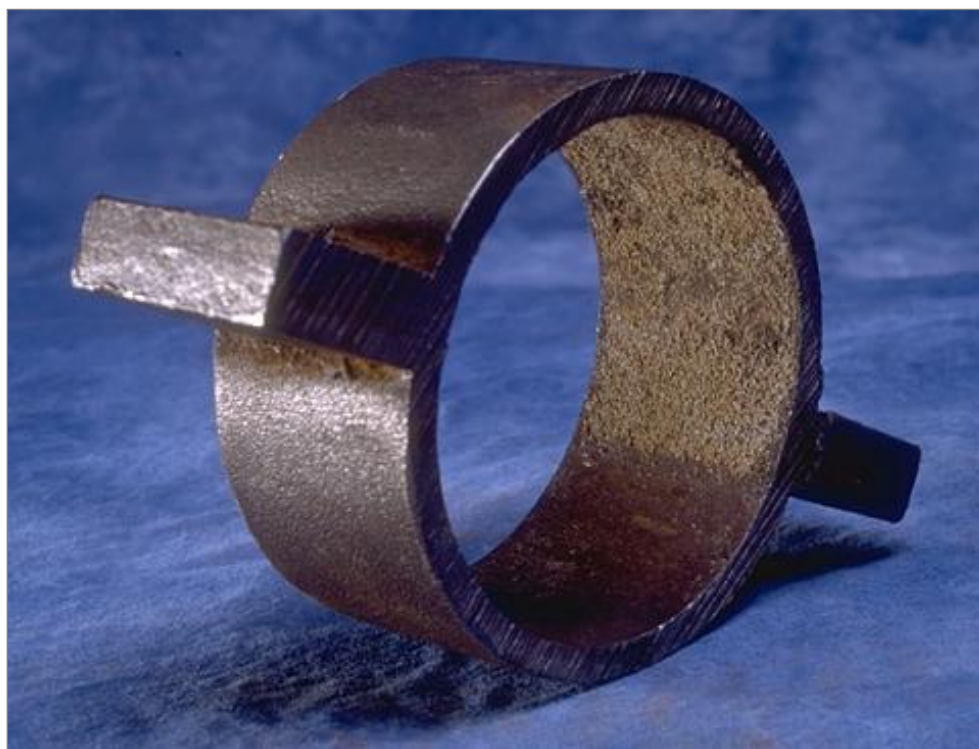
Rare example of a furnace wall tube section showing the effect of differential deposition from furnace zone radiant heat input (top side) vs. convection zone return gas passage (bottom side).
