# BOILER SYSTEM FAILURES

## *Analysis & Diagnostics Manual*

### EXAMPLES OF ISSUES IN SPECIFIC BOILER SYSTEM COMPONENTS

Metallurgy  
Volume 2.0 | Boiler Systems

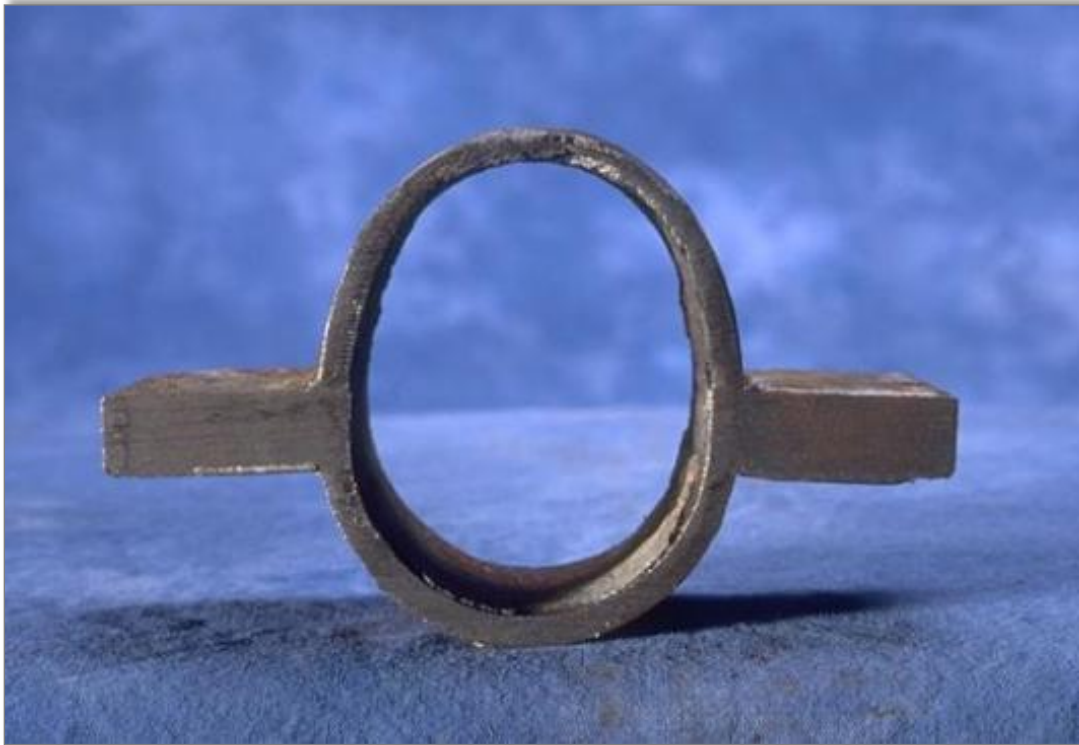
Generating tube elongated due to slow metal creep from long term overheating

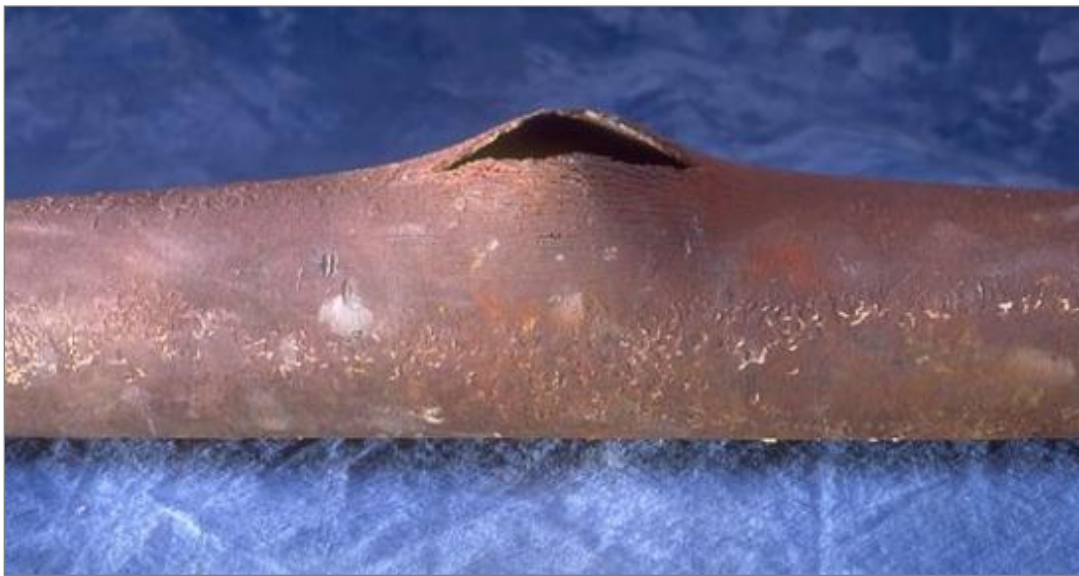
Thick lip failure due to metal creep from long term overheating  
*Lines of stretch marks visible beside tube failure*

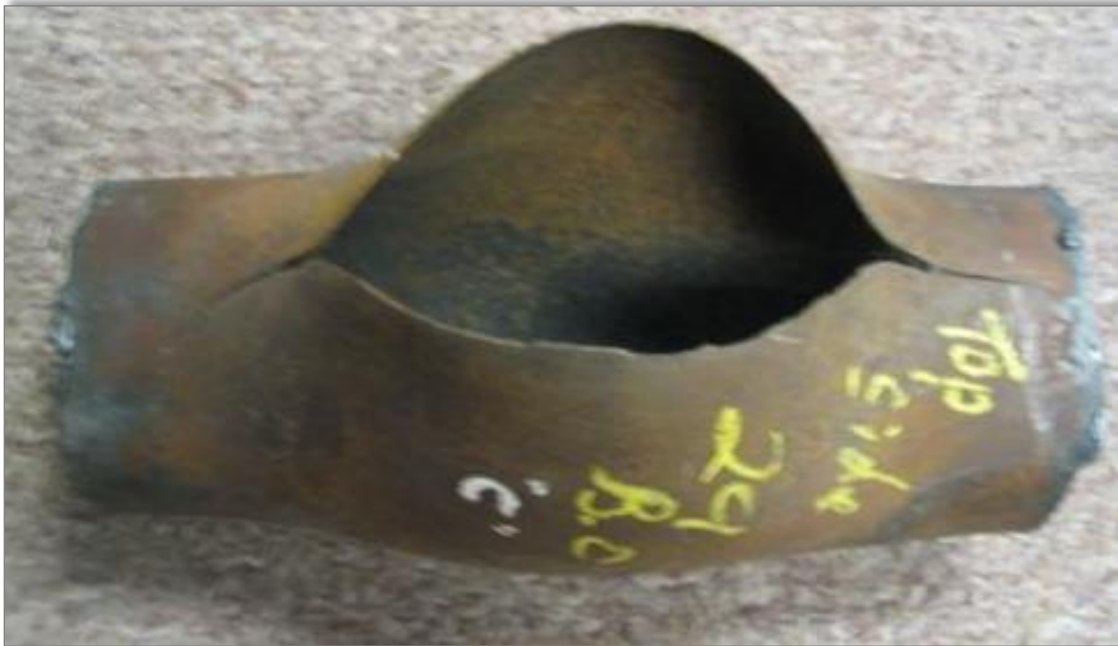
Thin lip failure due to rapid overheating

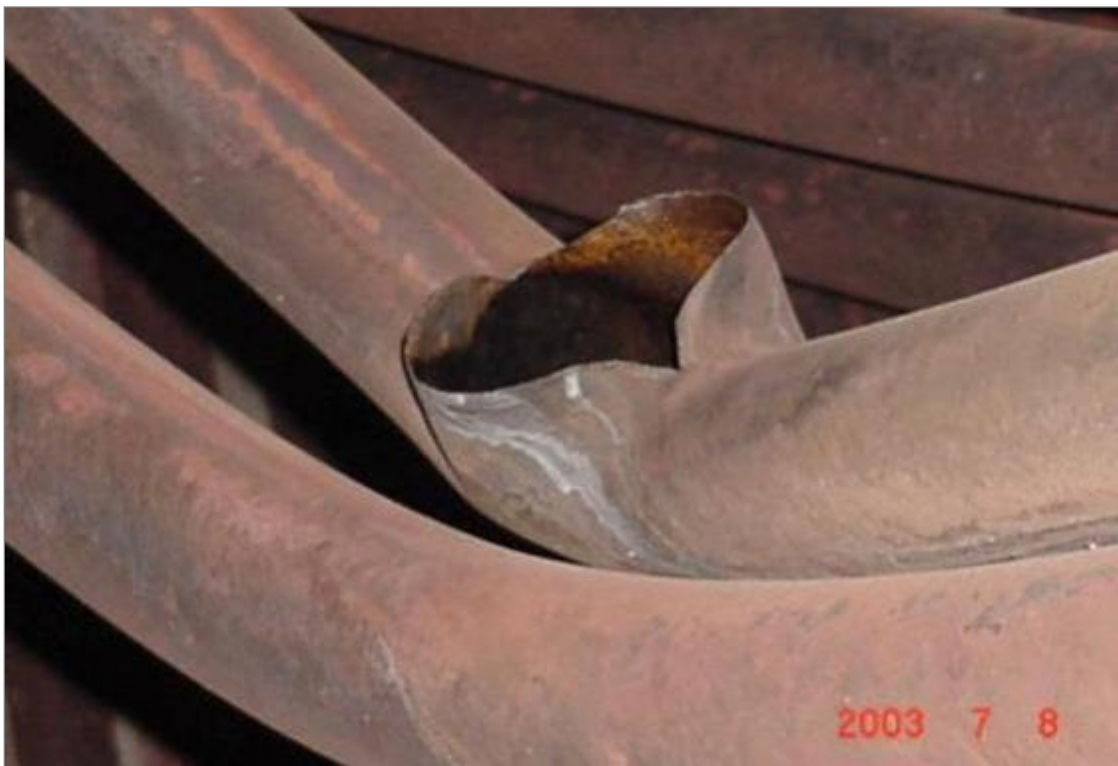
Thin lip failure due to rapid overheating

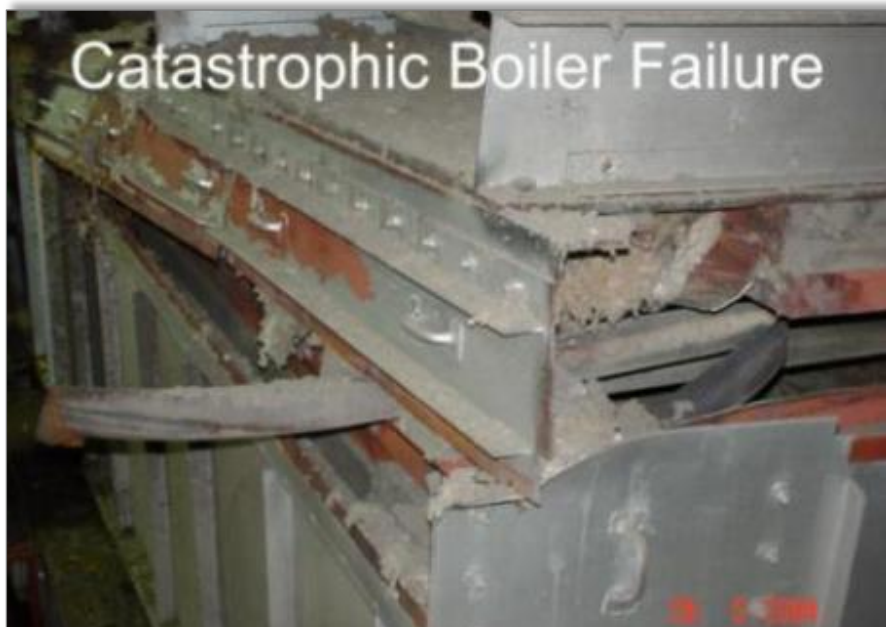
Crossover tube from upper header failed due to internal corrosion caused by oxygen pitting during layup. Several tubes sagged over time and were not corrected, resulting in incomplete draining of boiler water when off-line. Oxygen pitting at the internal stagnant waterline ultimately resulted in sudden tube failure.

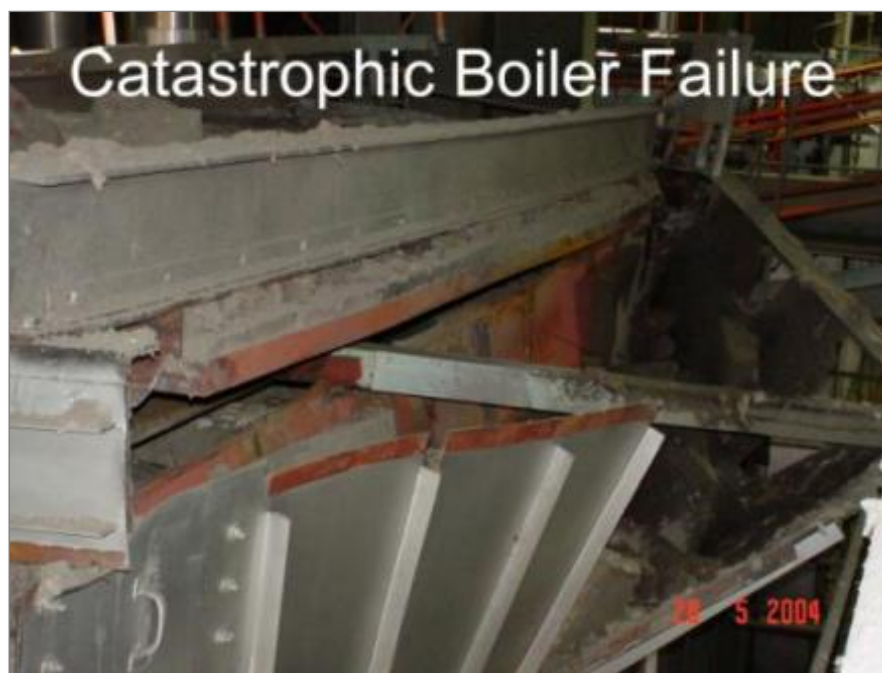
Top back plenum section of the 650 psig field erected boiler – severe damage caused by a single tube failure. The rapid steam release from the failed tube suddenly enveloped the plenum, momentarily raised the roof of the boiler and blew out the back wall.

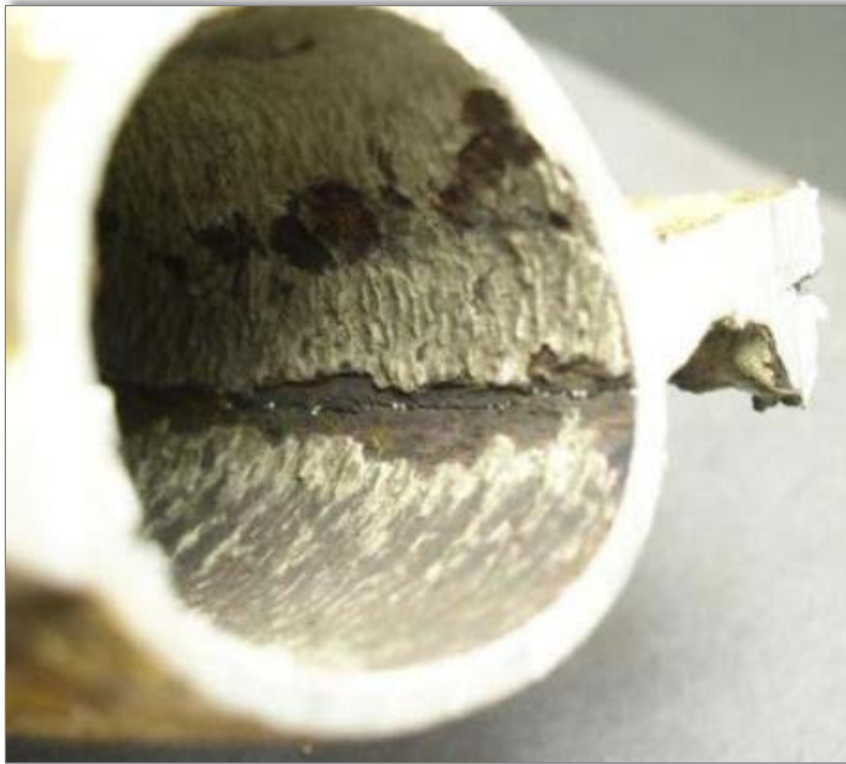
Stress crack opposite membrane weld, coincident with internal deposits which restricted heat transfer

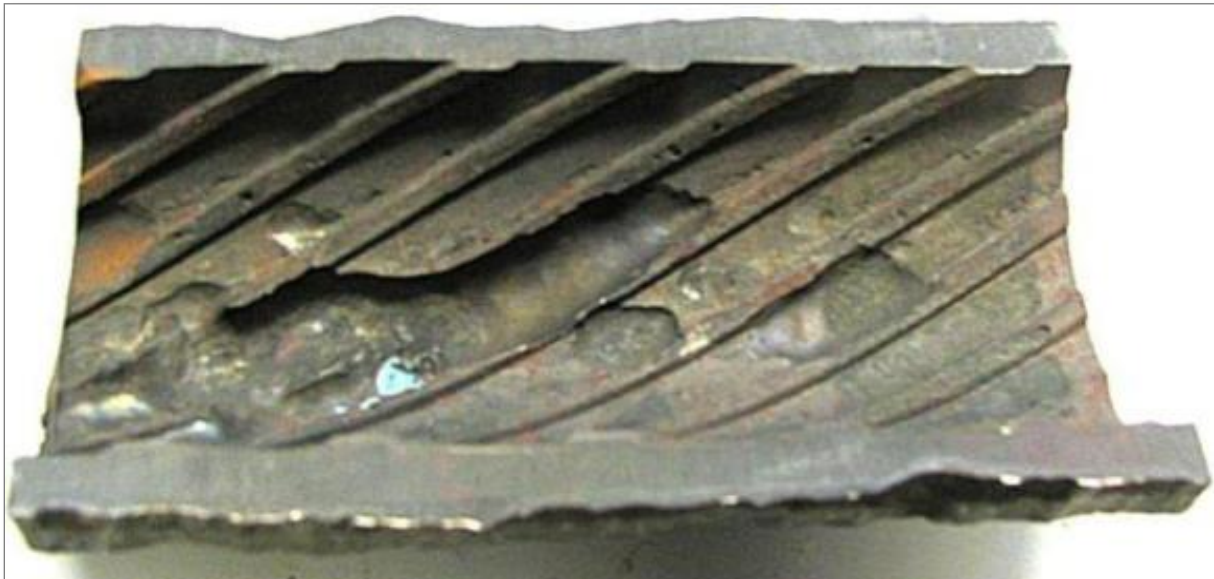
Rifled, high pressure boiler generating tube, after cleaning. Damage from condenser leak introduced chlorides from the cooling water, lowered the pH and deposited copper in the valleys of the tube. Copper since removed by cleaning with inhibited HCL.

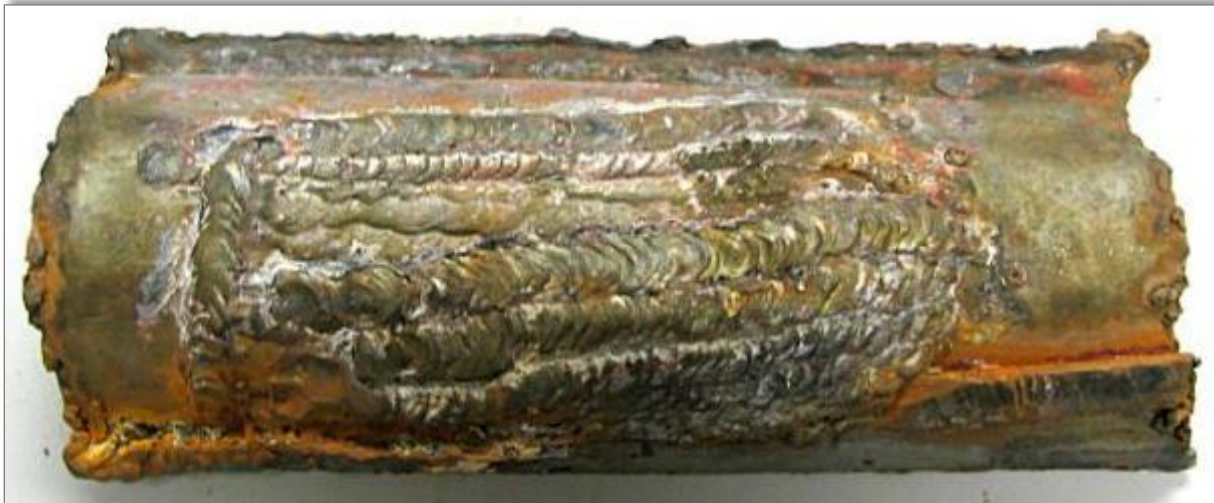
Heavy weld overlay to repair a tube leak

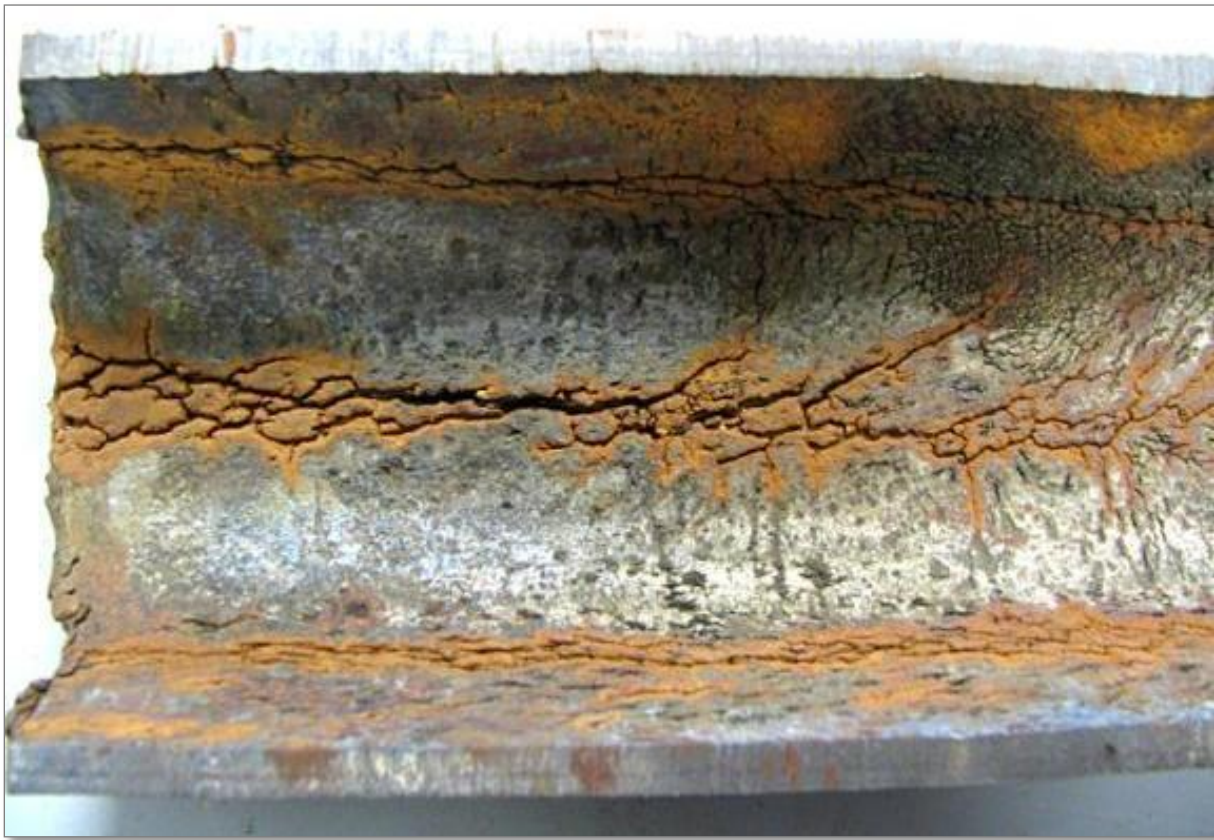
Internal tube surface cracks developed under coincident external surface weld overlay to repair a tube leak.

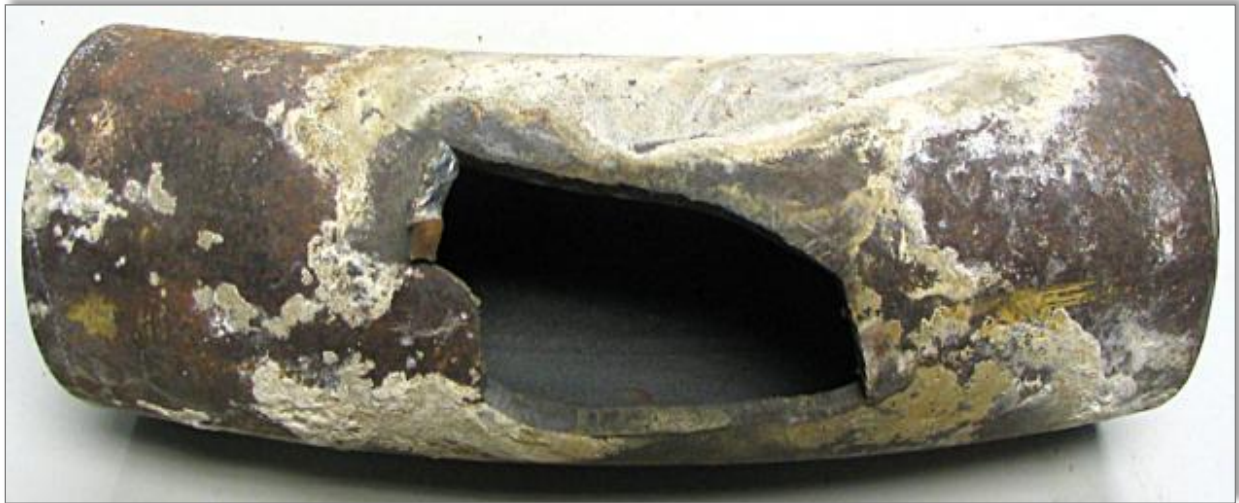
Hydrogen damage to high pressure boiler tube

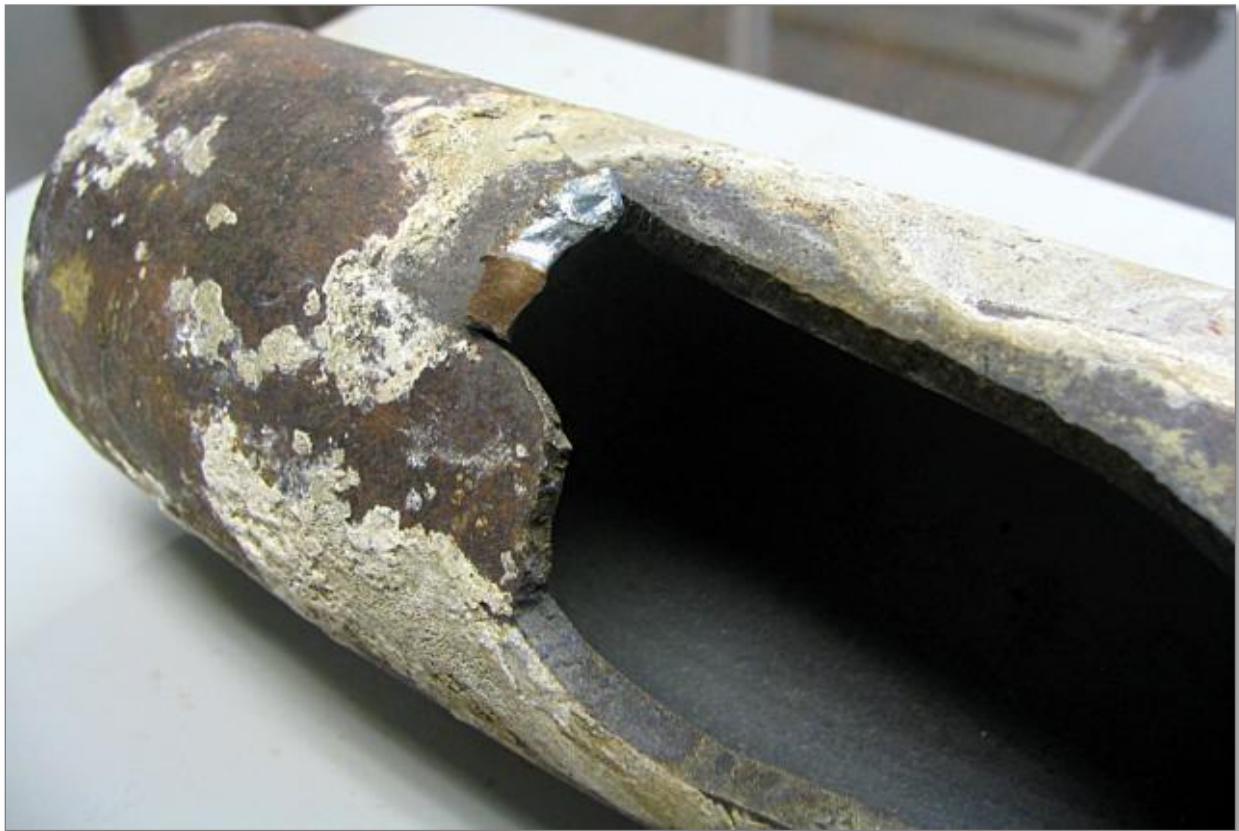
Hydrogen damage to high pressure boiler tube

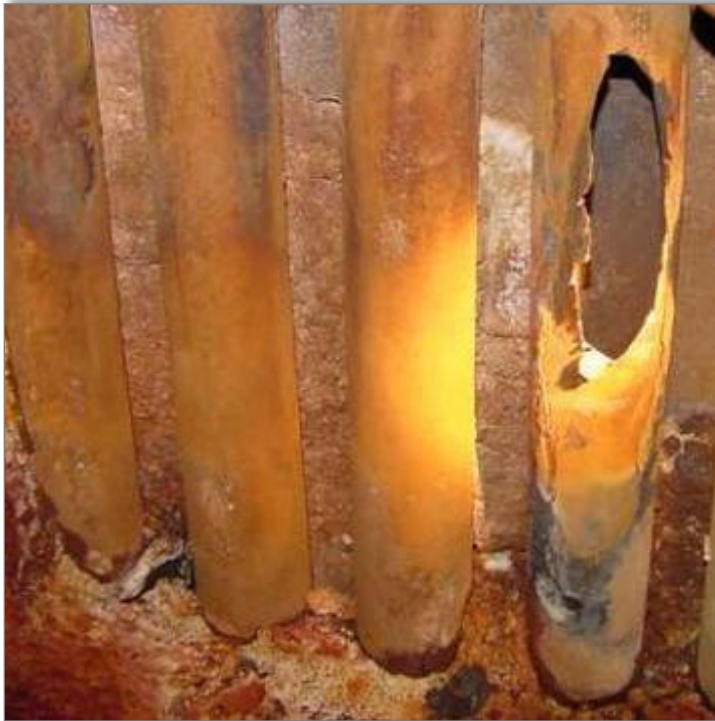
Flame impingement – rear wall

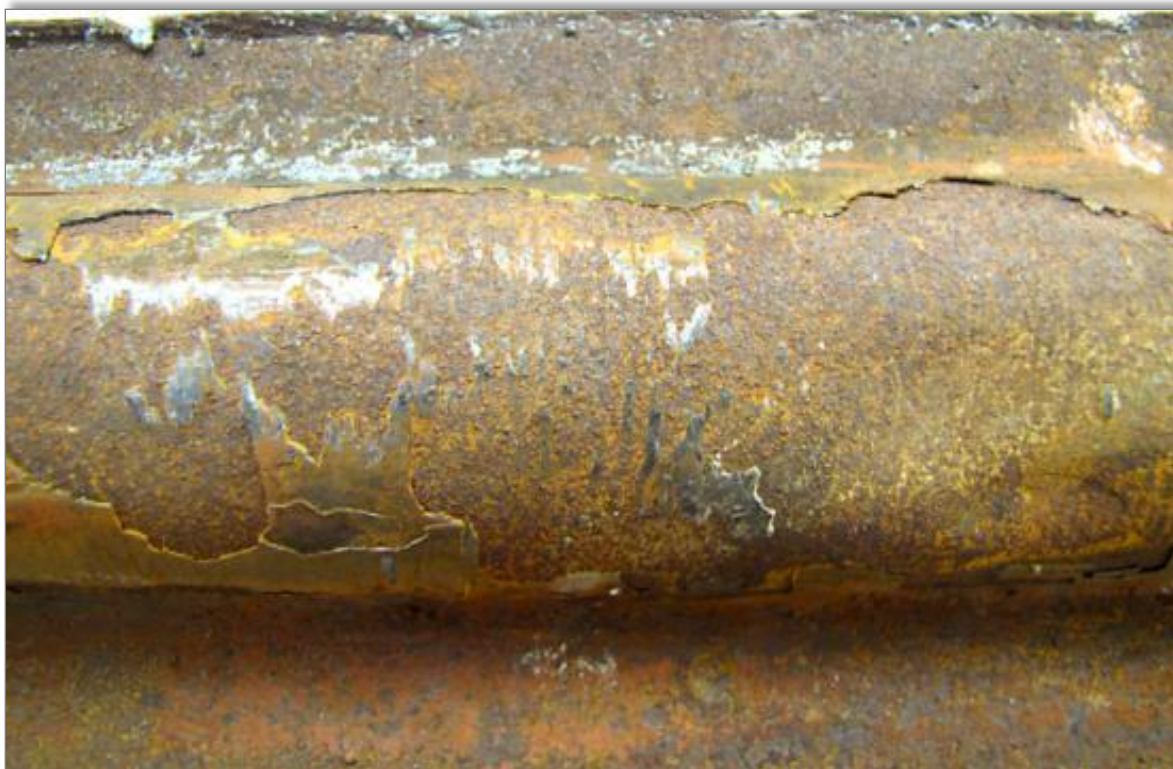
Tube surface metal exfoliation due to flame impingement, overheating

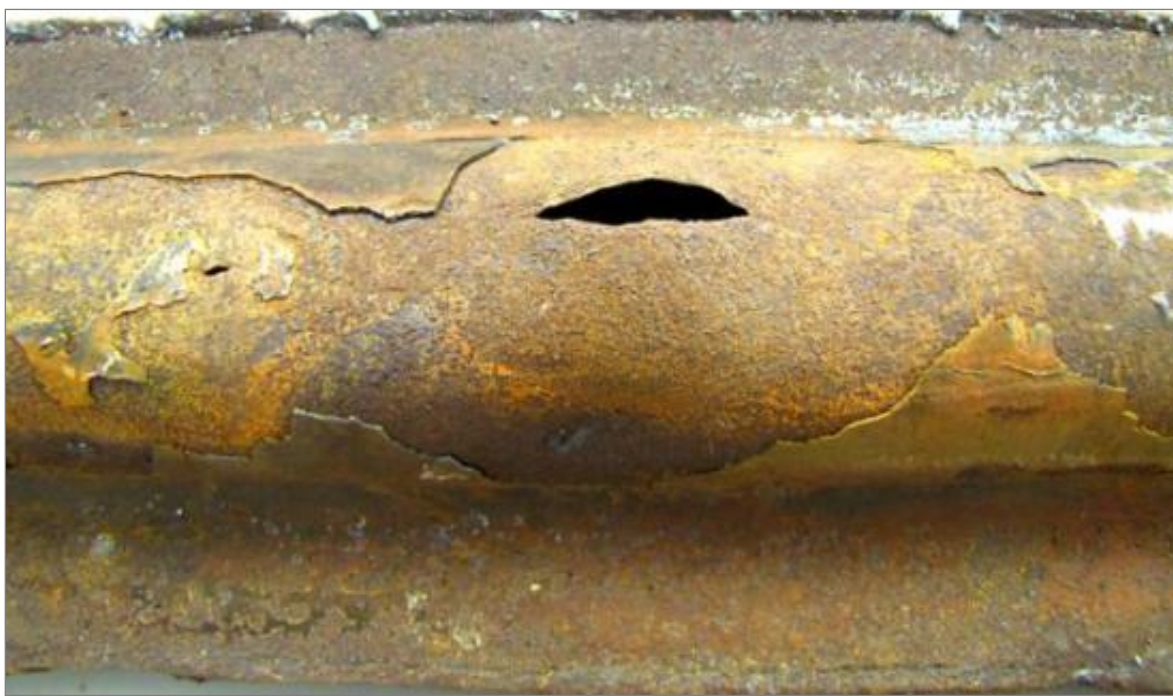
Tube metal creep and failure due to overheating from flame impingement

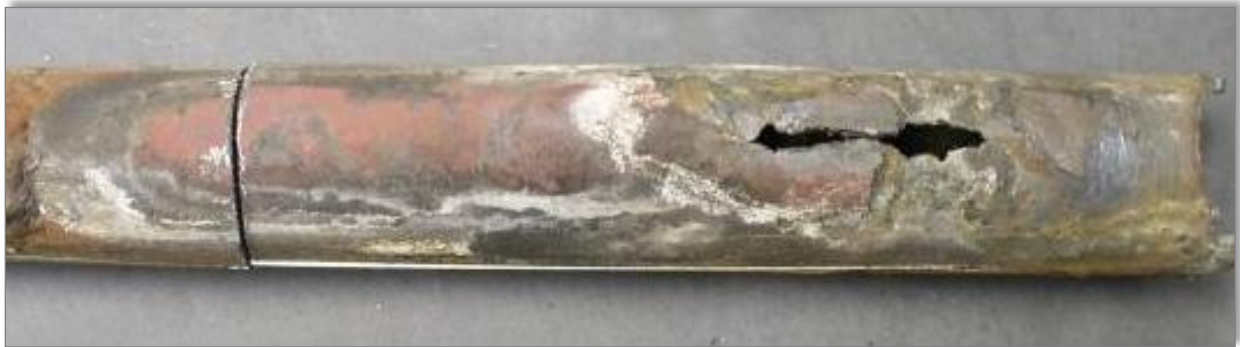
Tube surface damage resulting from flame impingement

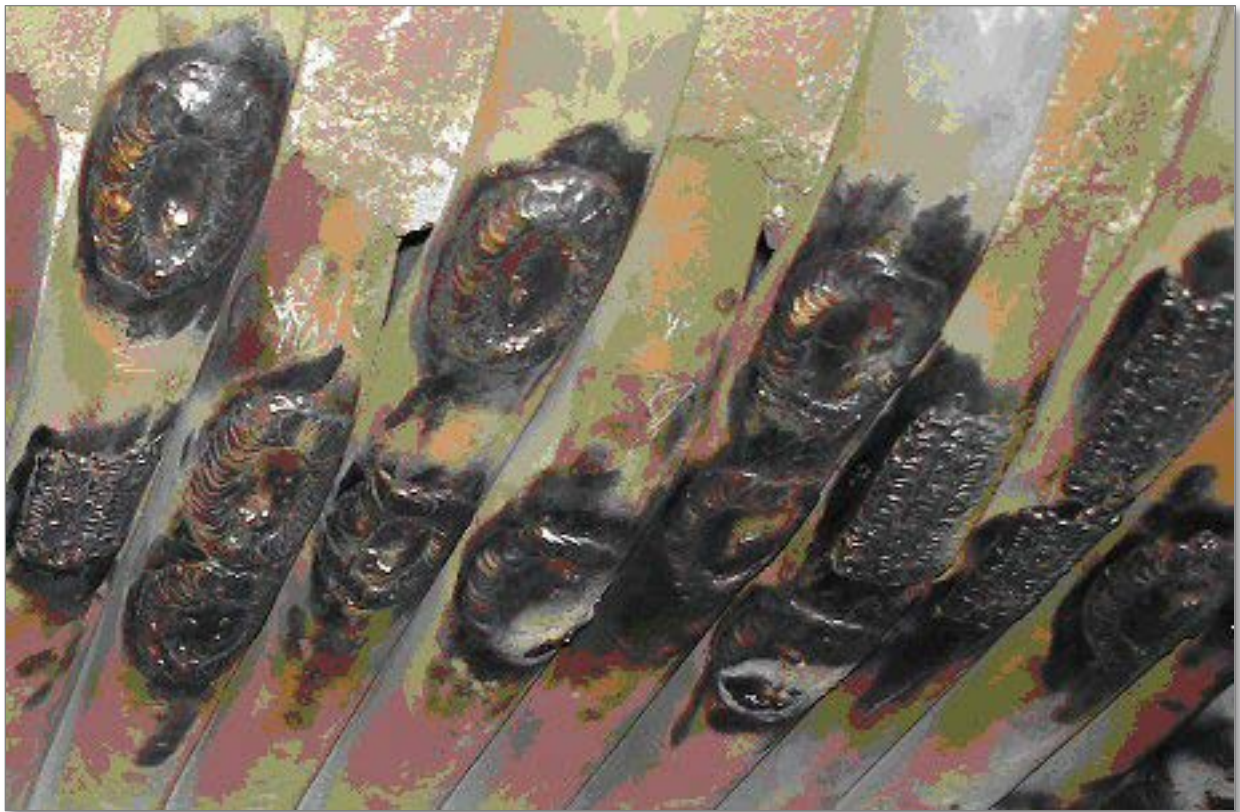
Weld overlay to repair furnace tube bulges resulting from flame impingement

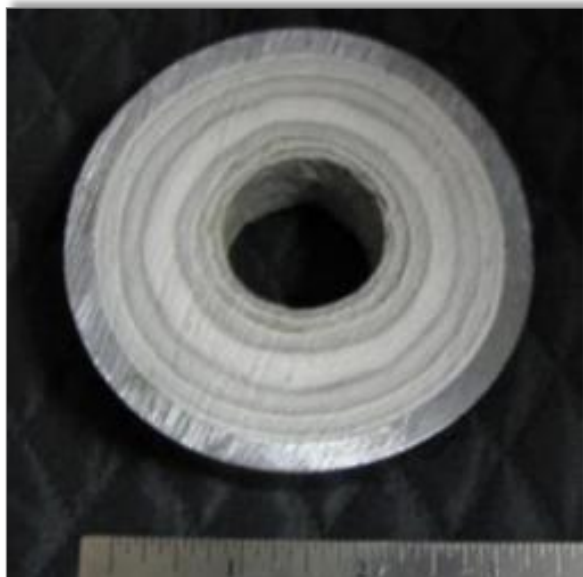
Deposits in 3 inch steam line, result of repeated instances of boiler water carryover

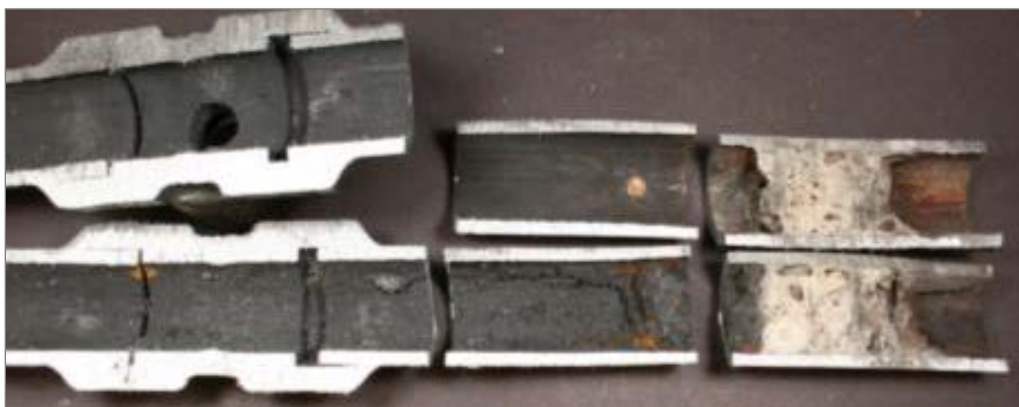
Steam line deposits

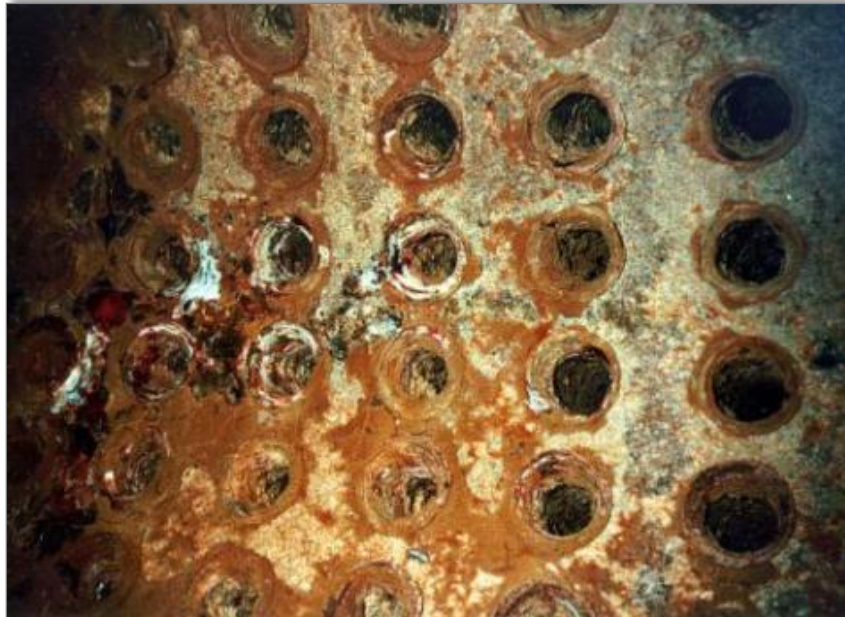
Mud drum, interior overhead view: Heavy iron, calcium and silica deposits caused by years of poor feedwater quality resulting in deposition throughout the boiler

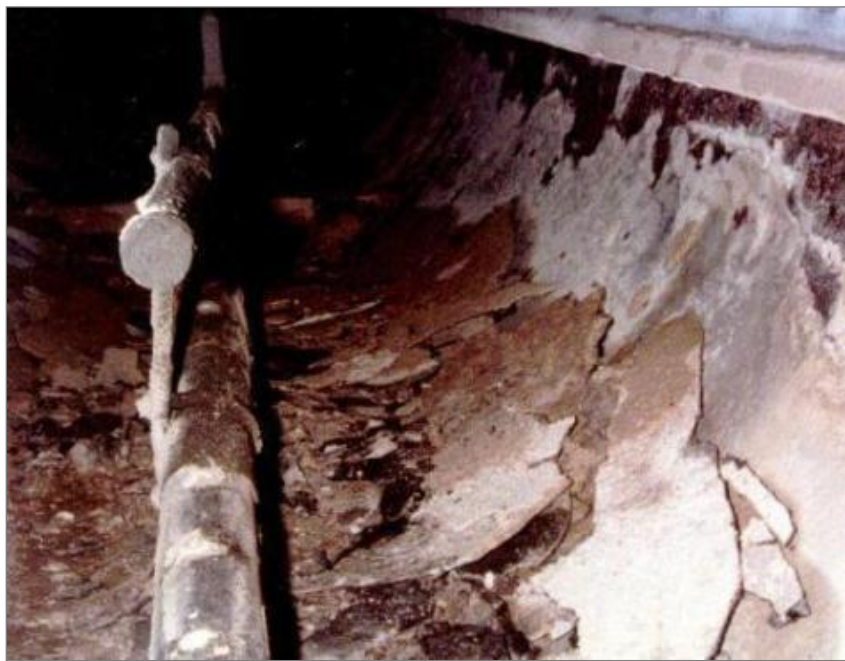
Steam drum: Extreme, excessive quantity of scale and surface deposits

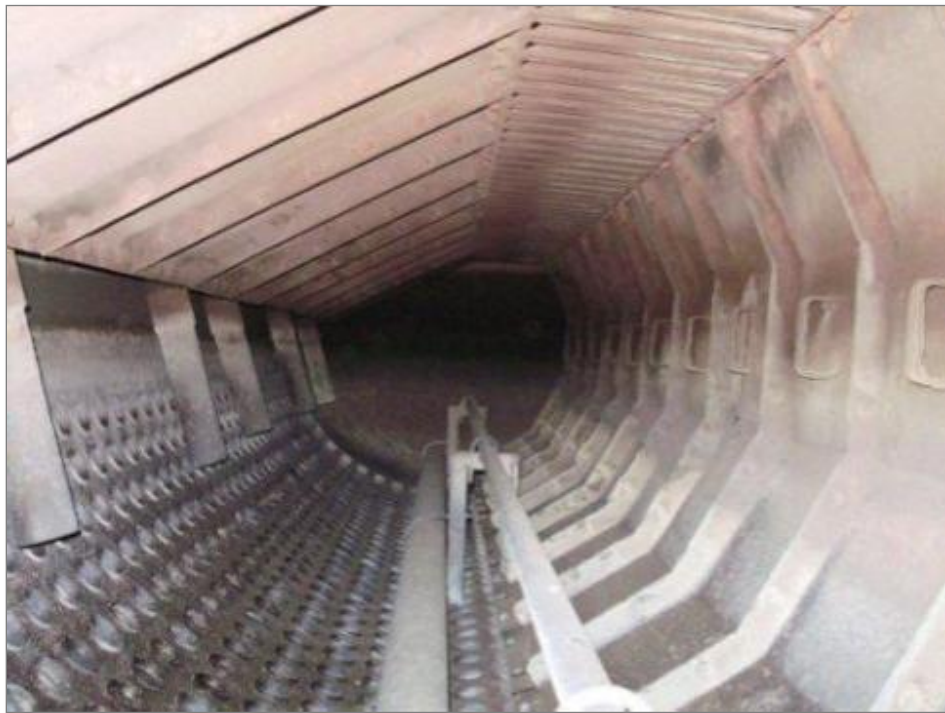
Steam drum surface after two years on an internal cleanup program

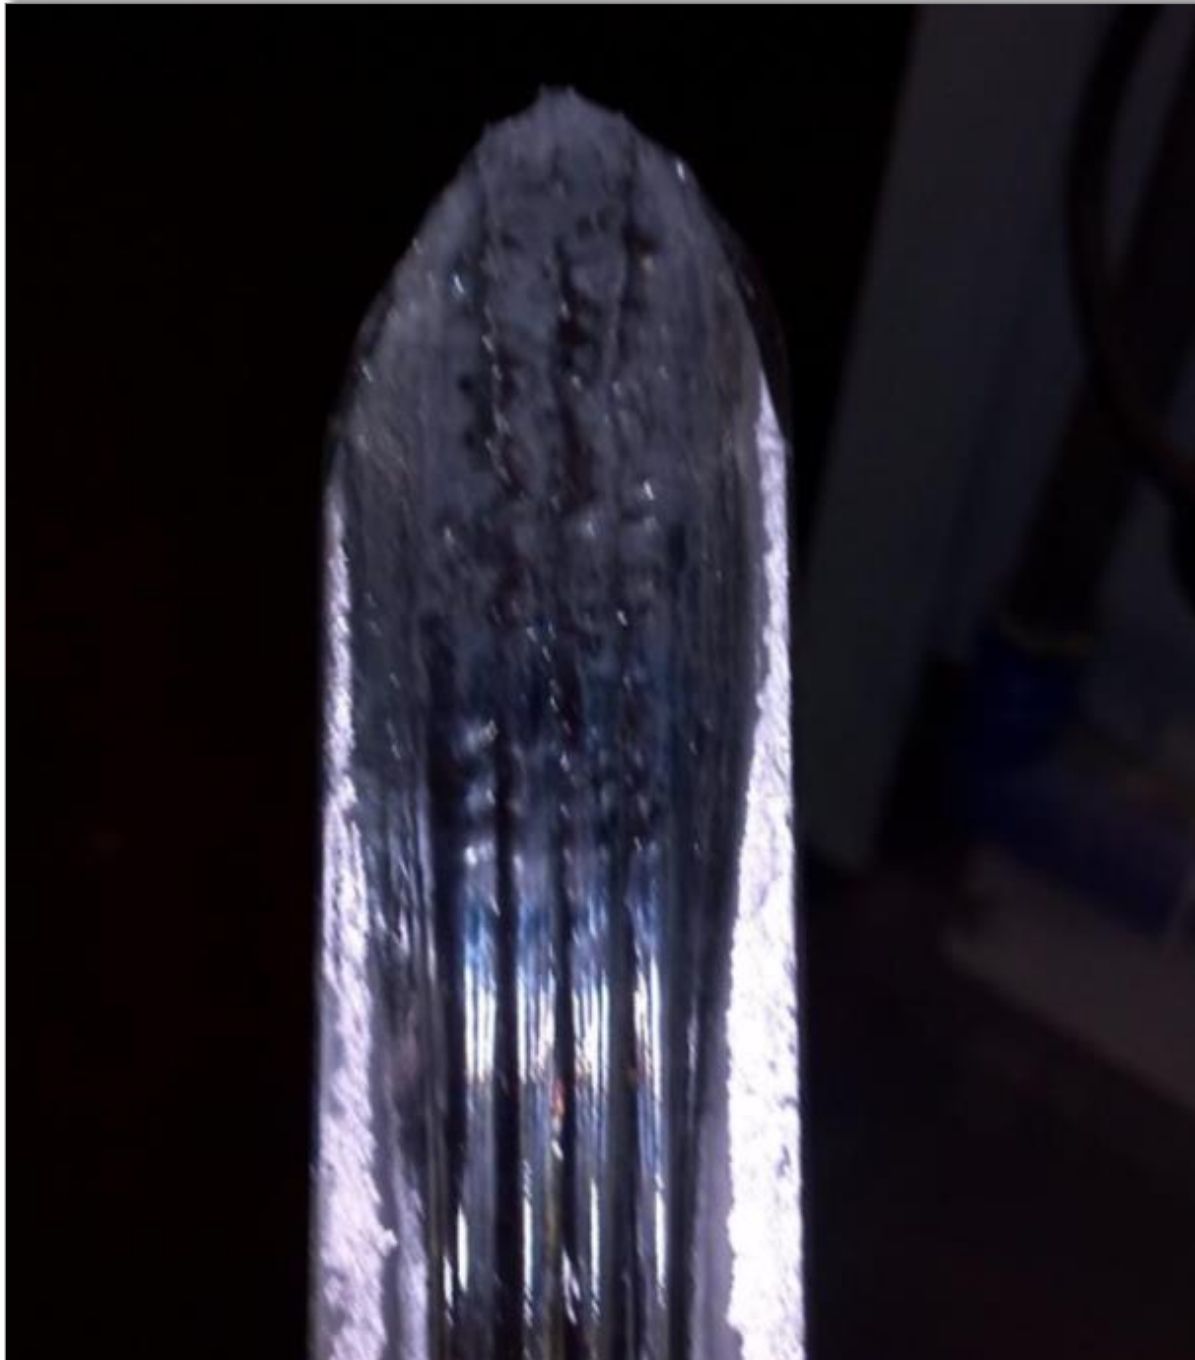
Boiler sight glass deterioration due to high alkalinity boiler water. Failure due to crack in protective mica shield, allowing boiler water with high hydroxide alkalinity to have direct contact with and dissolve the borosilicate glass.

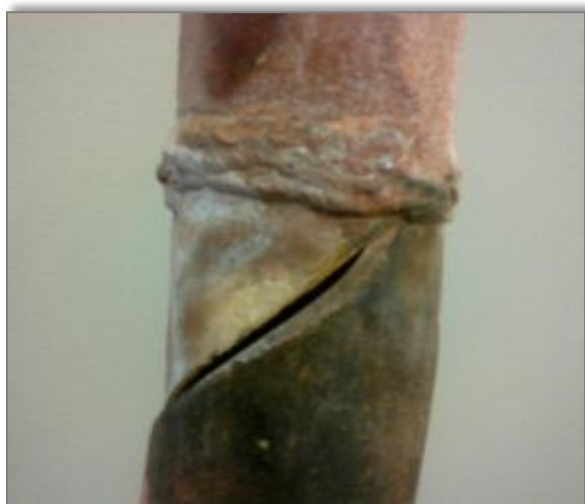
Crack initiation at radial weld

Superheater tube showing crack initiation at surface weld, progressive spiral tube crack due to operational stress. Rear of tube shows additional crack formation in the tube metal due to stress – away from the field weld.

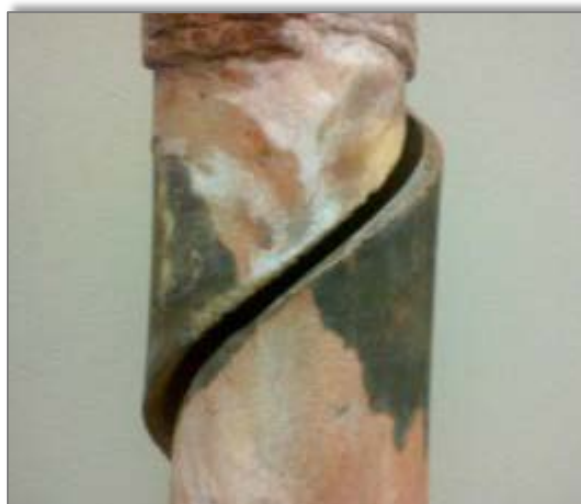
Spiral crack development

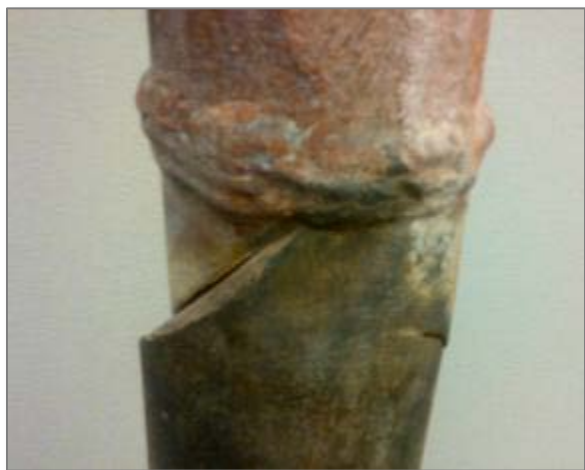
Back side of tube

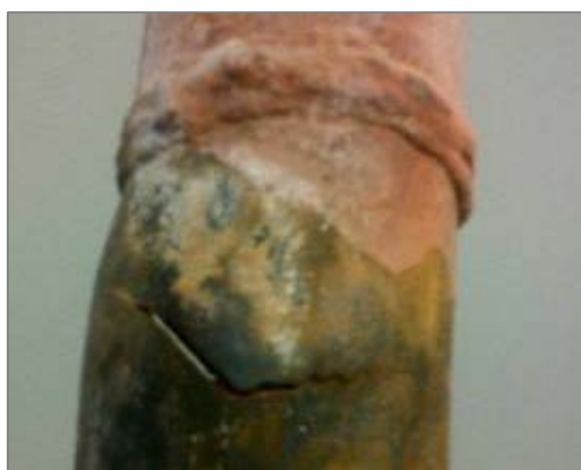
Additional surface crack formation

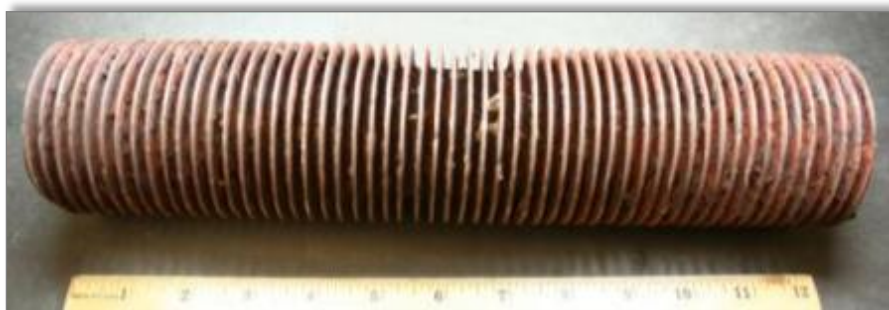
Finned superheater tube removed from a HSRG

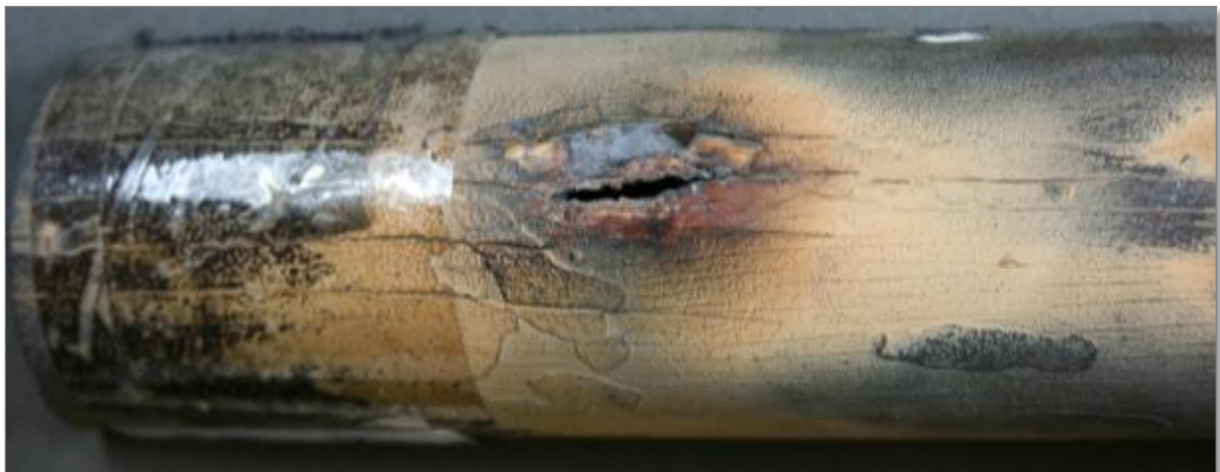
Superheater tube failure promoted by internal surface deposits

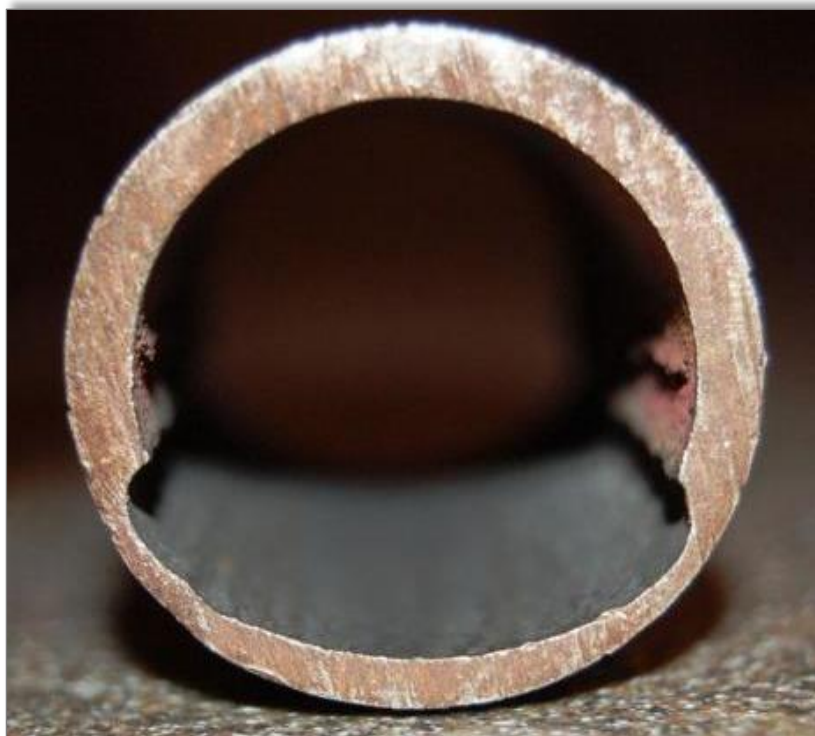
Corrosion due to low pH (from carbonic acid) at the bottom of a condensate return line

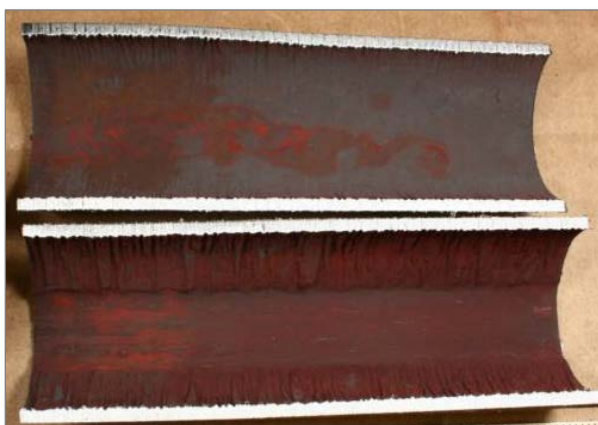
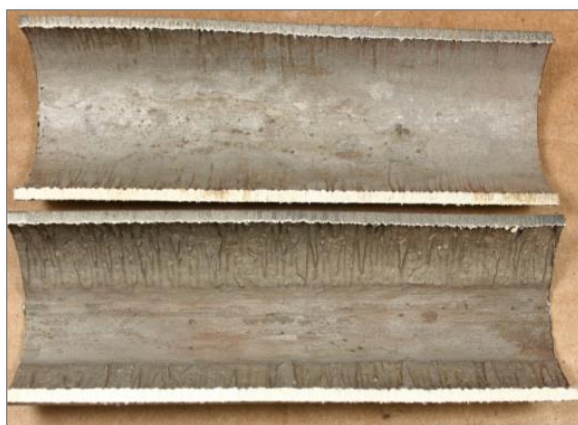
Corrosion and failure on the lower surface of a horizontal line etched due to low pH when steam condensed

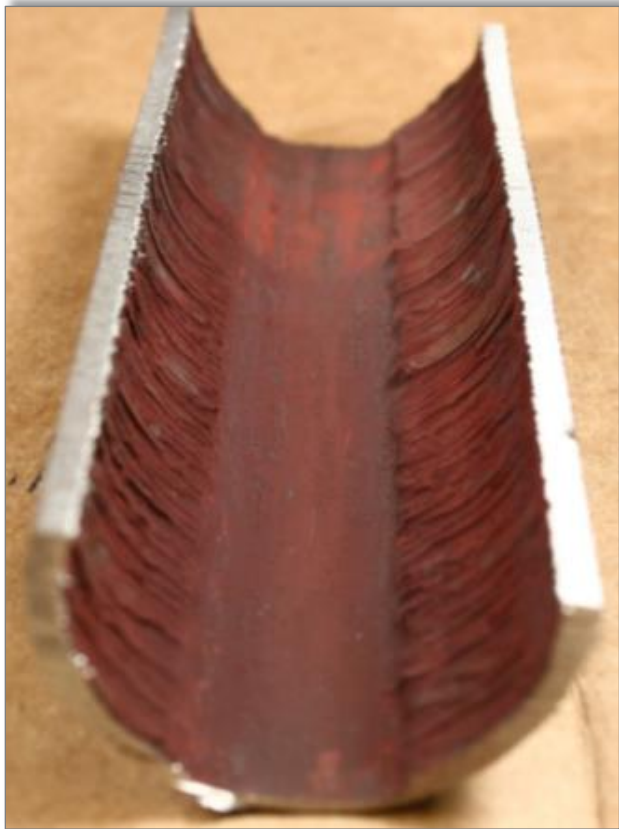
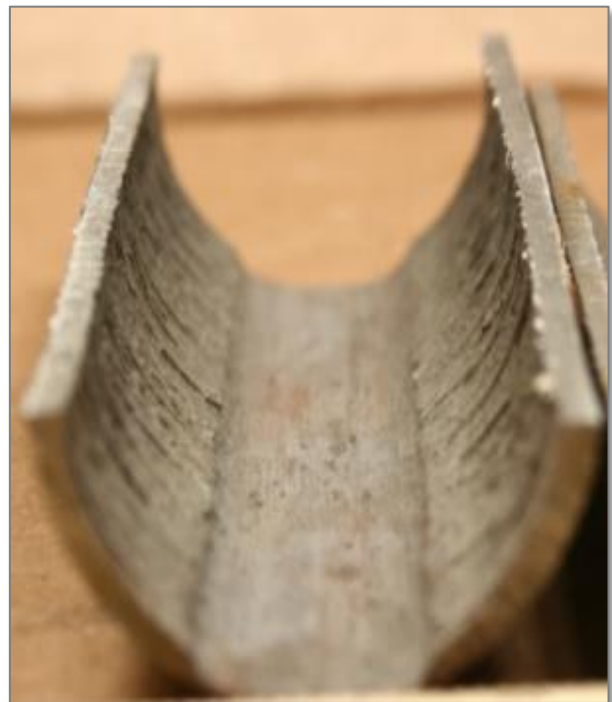
↑  
Loss of metal from the horizontal pipe  
surface where low pH condensate flowed →

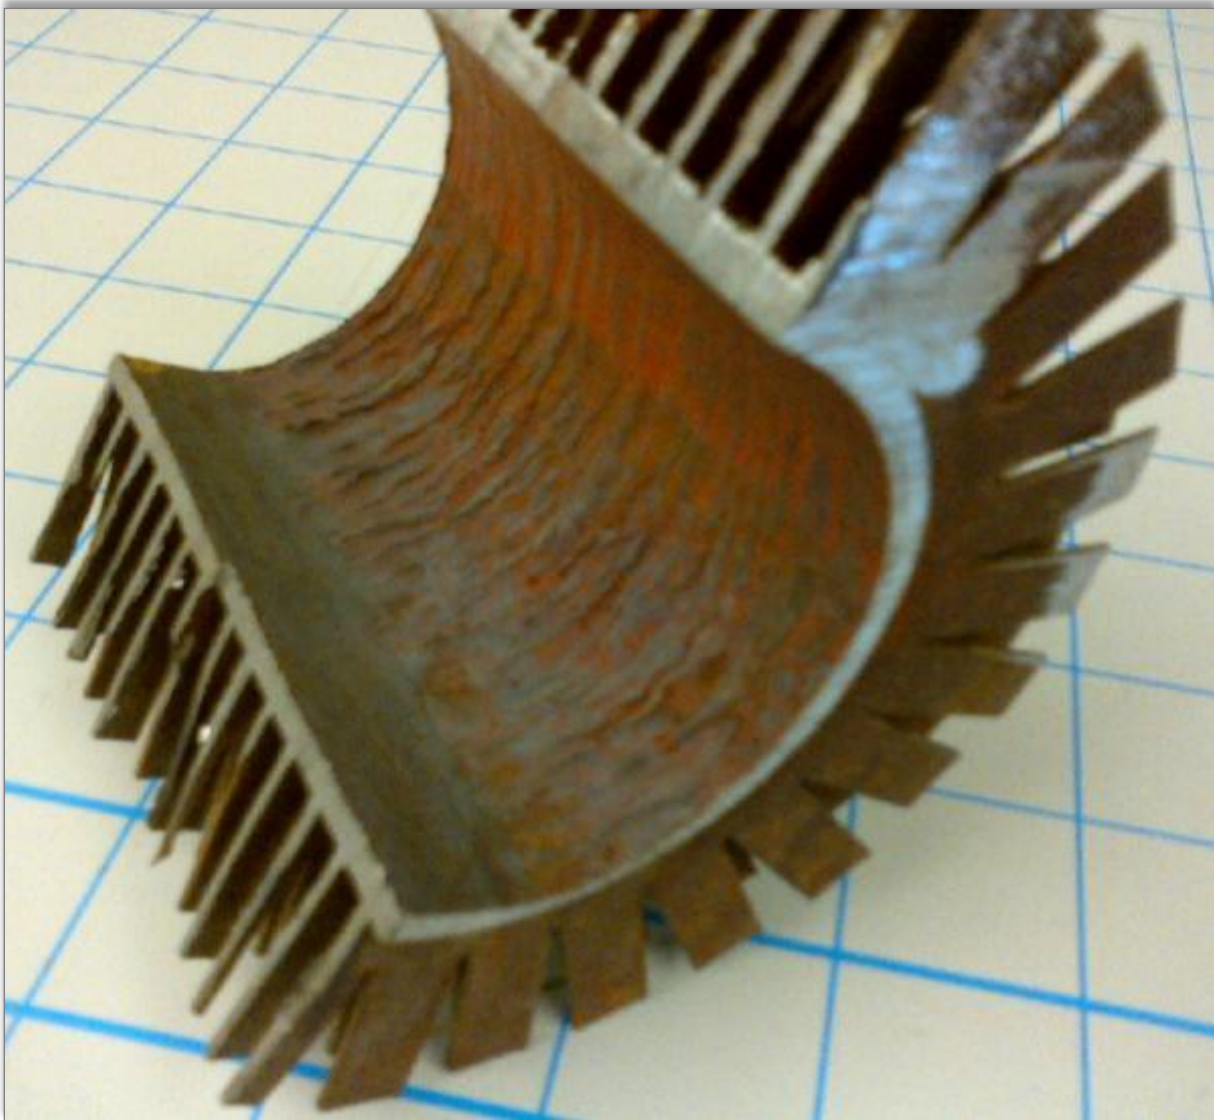
Horizontal finned tube from wood drying kiln. Insufficient amine to raise the low condensate pH resulted in corrosion on the internal pipe surface. Beginning in the top of the tube as steam condensed,  $\text{CO}_2$  dissolved in the condensate as it formed and the acidic condensate flowed down the sides of the tube in rivulets, dissolving the steel pipe surface in the process, thinning the wall and sending iron back to the boiler. A rare example of the actual point at which steam condenses and low pH corrosion occurs.
