Library of Congress Cataloging-in-Publication Data  
Kletz, Trevor A.

What went wrong? : case histories of process plant disasters and how they could have been avoided / Trevor Kletz. —5th ed.

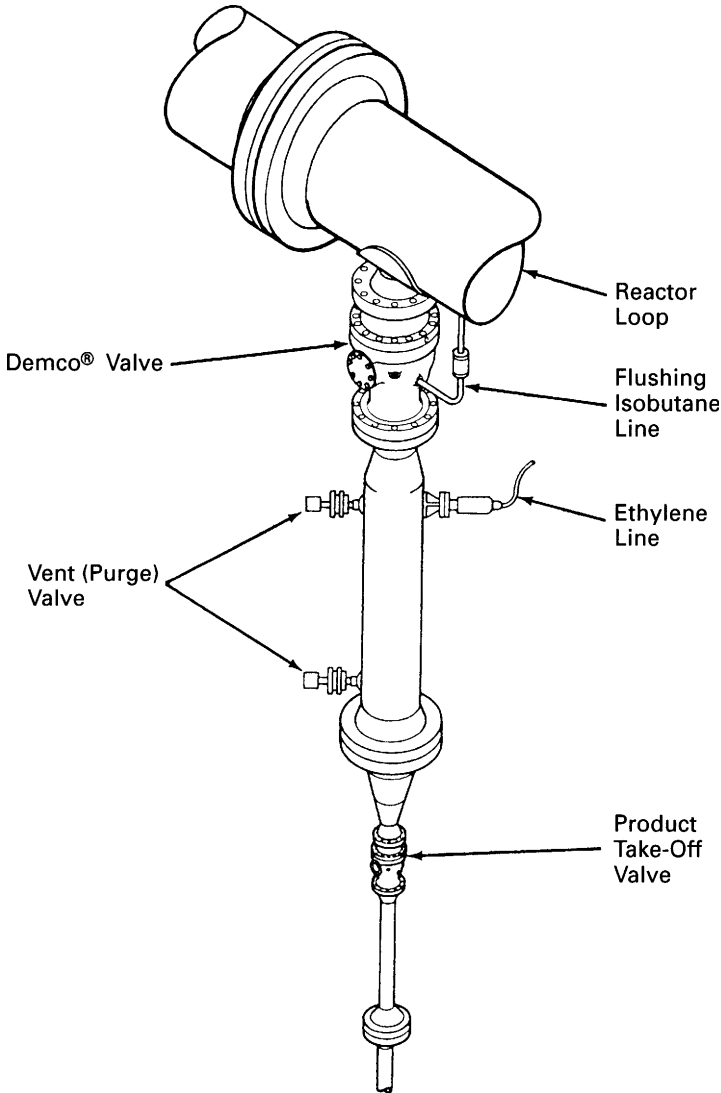
A similar but more serious incident occurred in a polyethylene plant in 1989. A take-off branch was dismantled to clear a choke. The 8-in. valve isolating it from the reactor loop (the Demco valve in Figure 1-2) was open, and hot ethylene under pressure came out and exploded, killing 23 people, injuring more than 130, and causing extensive damage. Debris was thrown 10 km (6 miles), and the subsequent fire caused two liquefied petroleum gas tanks to burst.

**FIGURE 1-2** The take-off branch was dismantled with the Demco valve open. (Illustration courtesy of the U.S. Department of Labor.)

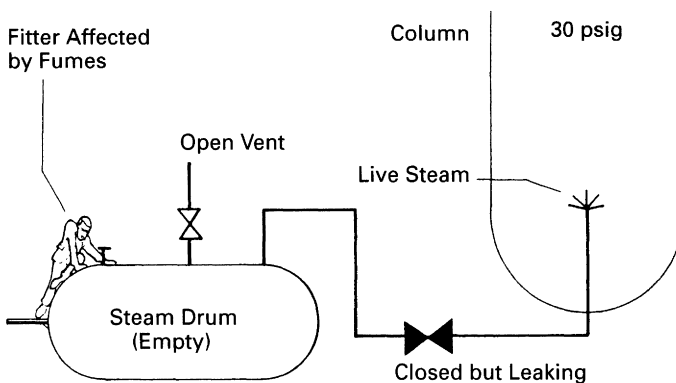
FIGURE 1-3 Contamination of a steam drum by process materials.

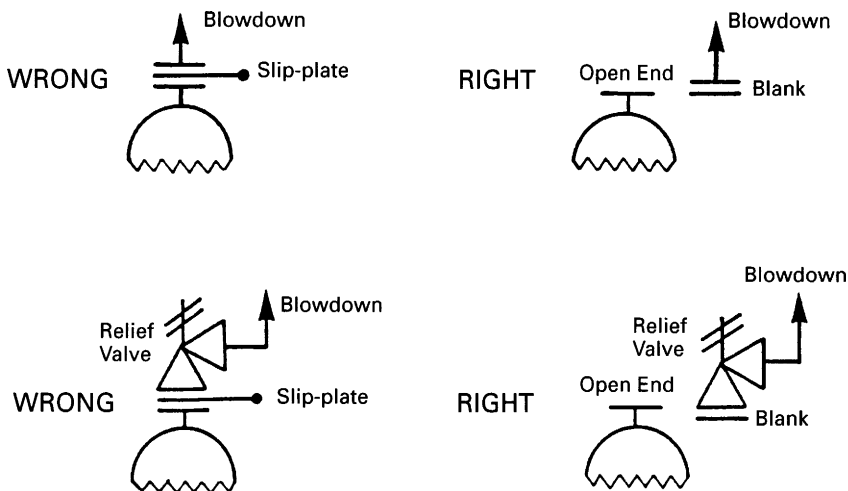
FIGURE 1-4 The right and wrong ways to isolate a vent line.

If a vent line has to be slip-plated because the line is too rigid to be moved, then the vents should be slip-plated last and de-slip-plated first. If all slip-plates inserted are listed on a register, they are less likely to be overlooked.

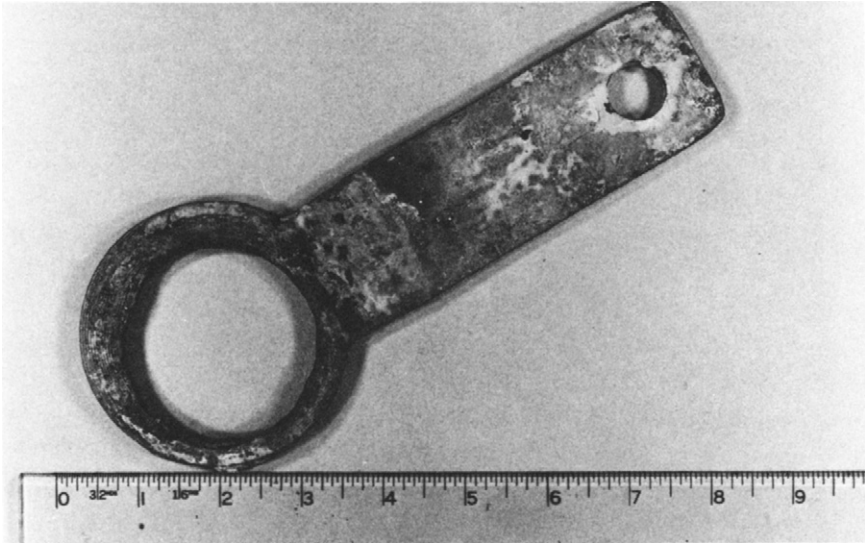
FIGURE 1-5 A slip-plate left in position for many months had corroded right through.

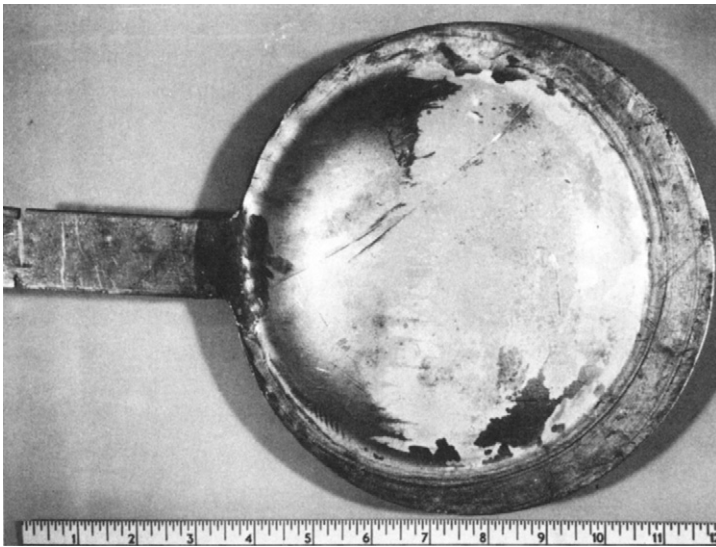
FIGURE 1-6 A slip-plate bowed by a gauge pressure of 470 psi (32 bar).

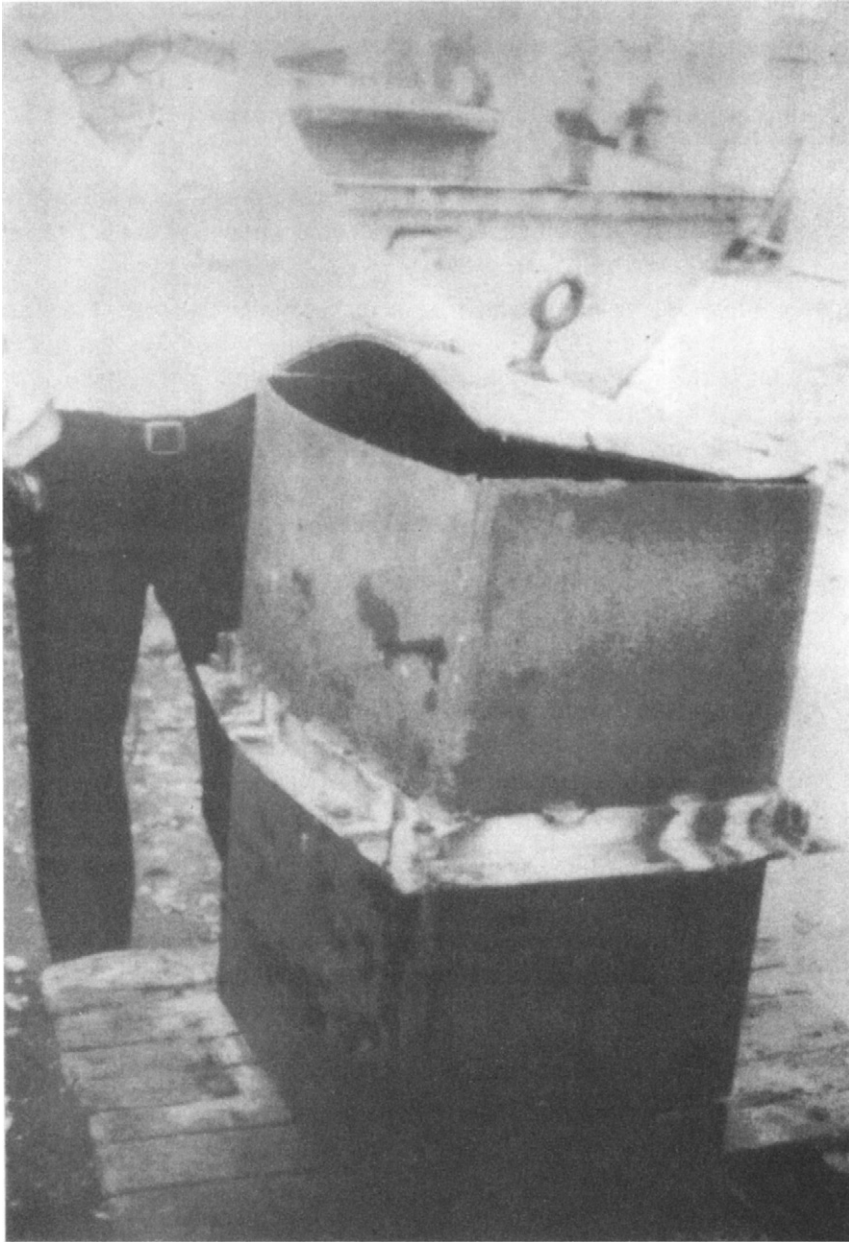
**FIGURE 1-13** This steel box was quite incapable of containing a leak of steam at a gauge pressure of 300 psi (20 bar).

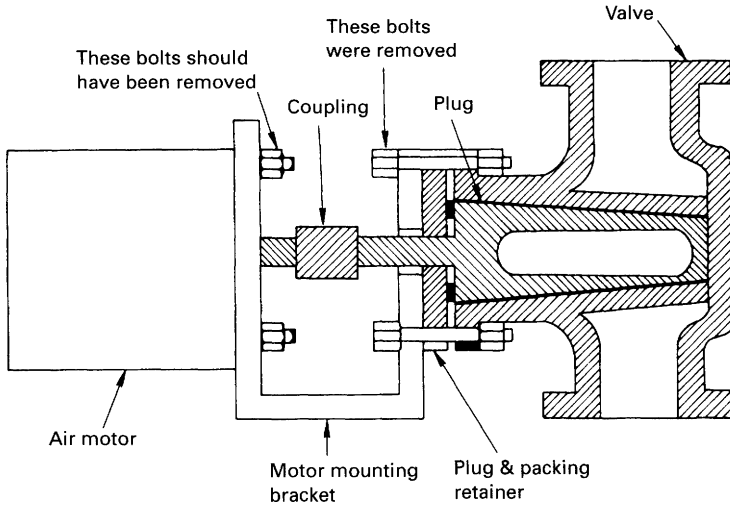
FIGURE 1-14 Wrong nuts undone to remove the valve actuator.

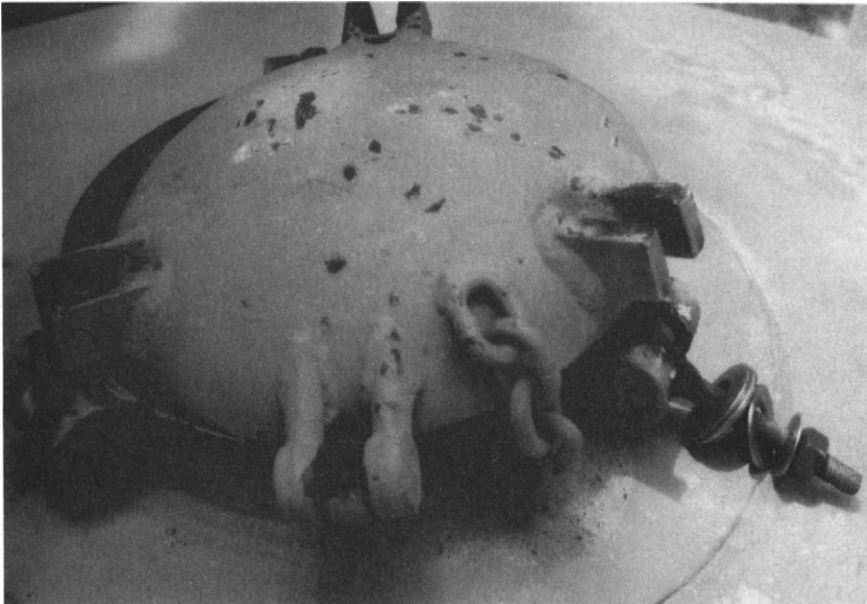
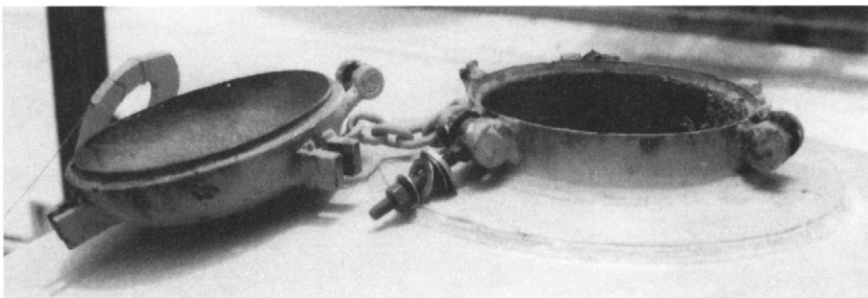
**FIGURE 1-18** Instead of replacing the eyebolts, new studs were welded in place of the threaded portions. They were made brittle by the heat and failed in use. Fortunately, the chain prevented the lid from going into orbit.

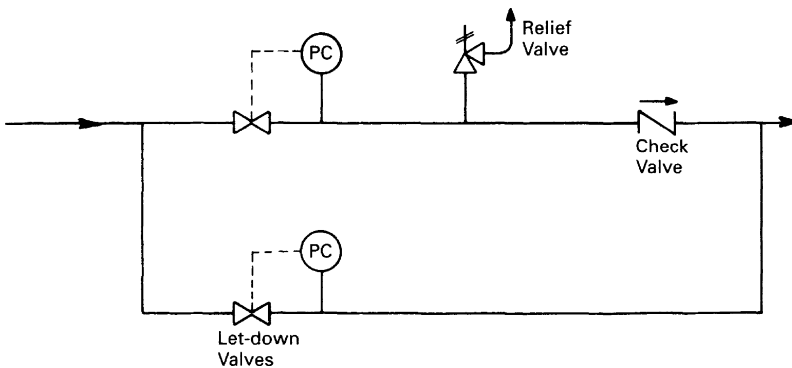
FIGURE 2-3 The second (*lower*) let-down valve was joined to the original line downstream of the check valve. When this let-down valve leaked, the downstream equipment was overpressured.

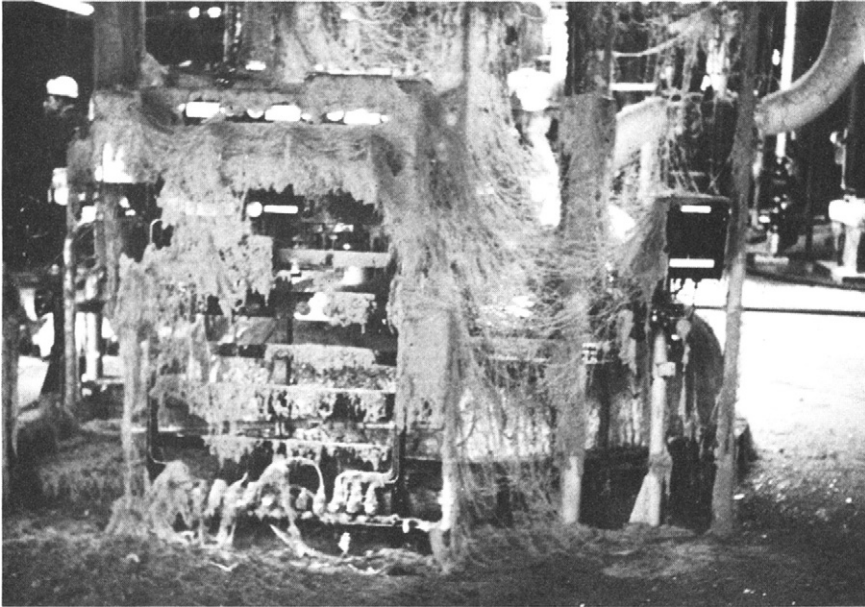
**FIGURE 3-1b** Because a rupture disc was fitted to the wrong side of a vacuum support, the flanges leaked, covering the reactor with “candy.”

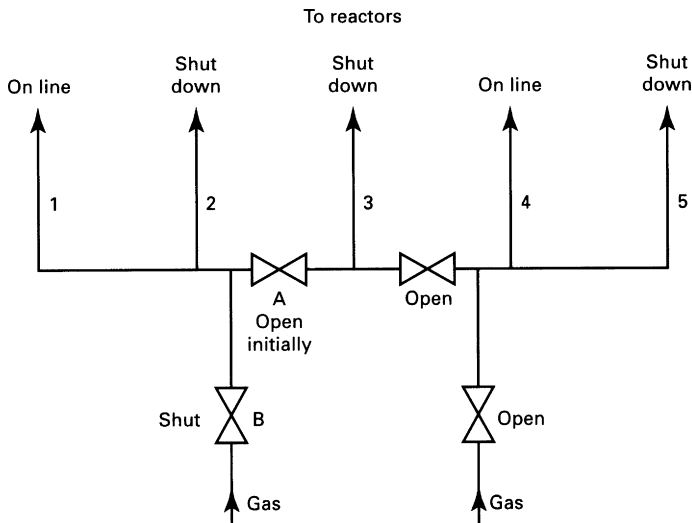
FIGURE 3-5 Accidental closing of a valve can cause an explosion.

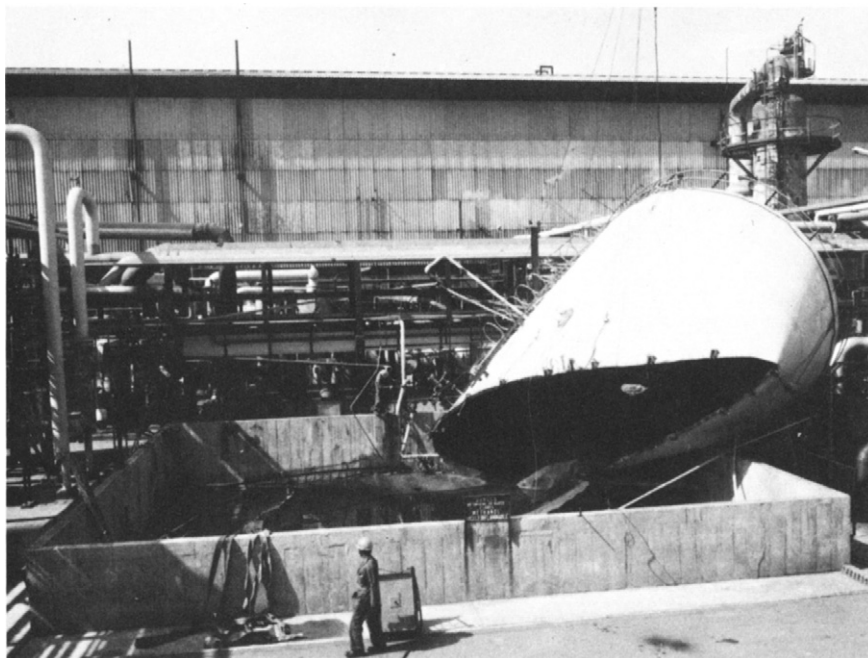
Tanks designed to fail at the roof/wall weld have failed at the base/wall weld because this weld was corroded or fatigued or because holding-down bolts were missing (Figure 5-1). Corrosion is most likely to occur in tanks containing a water layer or when spill absorbents have been placed

FIGURE 5-1 Corrosion and missing holding-down bolts caused this tank to fail at the base instead of the top.

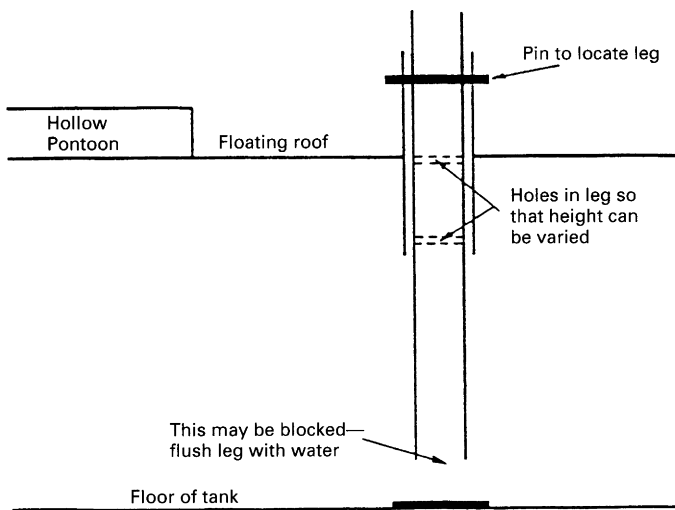
Fourteen days later, a small fire occurred. About a gallon of gasoline came out of one of the hollow legs that support the roof when it is off-float and was ignited by a spark. The fire was put out with dry powder. It is believed that the bottom of the hollow leg was blocked with sludge and that, as cutting took place near the leg, the leg moved and disturbed the sludge (Figure 5-15).

FIGURE 5-15 Oil trapped in the leg of a floating-roof tank caught fire during demolition.

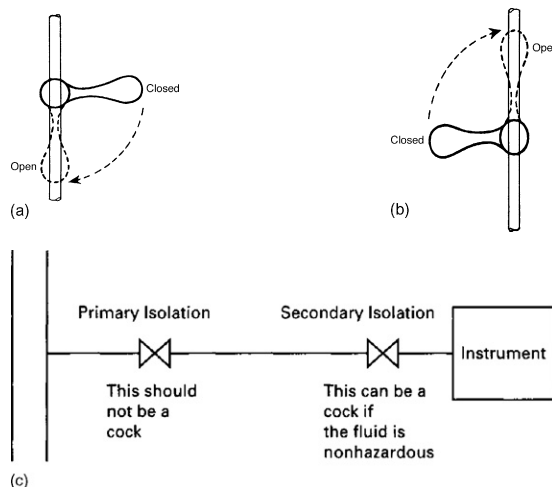
FIGURE 7-1 (a) Vibration can cause the cock to open. (b) A better arrangement. (c) Small cocks should not be used as primary isolation valves.

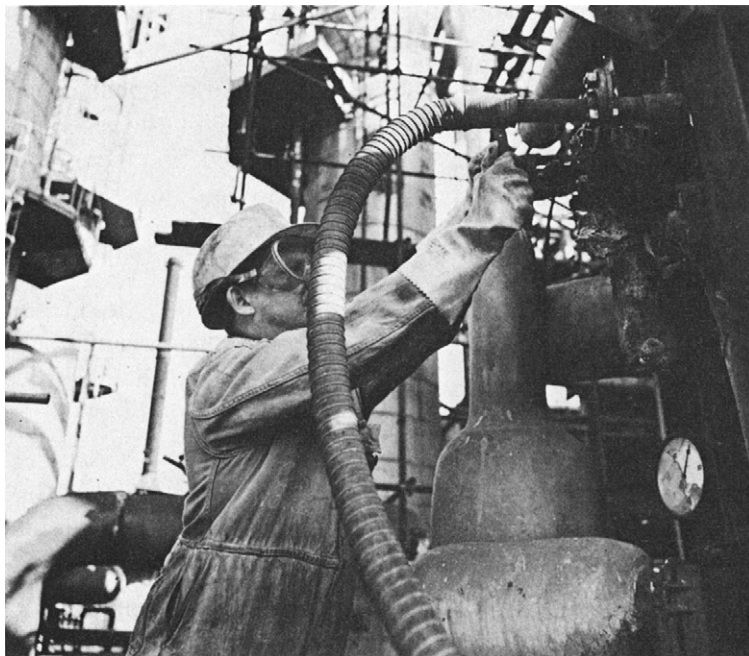
**FIGURE 7-3** This hose burst, injuring the operator. It was the wrong type, was damaged, and was badly located.

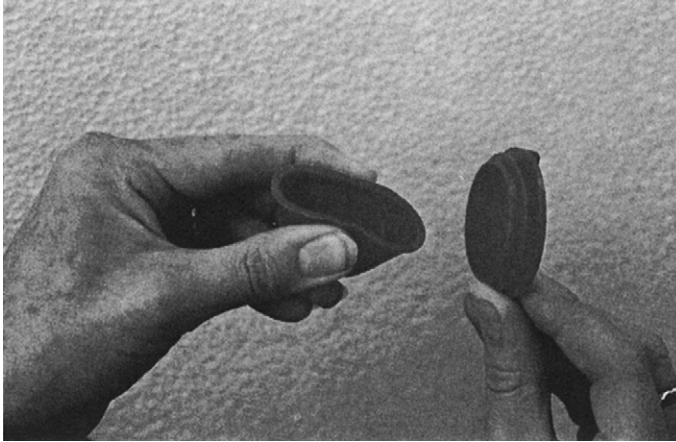
**FIGURE 7-4** A soft plastic “top hat” plug (*left*) was fitted to the end of a railway carriage brake pipe to keep it clean. It was the same color as the end of the pipe and was not noticed and removed before the pipe was installed. The brakes failed, and the train overran. A more rigid plug with a larger lip (*right*) would have failed the brake test and would have been more visible. (*Photo courtesy of Roger Ford.*)

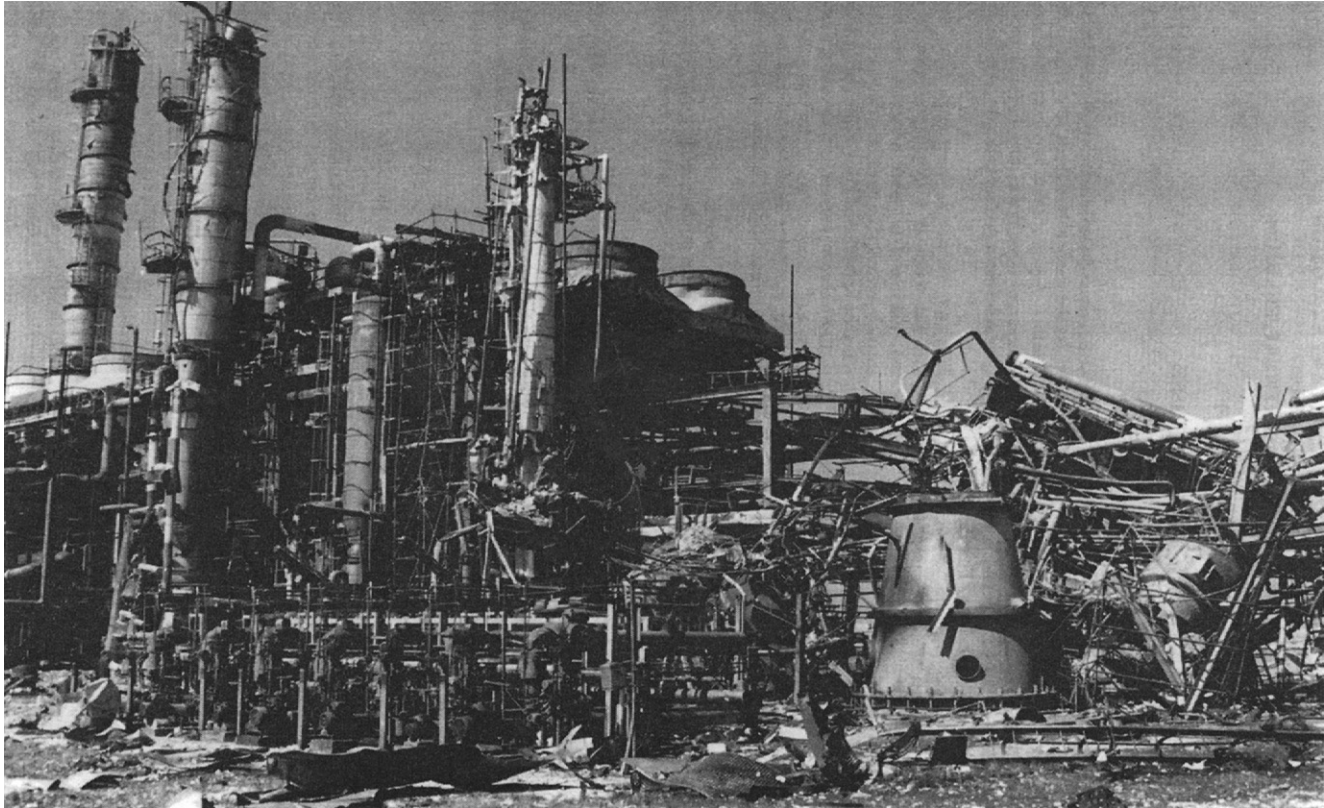
FIGURE 7-8 The ethylene oxide plant after the fire and explosion. (Photo courtesy of BP Chemicals Limited.)

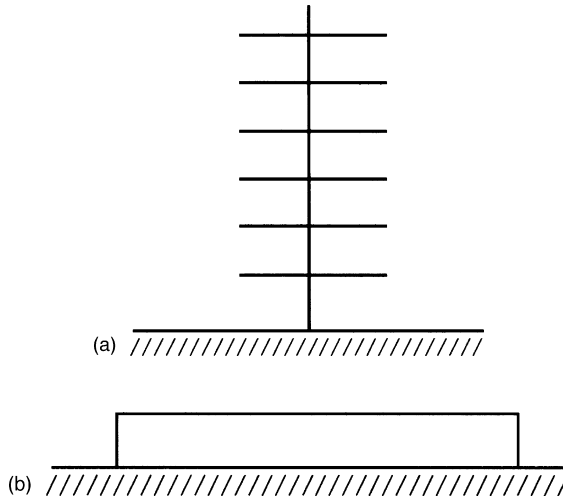
FIGURE 9-5 (a) The original pipe supports. (b) The supports used after the collapse.

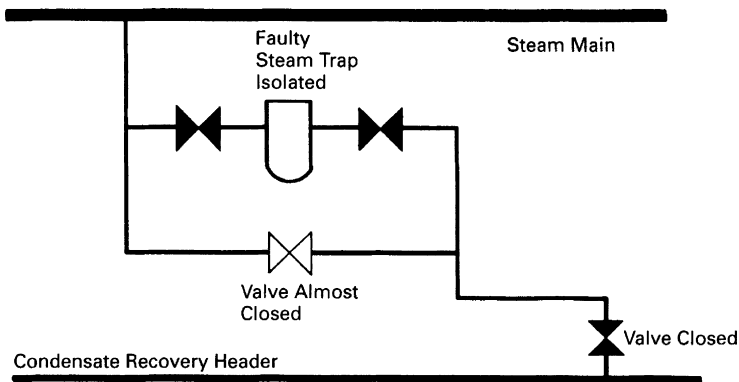
FIGURE 9-9 Arrangement of valves on a steam main that was broken by a water hammer.

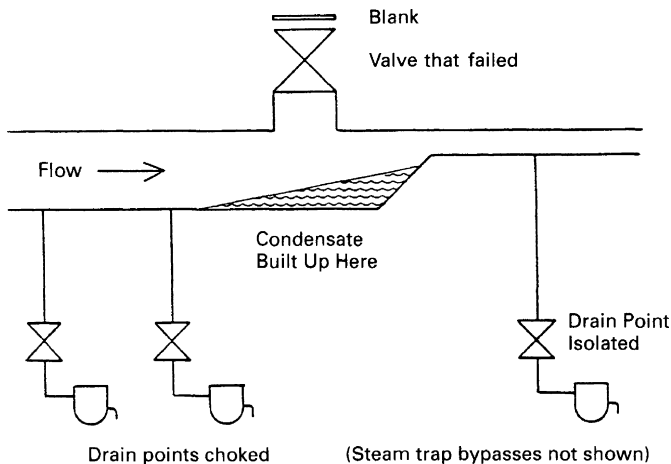
FIGURE 9-10 Arrangement of drains on a steam main that was broken by a water hammer.

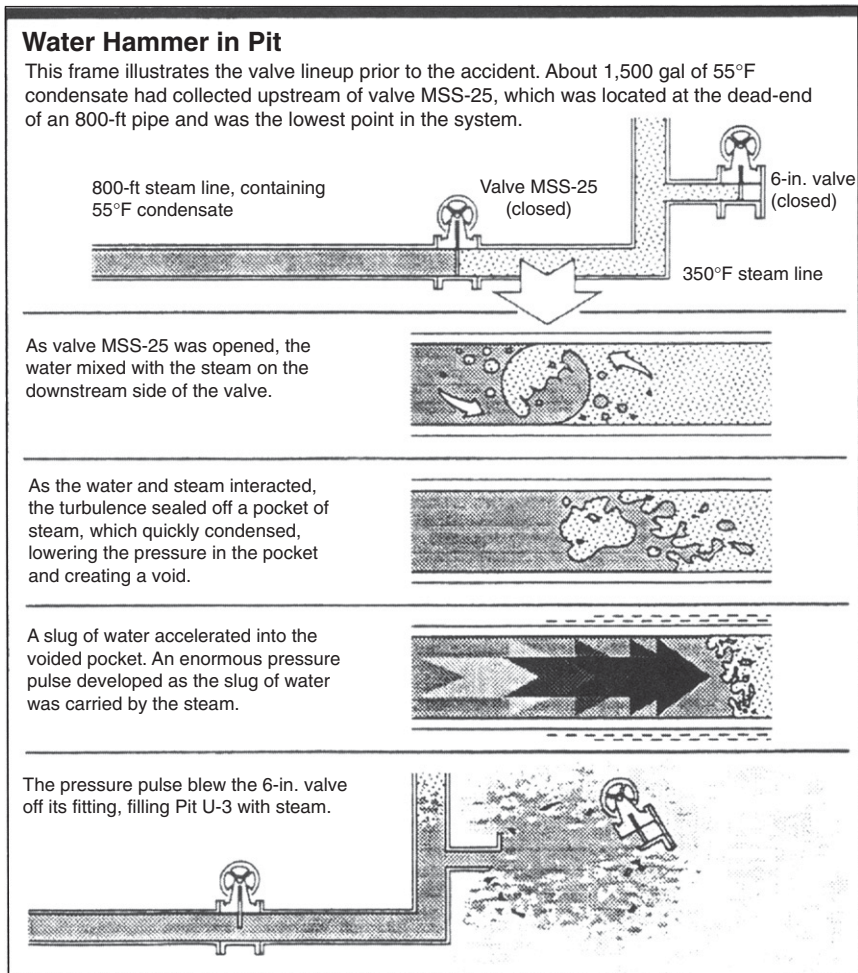
**FIGURE 9-11** Condensate collected in a steam main. A valve was opened quickly. Sudden movement of the condensate fractured another valve. The figure explains how this occurred. (Reproduced by permission of the Office of Environment, Safety, and Health, U.S. Department of Energy.)

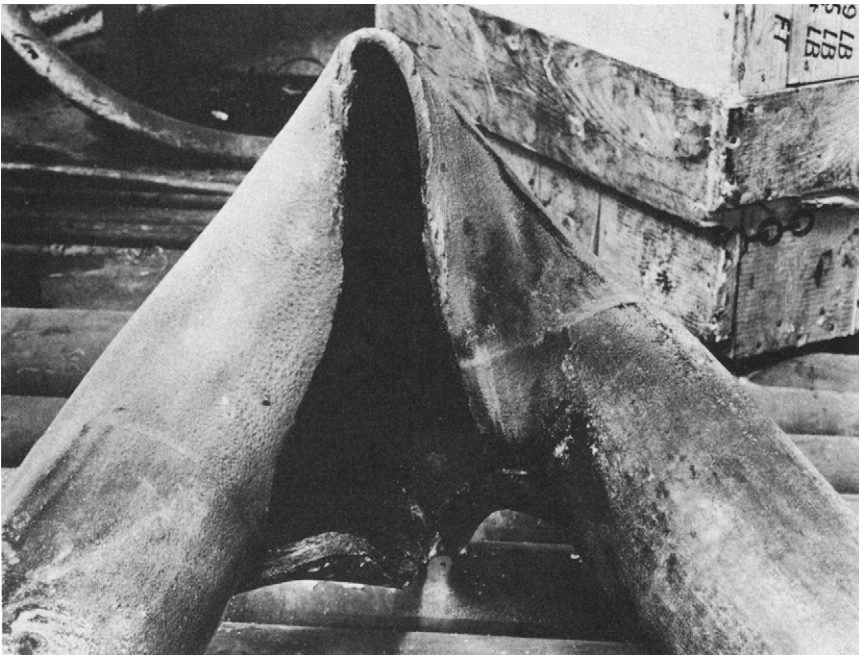
FIGURE 9-12 An old pipe was reused and failed by creep.

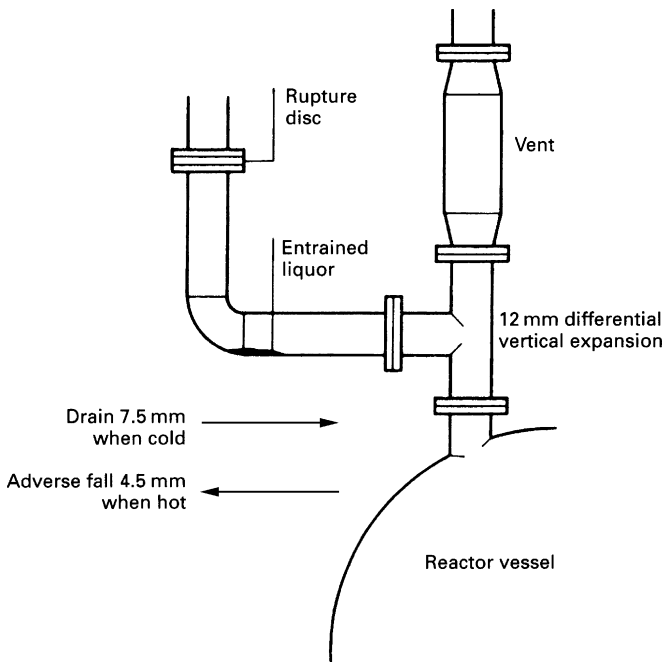
FIGURE 9-13 The vent arrangements at the top of the reactor. Liquid drained out when the pipework was cold but not when it was hot.

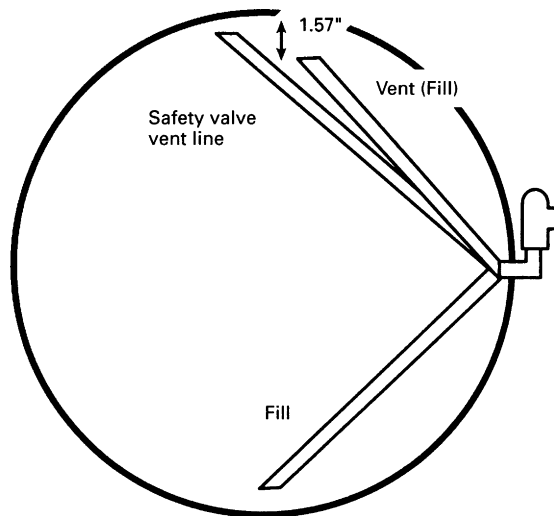
**FIGURE 9-14** Unusual arrangement of a relief valve and pipework on a tank truck used to transport liquid carbon dioxide. The relief valve was cooled by the liquid and became blocked by ice from condensed atmospheric moisture. (Illustration courtesy of the Institution of Chemical Engineers.)

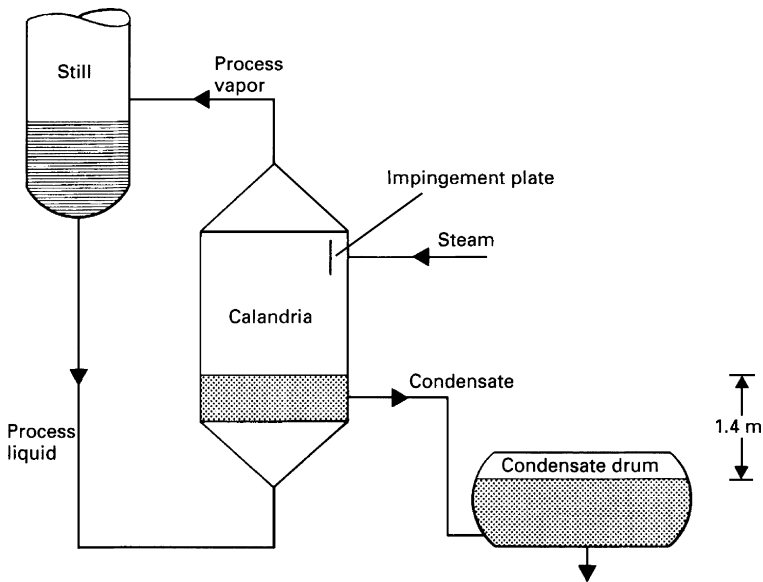
FIGURE 10-11 Condensate in the steam—the result of too few steam traps—knocked off the impingement plate and damaged the calandria tubes.

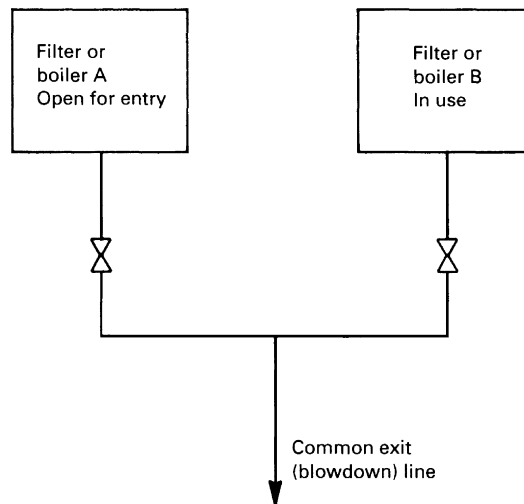
FIGURE 11-2 Liquid or gas traveled backward from the common line into the vessel that was open for entry.

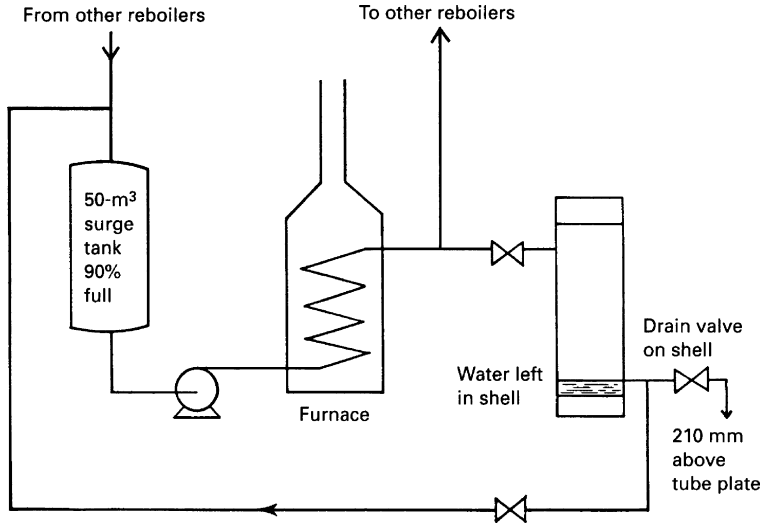
FIGURE 12-2 Water left in the heat exchanger was vaporized by hot oil.

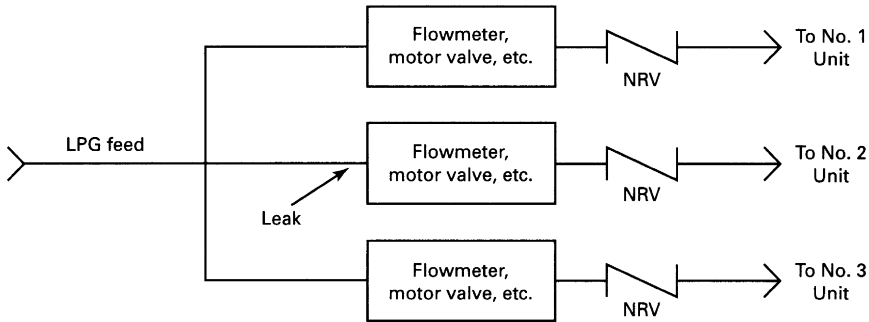
FIGURE 14-2 The check valves (nonreturn valves, NRV) prevented a leak test of the equipment to the left of them. During startup, a leak occurred at the point indicated.

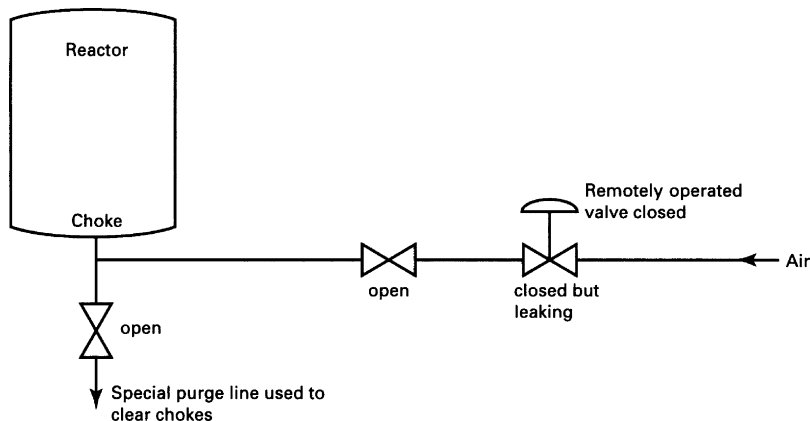
FIGURE 17-2 Liquid purge burned in the drain line.

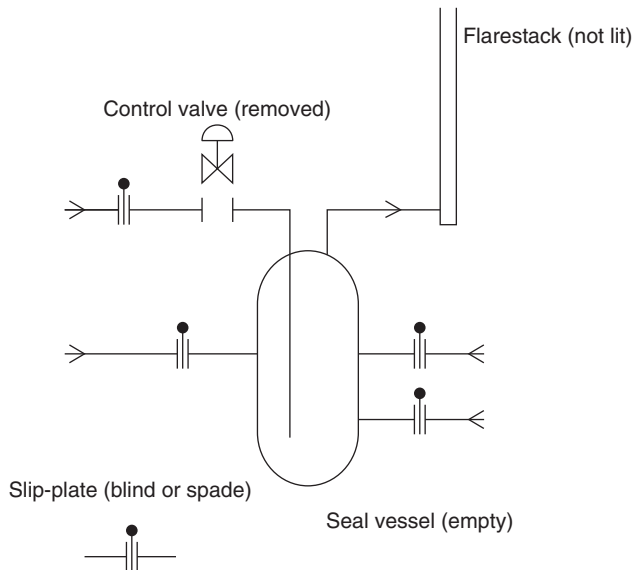
FIGURE 17-6 When the control valve was removed, a chimney effect caused air to enter the system, and an explosion occurred. (Reproduced with permission of the American Institute of Chemical Engineers. Copyright © 1995 AIChE. All rights reserved.)

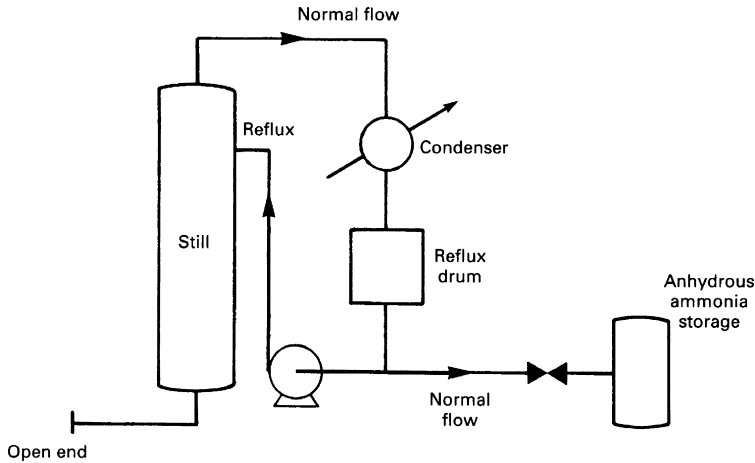
FIGURE 18-1 Reverse flow occurred from the storage vessel to the open end.

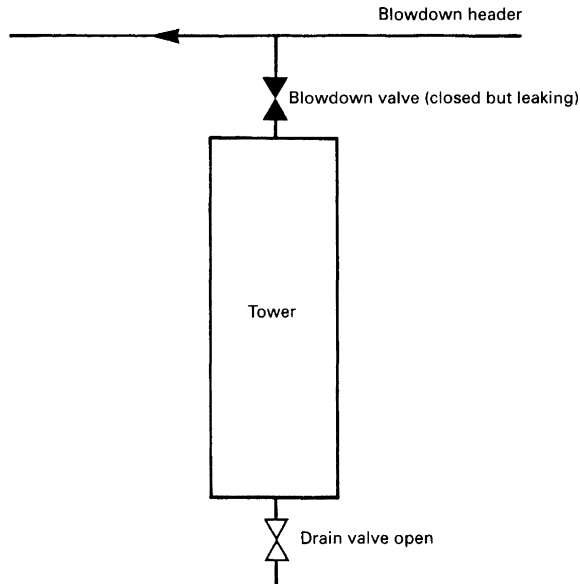
FIGURE 18-2 Flow occurred from the blowdown header into the vessel and out of the drain valve.

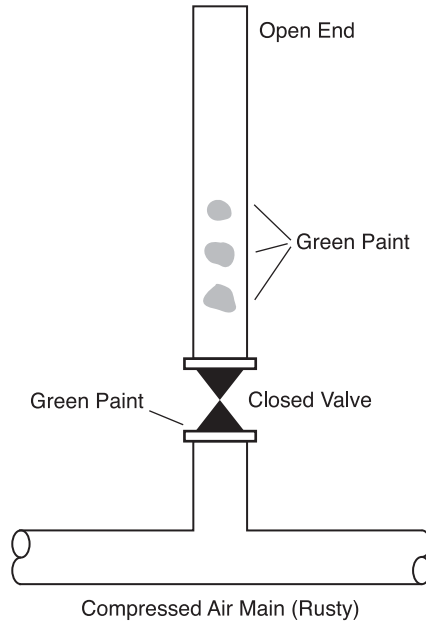
FIGURE 23-1 The lower flange was unbolted in error.

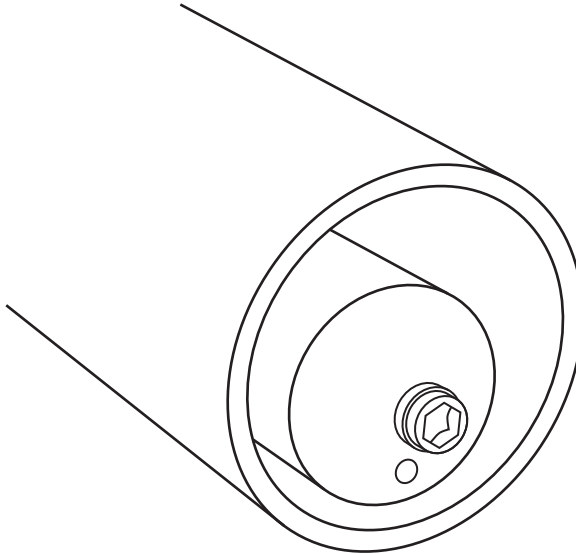
**FIGURE 23-2** When a length of new pipe was cut open, a propane cylinder was found inside it. Fortunately, the cutting tool just missed it.

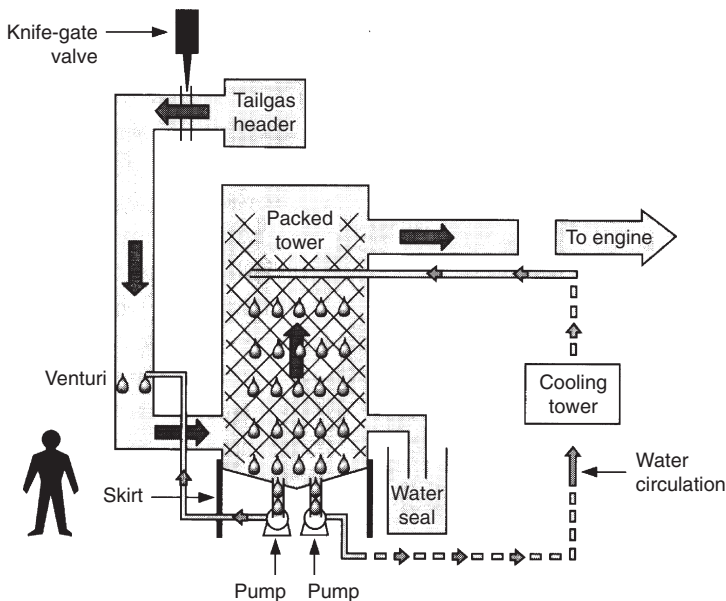
**FIGURE 24-1** A man was overcome by leaking gas while replacing a pump in a confined space. From reference 7. (Reprinted with the permission of the Institution of Chemical Engineers.)

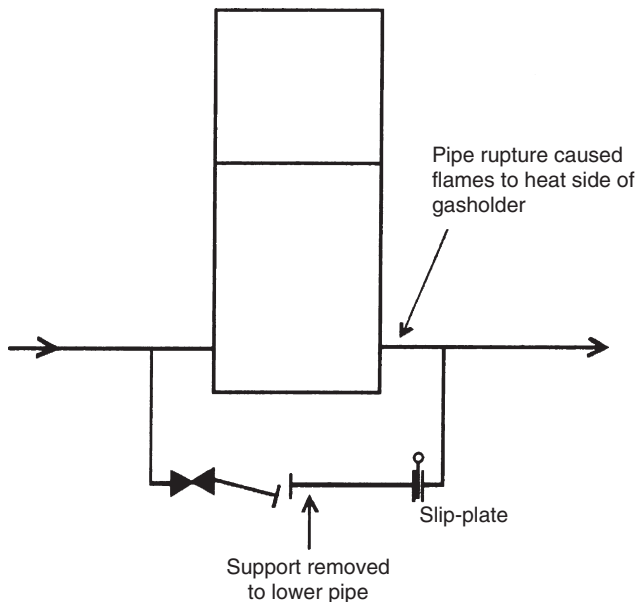
FIGURE 24-3 Gas leaked through a closed valve while burning was in progress nearby.

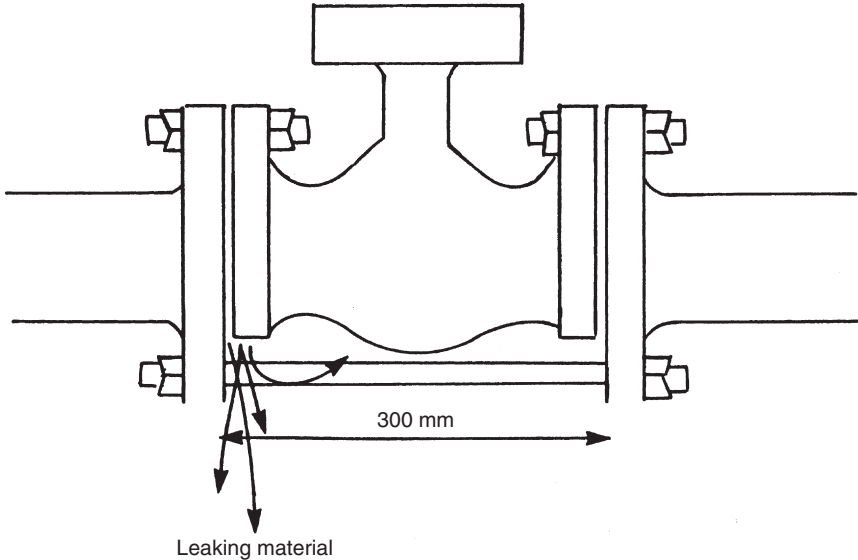
FIGURE 25-2 When this valve was insulated to save heat, the long bolts expanded and the flanges leaked.

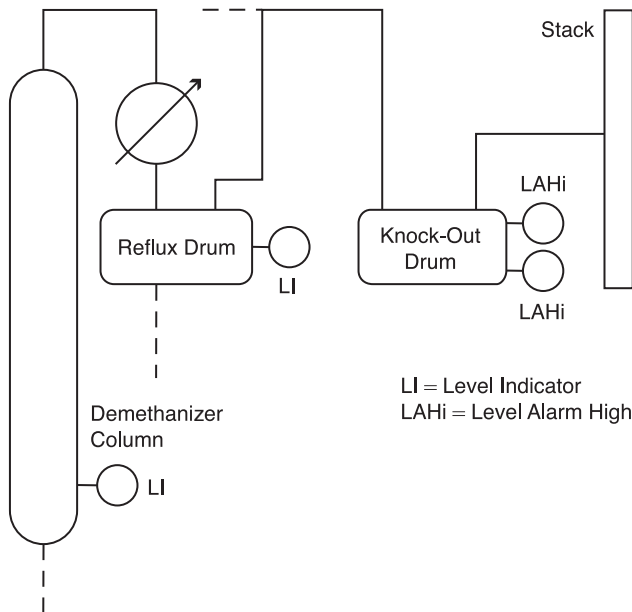
**FIGURE 26-1** The level indicator on the column and the level alarms on the knock-out drum were out of order. The column filled with liquid, which overflowed into the drums and then into the stack.

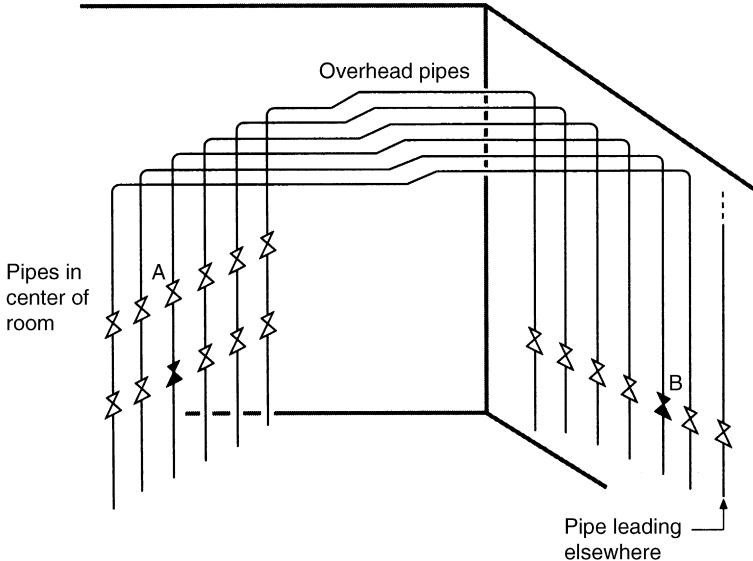
**FIGURE 27-1** To change valve A, the operator closed valve B and the valve below valve A. Both closed valves are shown in black. From reference 5. (Reprinted with the permission of the Institution of Chemical Engineers.)

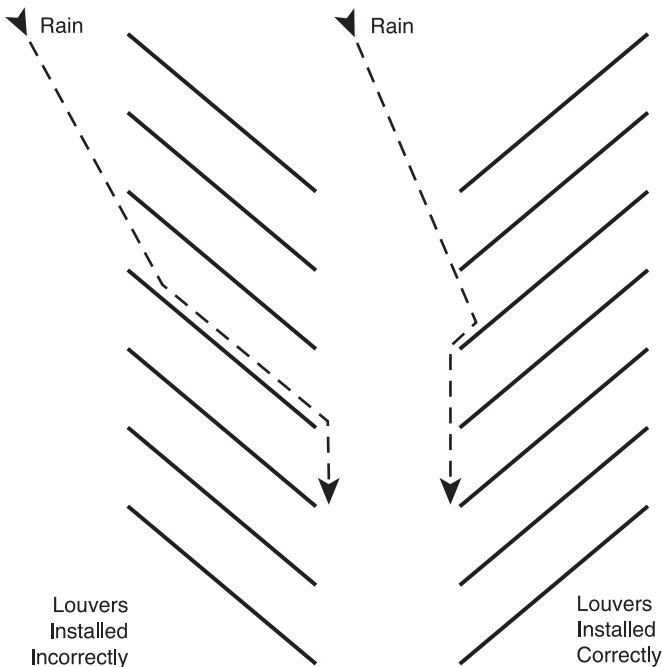
FIGURE 27-5 The louvers were installed so that they directed spray and rainwater through them.

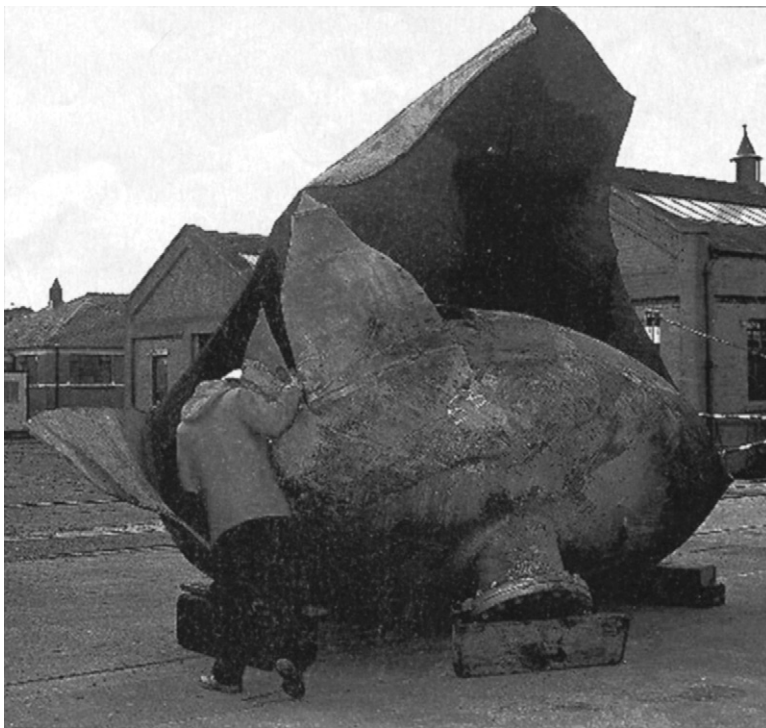
**FIGURE 28-1** The result of an absorber failure. From reference 18. (Reprinted with the permission of Gulf Professional Publishing.)

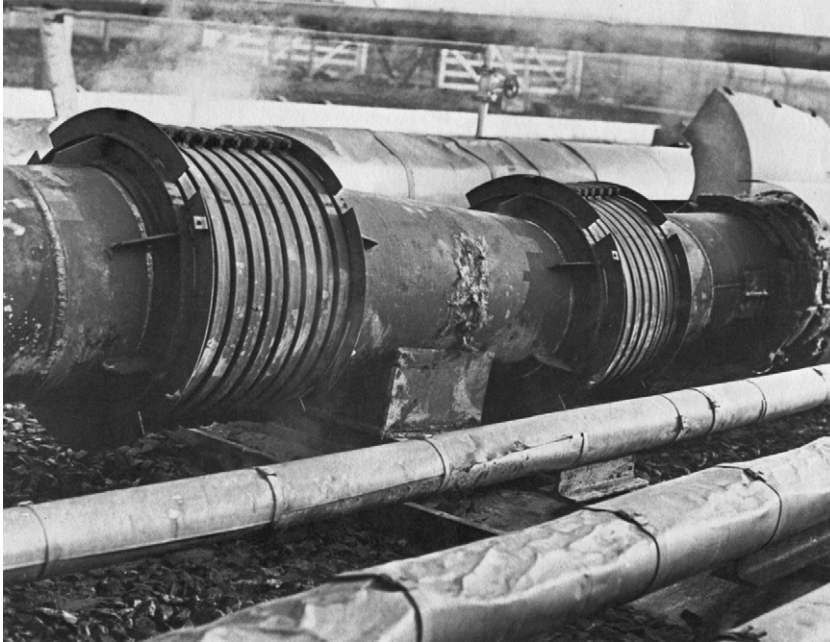
**FIGURE 28-2** This low-pressure steam main was not scheduled for regular inspection and the damage was undetected for months, perhaps years.

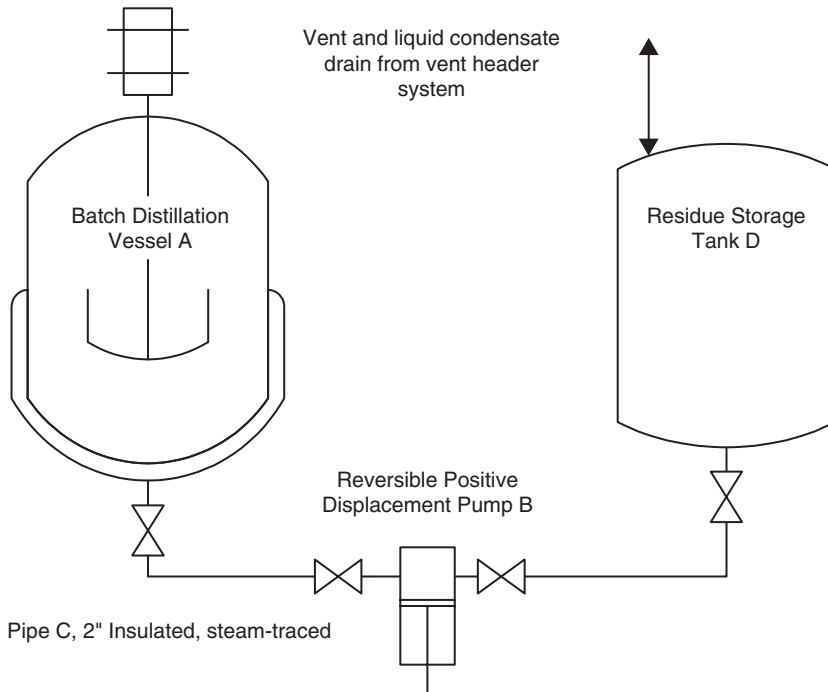
**FIGURE 30-1** Some of the residue moved from D to A and left in pipe C decomposed and ruptured the pipe. From reference 9. (Reprinted with the permission of the American Institute of Chemical Engineers.)

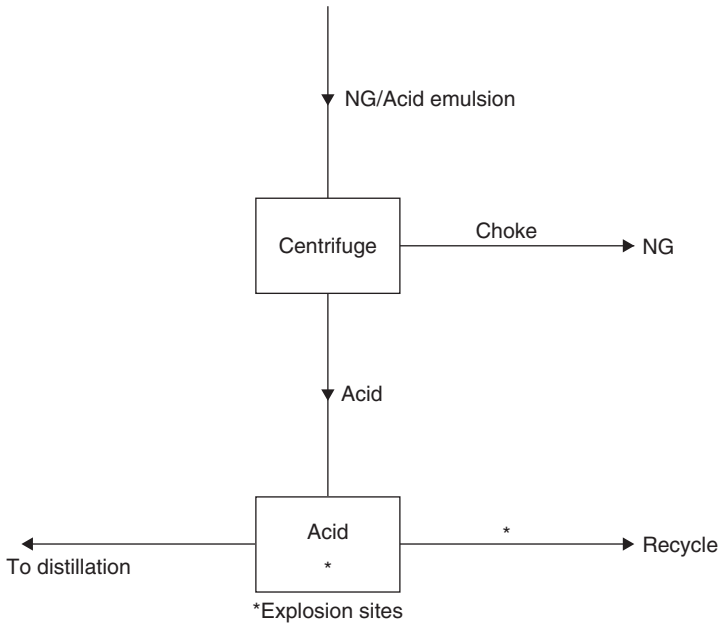
FIGURE 32-1 A choke caused NG to enter the acid line. A Hazop could have foreseen this.

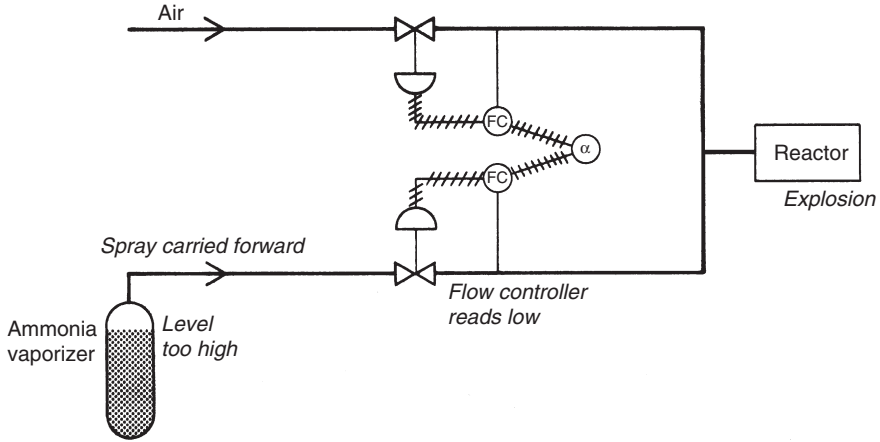
**FIGURE 33-5** An increase in the level in the vaporizer led to an explosion in the nitric acid reactor. From *Chemical Engineering Progress*, July 1980. (Reprinted with the permission of the American Institute of Chemical Engineers.)

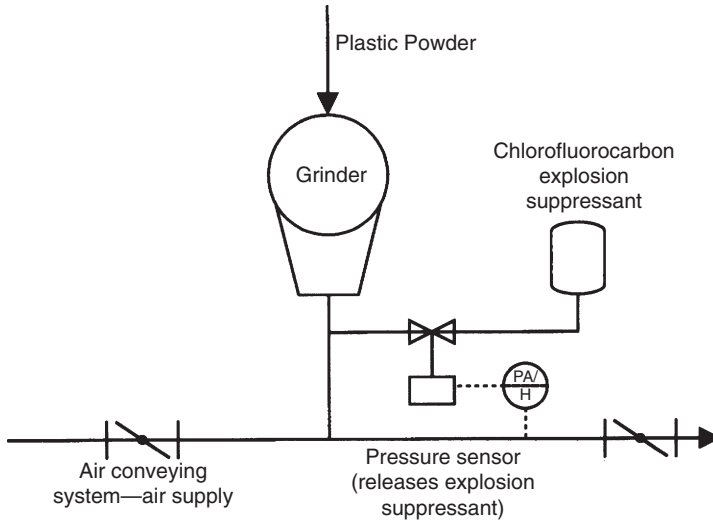
**FIGURE 33-7** Accidental operation of the protective equipment—the explosion suppressant—caused an explosion. From reference 2. (Reprinted with the permission of the American Institute of Chemical Engineers.)

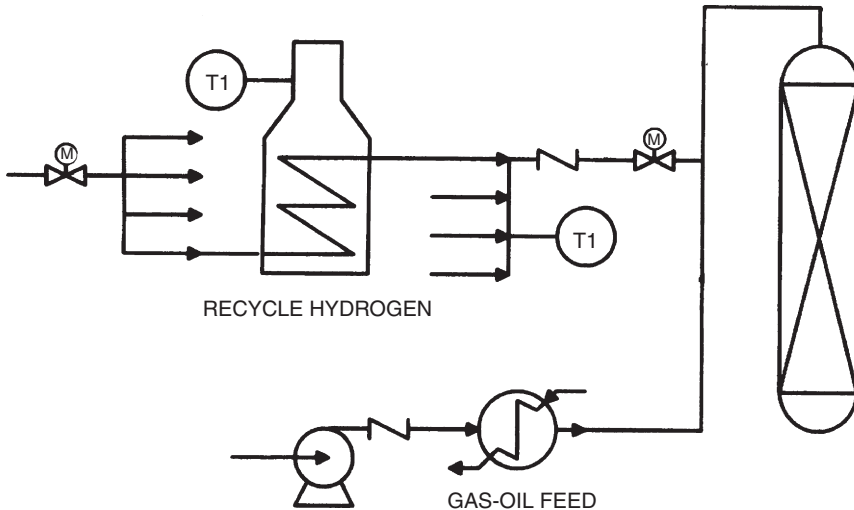
FIGURE 33-9 Restricted flow in one of the parallel streams led to a tube rupture and fire. From reference 4. (Reprinted with the permission of Elsevier (United Kingdom).)
