Library of Congress Cataloging-in-Publication Data  
Kletz, Trevor A.

What went wrong? : case histories of process plant disasters and how they could have been avoided / Trevor Kletz. —5th ed.

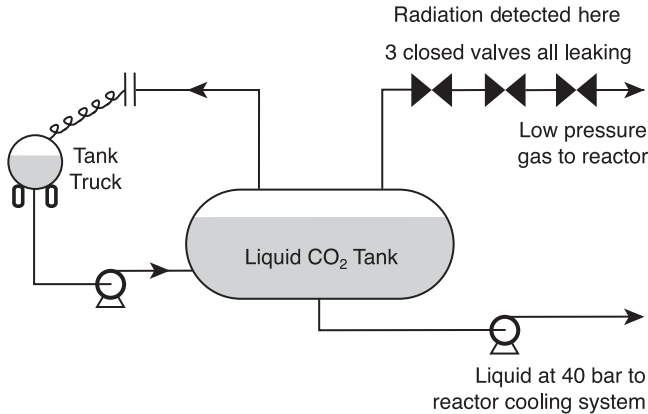
**FIGURE 34-1** Contaminated gas leaked through three valves into the fixed tank and from there could have entered the tank truck.

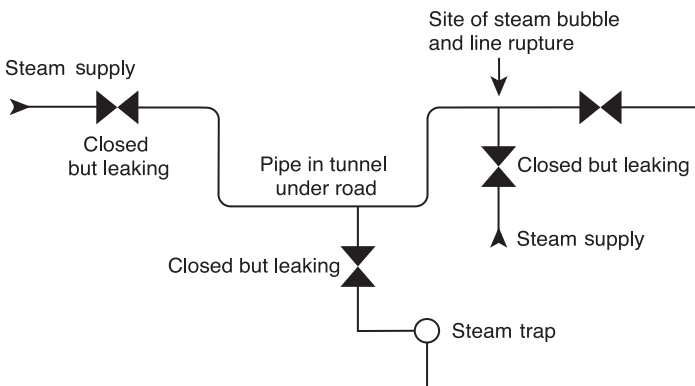
**FIGURE 34-2** Condensate filled the dip in the steam main and overflowed into the horizontal section on the right, condensing a steam bubble. The resultant water hammer ruptured the main.

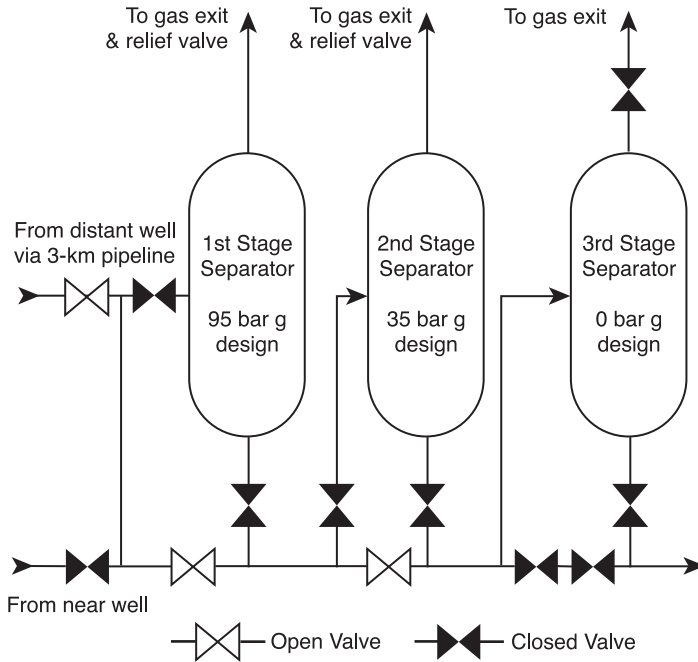
**FIGURE 36-1** The third separator was overpressured and ruptured when its bypass valves were closed in error.
