# BOILER SYSTEM FAILURES

## *Analysis & Diagnostics Manual*

### EXAMPLES OF ISSUES IN SPECIFIC BOILER SYSTEM COMPONENTS

Metallurgy  
Volume 2.0 | Boiler Systems

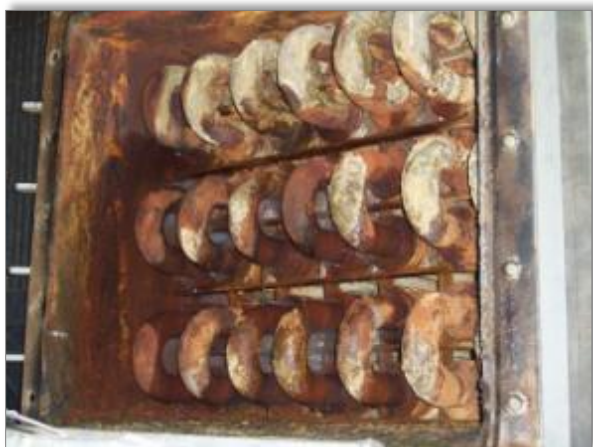
Return bends outside the flue gas envelope.

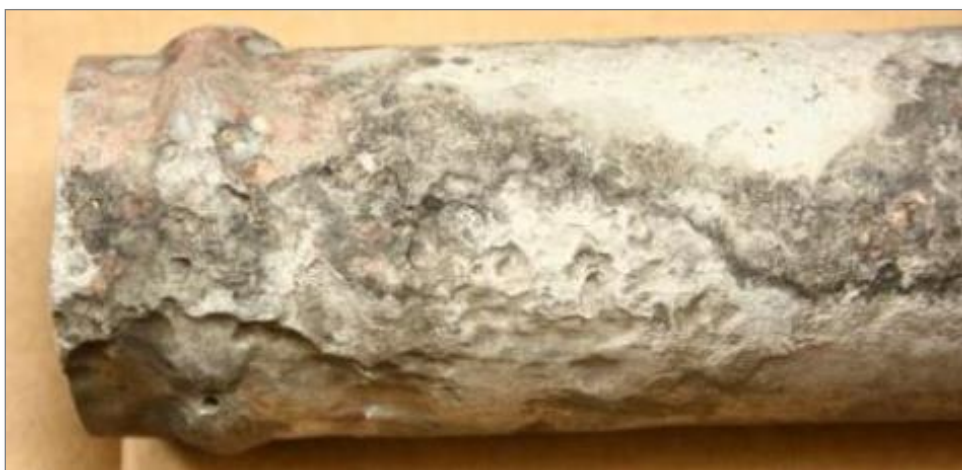
Close-up after cleaning, showing external surface metal loss

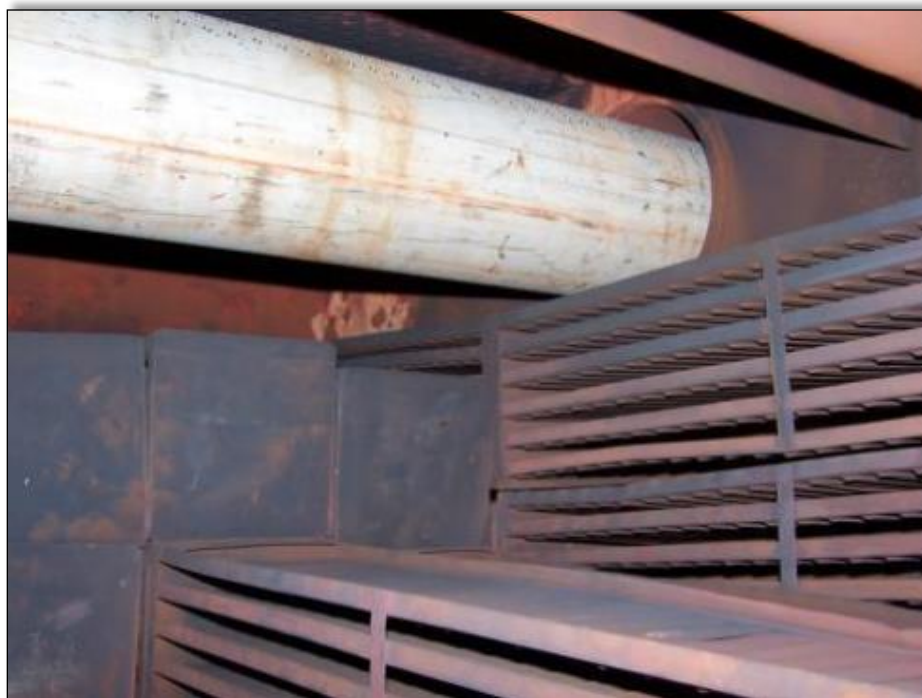
Distorted and collapsed deaerator trays

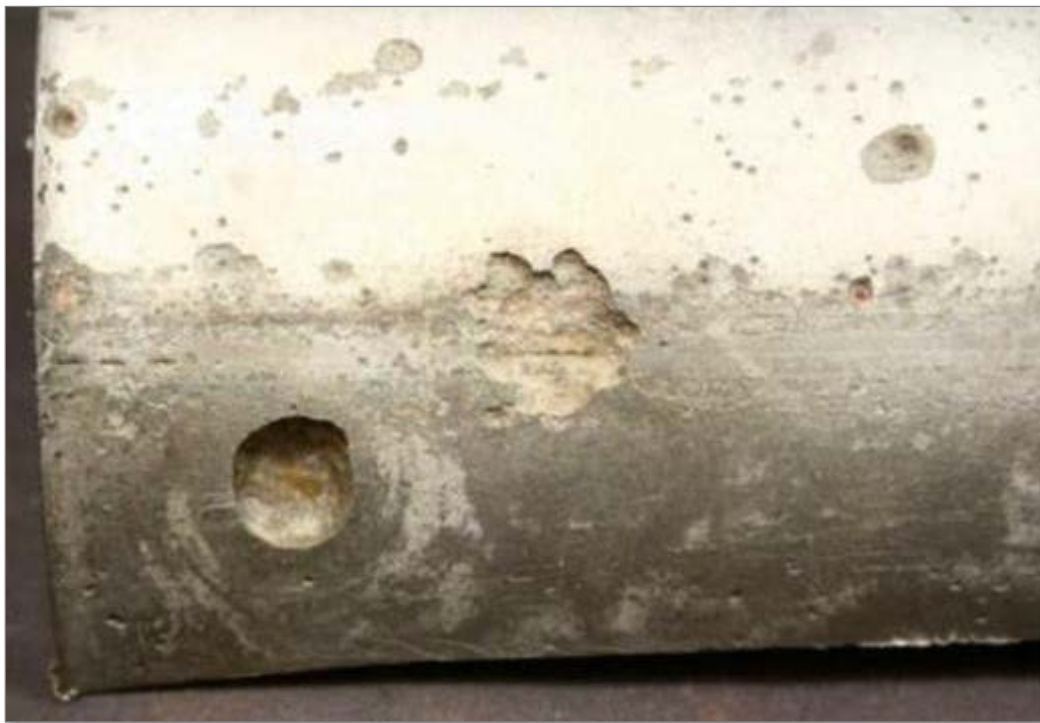
Oxygen pitting, after cleaning

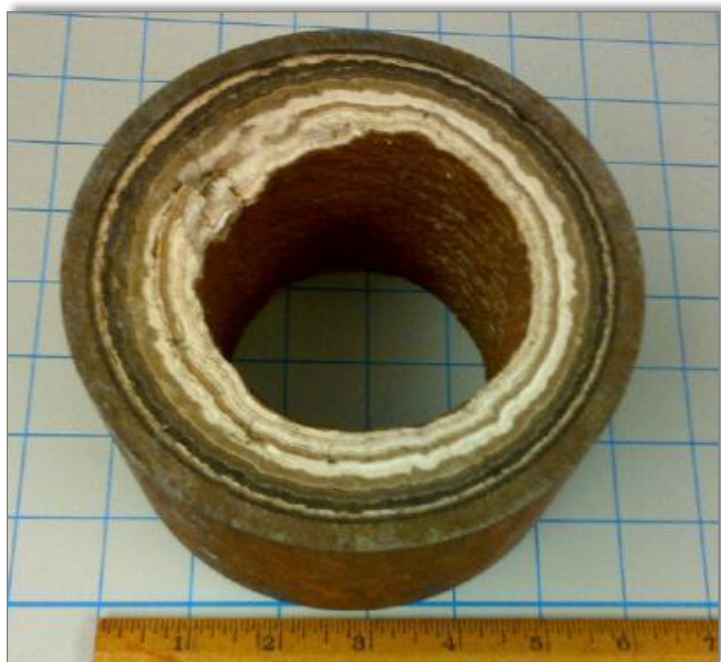
Feedwater line deposits – multiple hardness upsets in 100 year old system

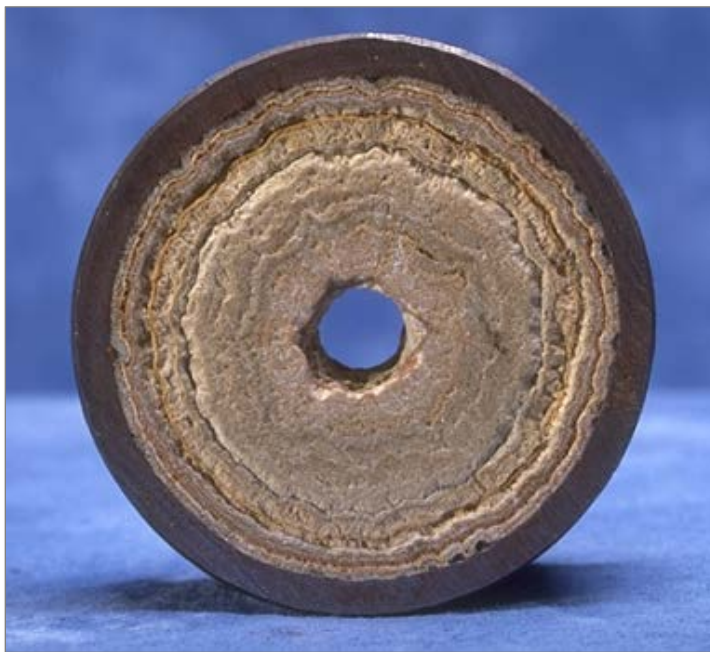
Feedwater line deposits due to years of repetitive hardness intrusion

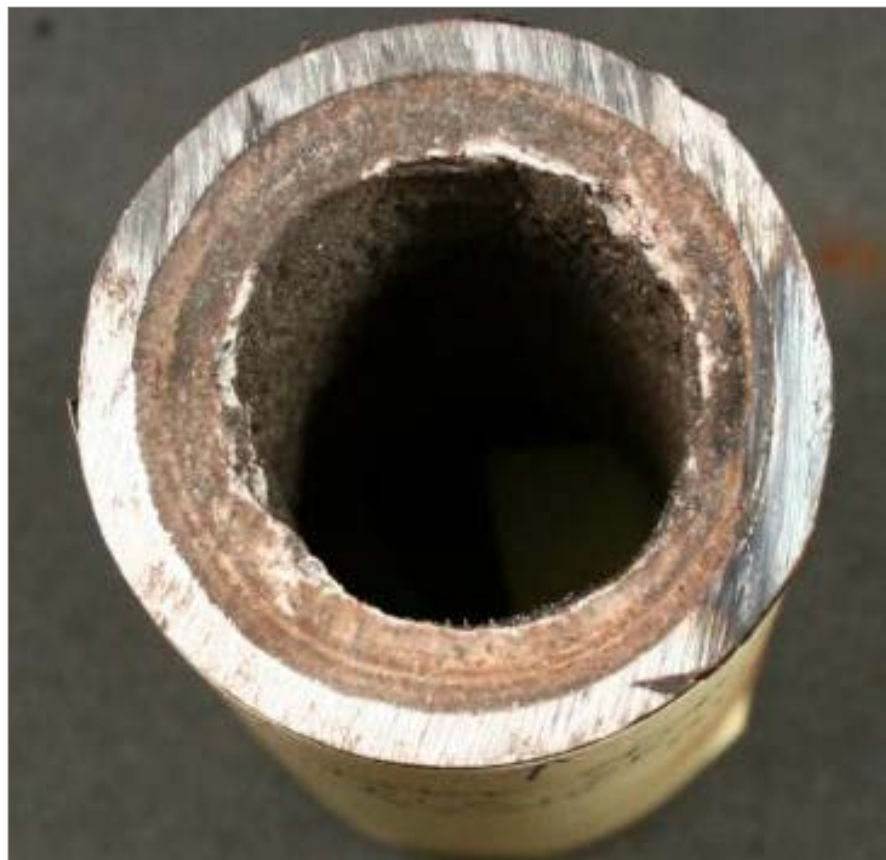
1.5" diameter wall tube from watertube boiler. Layered phosphate and iron deposits from years of multiple feedwater hardness and internal water treatment chemistry upsets.

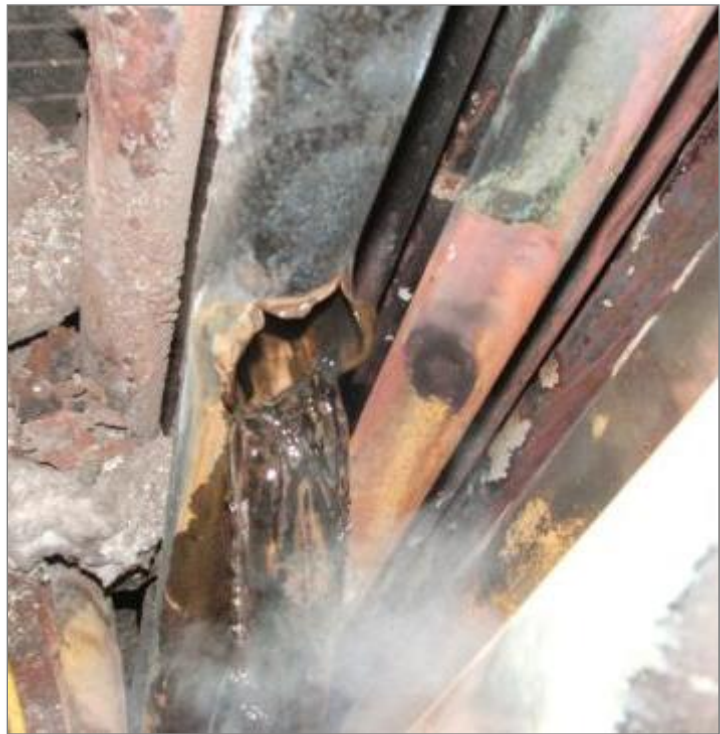
Flame impingement – back corner of furnace

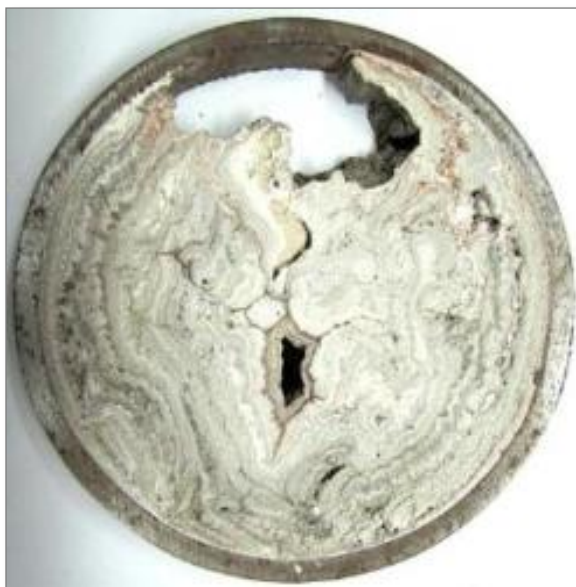
Deposits in 6 inch diameter steam line due to long term intermittent boiler water carryover

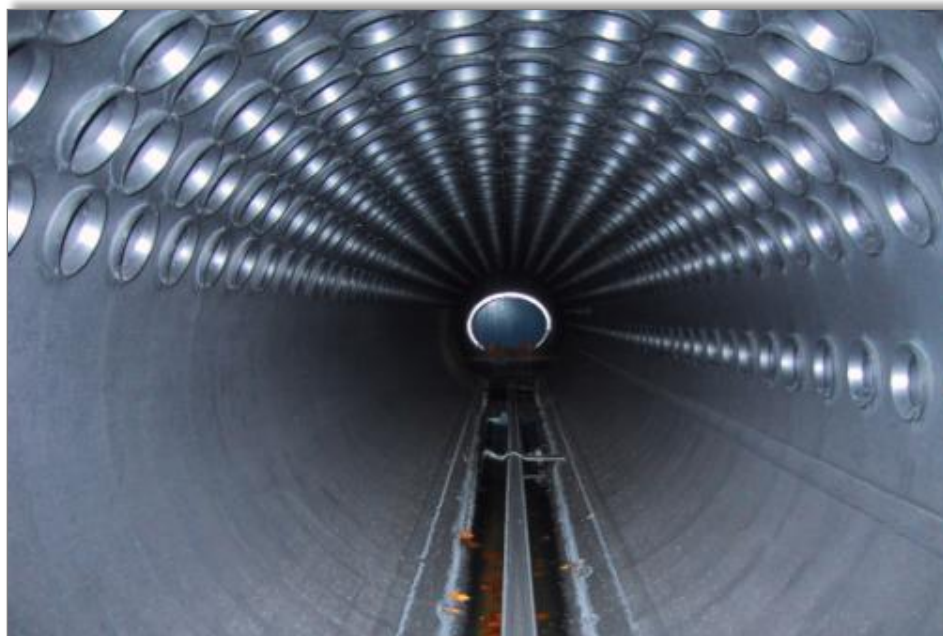
Clean mud drum and tubes

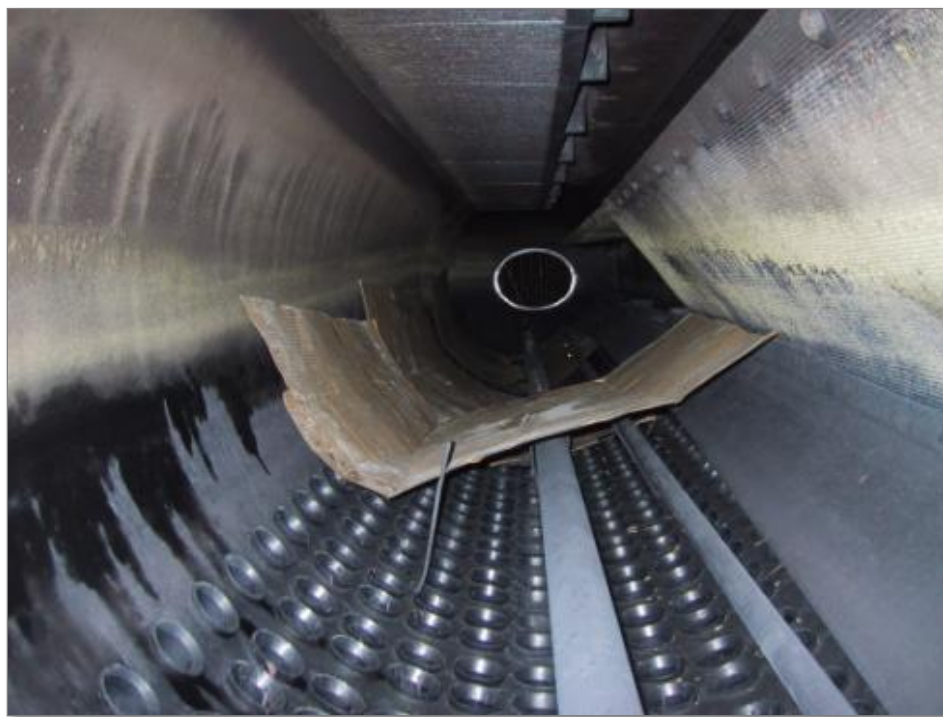
Clean steam drum downcomer tubes, deposit fouled steam diffuser screen and boiler drum sidewalls

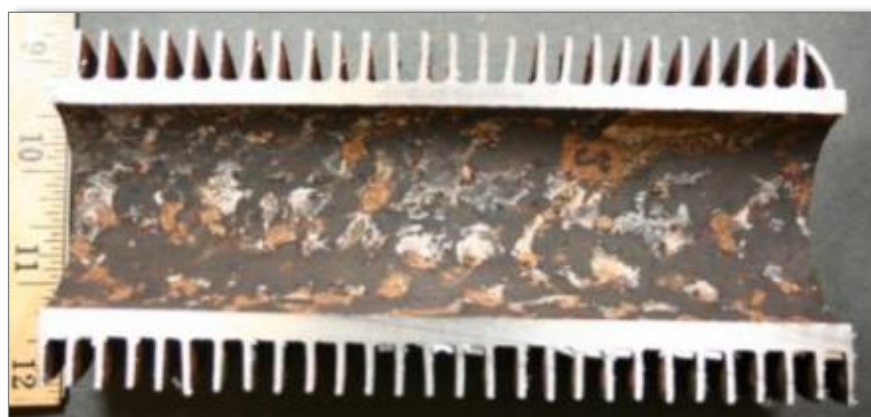
Heavy magnetite formation in a superheater tube

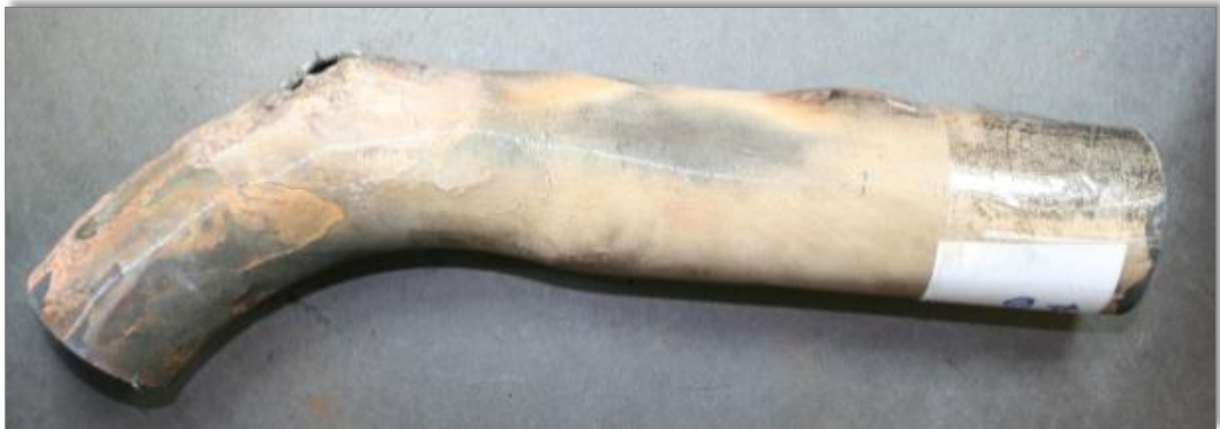
Superheater tube bulges

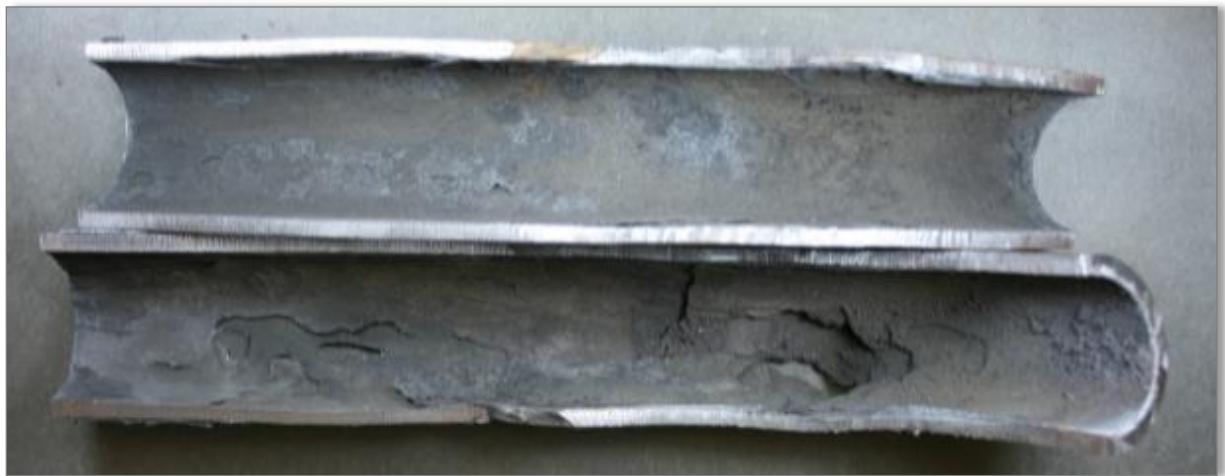
Superheater tube internal deposits
