Library of Congress Cataloging-in-Publication Data  
Kletz, Trevor A.

What went wrong? : case histories of process plant disasters and how they could have been avoided / Trevor Kletz. —5th ed.

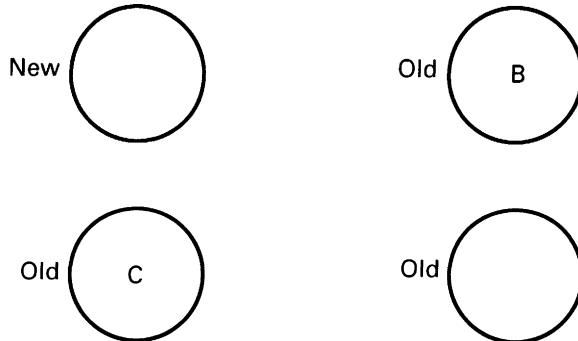
FIGURE 1-8 Which is crystallizer A?

- (b) There were four crystallizers in a plant, three old ones and one just installed. A man was asked to repair A. When he went onto the structure, he saw that two were labeled B and C but the other two were not labeled. He assumed that A was the old unlabeled crystallizer and started work on it. Actually, A was the new crystallizer. The original three were called B, C, and D. Crystallizer A was reserved for a possible future addition for which space was left (Figure 1-8).

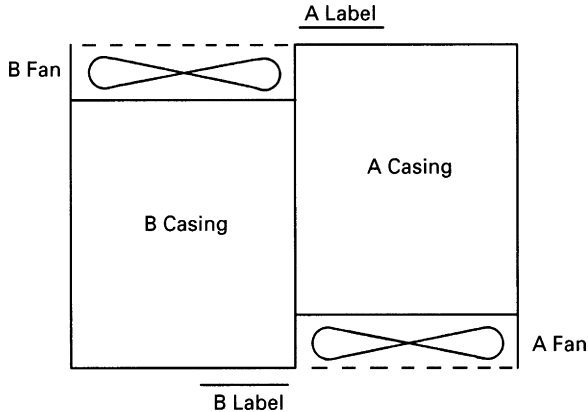
FIGURE 1-9 Which is the A fan?

- (c) The labels on two air coolers were arranged as shown in Figure 1-9. The B label was on the side of the B cooler farthest away from the B fan and near the A fan. Not unreasonably, workers who were asked to overhaul the B fan assumed it was the one next to the B label and overhauled it. The power had not been isolated. But fortunately, the overhaul was nearly complete before someone started the fan.

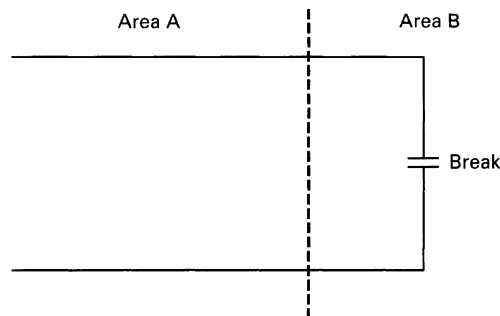
FIGURE 1-10 Who should authorize the pipeline break?

Suppose a pipeline belonging to area A passes through area B and that this pipeline has to be broken in area B (Figure 1-10).

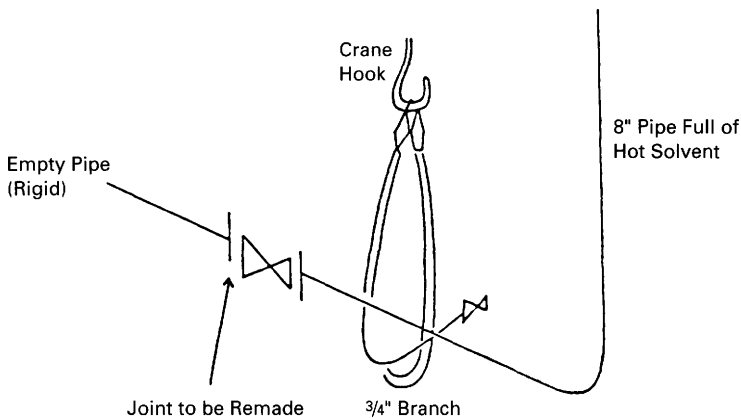
FIGURE 1-11 A branch broke when a crane was used to move a live line.

A joint on an 8-in. line containing a hot solvent had to be remade. The two sides were  $\frac{3}{4}$ -in. out of line. There was a crane in the plant at the time, so it was decided to use it to lift one of the lines slightly. The lifting strap pulled against a  $\frac{3}{4}$ -in. branch and broke it off (Figure 1-11).

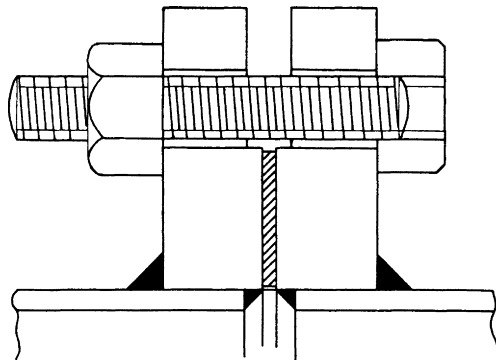
FIGURE 1-12 Nuts fitted incorrectly to studs.

- (a) When a plant came back on line after a long shutdown, some of the flanges had been secured with stud bolts and nuts instead of ordinary bolts and nuts. And some of the stud bolts were located so that

more protruded on one side than on the other. On some flanges, one of the nuts was secured by only two or three threads (Figure 1-12).

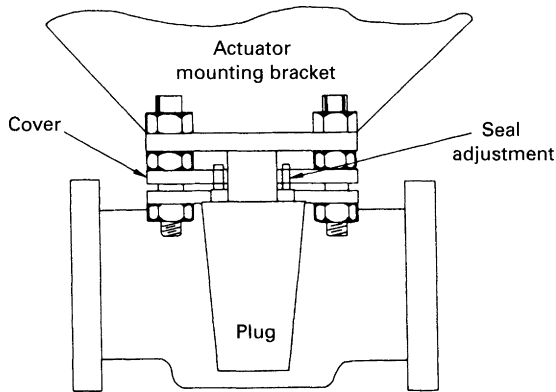
FIGURE 1-15 Another example of wrong nuts undone to remove the valve actuator.

- (a)** Several spillages have occurred from power-operated valves while the actuators were being removed because the bolts holding the valve bonnets in position were removed in error. Figures 1-14 and 1-15 show how two such incidents occurred. The second system is particularly vulnerable because in trying to unscrew the nuts that hold the actuator mounting bracket in place, the stud may unscrew out of the lower nuts. This incident could be classified as due to poor design [10].

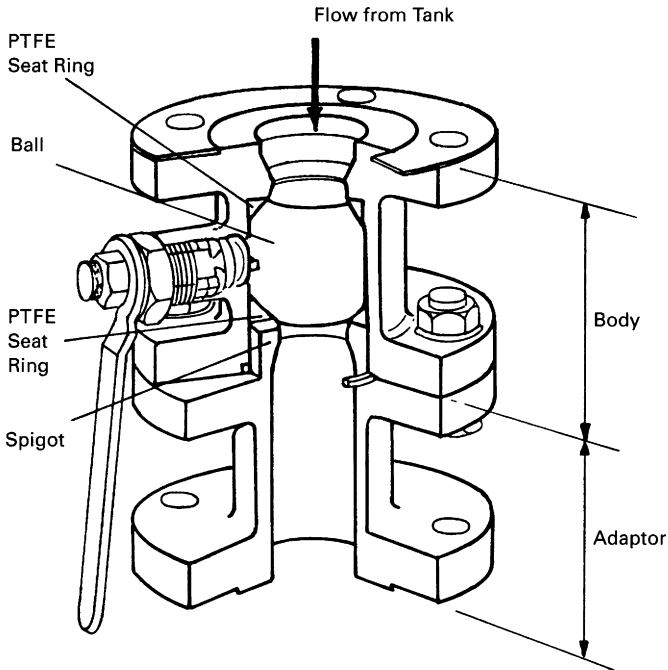
FIGURE 1-16 Valve dismantled in error.

- (b)** A similar accident occurred on a common type of ball valve. Two workers were asked to fit a drain line below the valve. There was not much room, so they decided to remove what they thought was a distance piece or adaptor below the valve but that was in fact the lower part of the valve body (Figure 1-16). When they had removed three bolts and loosened the fourth, it got dark, and they left the job to the next day.

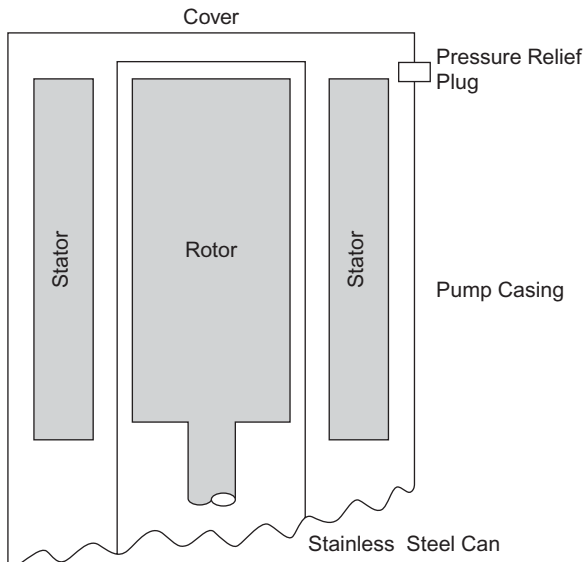
FIGURE 1-17 Canned pumps.

The fixed part of the electric motor—the stator—is not immersed in the process liquid and is separated from the rotor by a stainless steel can (Figure 1-17).

If there is a hole in the can, process liquid can get into the stator compartment. A pressure relief plug is therefore fitted to the compartment

and should be used before the compartment is opened for work on the stator. Warning plates, reminding us to do this, are often fitted to the pumps.

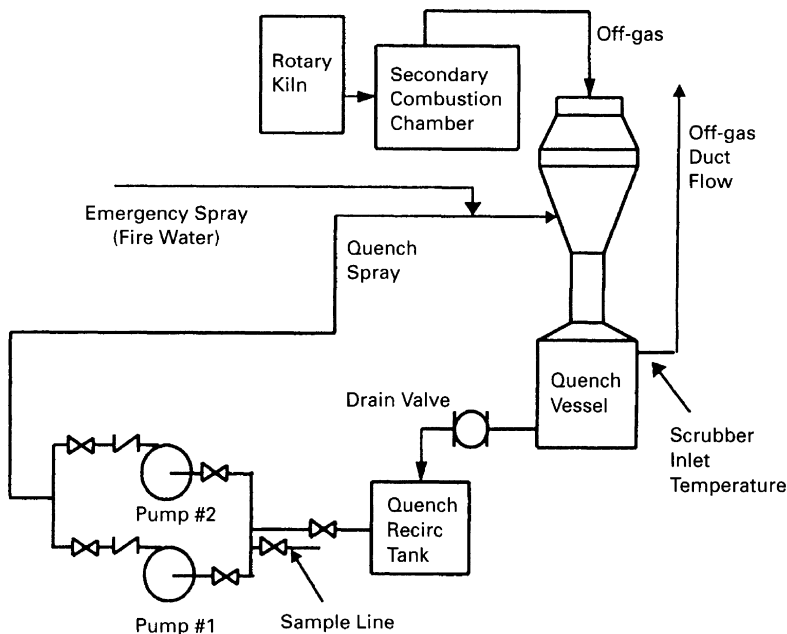
FIGURE 1-19 Simplified drawing of incinerator quench recirculation system. (Illustration courtesy of the U.S. Department of Energy.)

A sample point on the suction line of two water pumps became choked, and a maintenance worker was asked to clear it. He was not told how to do so—craftspeople dislike people from other departments telling them how to do their jobs—but the operators assumed he would use water under pressure or a rod. Instead he used compressed air at a gauge pressure of 115 psi (8 bar), and a pocket of air caused the pumps to lose suction (Figure 1-19).

The results were not serious. The pumps supplied water to cool the hot gases leaving an incinerator; when the water flow stopped, a high-temperature trip shut down the burner. The incinerator was new, it was still undergoing tests, and the job had not been done before. The water was recycled, and ash in it probably caused the choke [40].

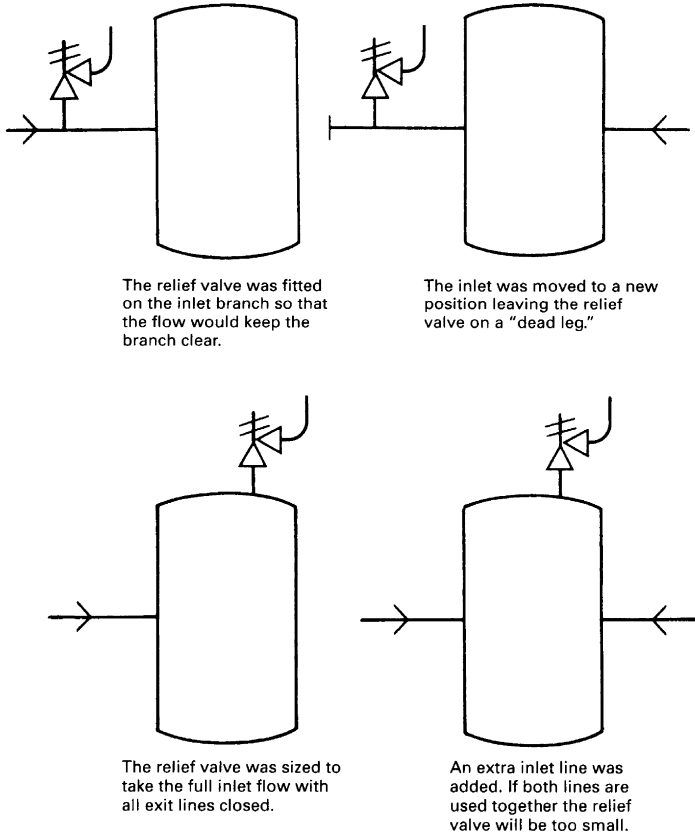
FIGURE 2-1 Some of the modifications made to the relief system in a plant during its first year on line.

At one plant, a repeat relief and blowdown review was carried out one year after startup. The startup team had been well aware of the need to look for the consequences of modifications and had tried to do so as modifications were made. Nevertheless, the repeat relief and blowdown review brought to light 12 instances in which the assumptions of the original review were no longer true and additional or larger relief valves, or changes in the position of a relief valve, were necessary. Figure 2-1 shows some examples.

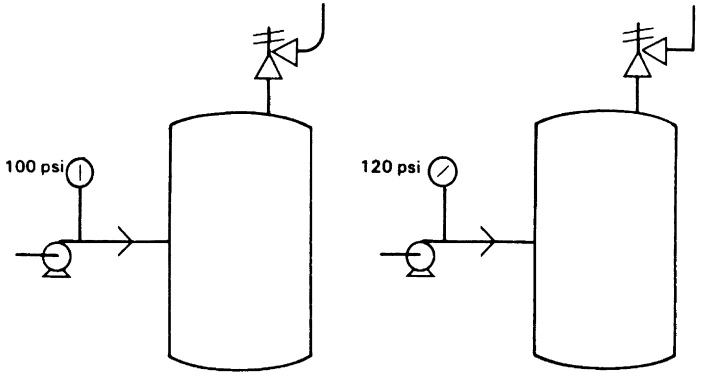
The vessel was designed to withstand the maximum pressure the pump could deliver. The relief valve was not designed to take the maximum flow from the pump.

The pump actually proved capable of producing 20 psi more than design. If the exit from the vessel is isolated when the pump is running the vessel will be overpressured.

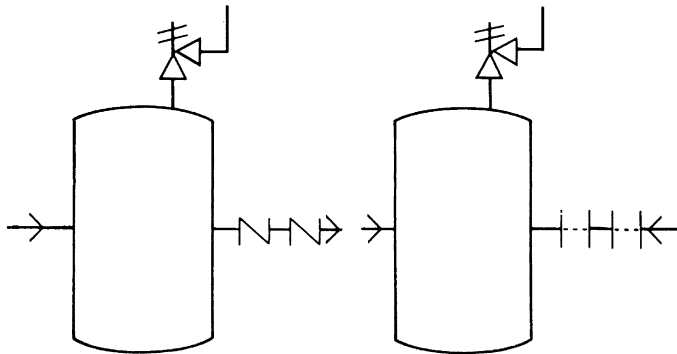
The relief valve was sized on the assumption that two nonreturn valves in series would prevent backflow into the vessel.

Both nonreturn valves corroded, allowing backflow to take place.

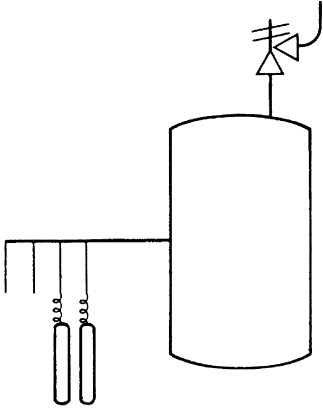
The relief valve was sized on the assumption that only two gas cylinders would be used at a time, though connections were provided for four cylinders.

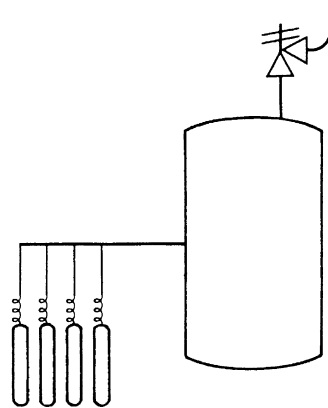
Inevitably, four cylinders were connected up and sometimes used.

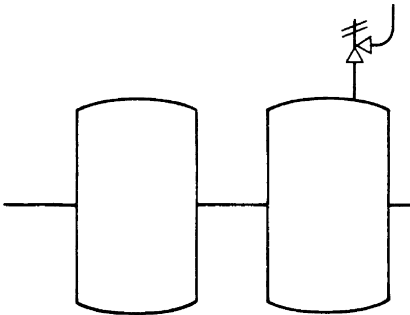
A single relief valve was designed to protect two vessels, which were connected together by a line without any valve or other restriction between them.

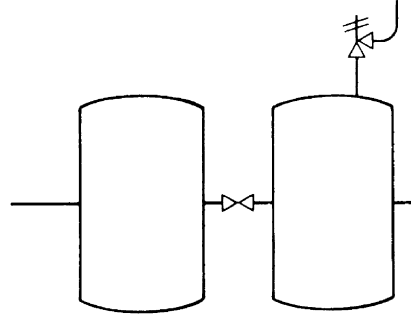
An extra isolation valve was fitted between the two vessels, thus making it possible to isolate the first vessel from its relief valve.

In another similar case, chokes occurred in the line between the two vessels.

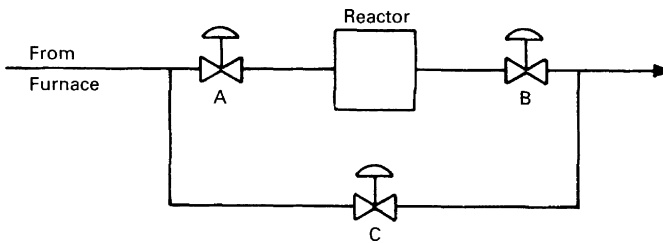
FIGURE 2-2a Original reactor bypass.

- (b)** A reactor was fitted with a bypass (Figure 2-2a). The remotely operated valves A, B, and C were interlocked so that C had to be open before A or B could be closed. It was found that the valves leaked, so hand-operated isolation valves (a, b, and c) were installed in series with them (Figure 2-2b).

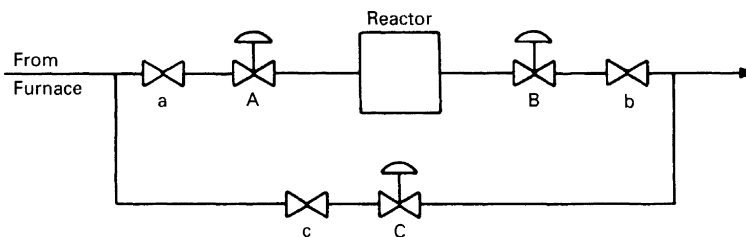
FIGURE 2-2b Modified reactor bypass.

After closing A and B, the operators were instructed to go outside and close the corresponding hand valves a and b. This destroyed the interlocking. One day, an operator could not get A and B to close. He had forgotten to open C. He decided that A and B were faulty and closed a and b. Flow stopped. The tubes in the furnace were overheated. One of them burst, and the lives of the rest were shortened.

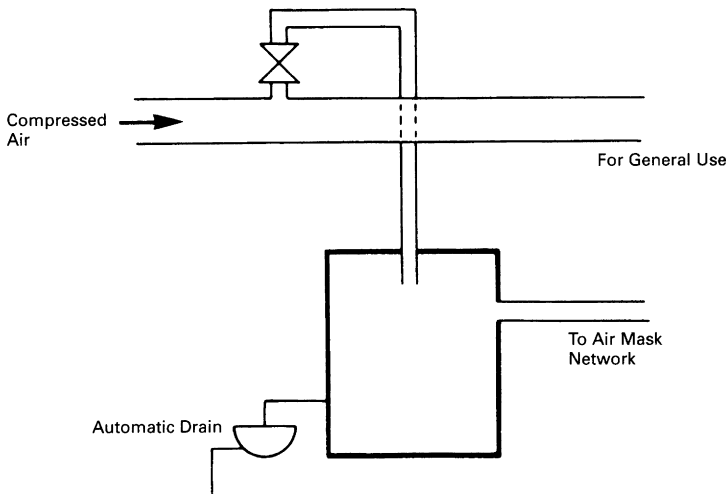
FIGURE 2-4 Original arrangement of air lines.

Many years ago, a special network of air lines was installed for use with air masks only. A special branch was taken off the top of the compressed air main as it entered the works (Figure 2-4).

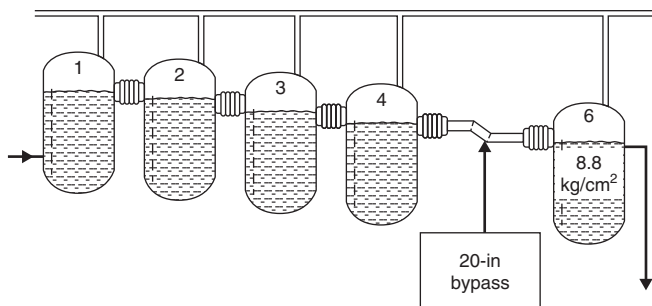
FIGURE 2-5 Arrangement of reactors and temporary pipe at Flixborough.

At the Flixborough plant, there were six reactors in series. Each reactor was slightly lower than the one before so that the liquid in them flowed by gravity from No. 1 down to No. 6 through short 28-in.-diameter connecting pipes (Figure 2-5). To allow for expansion, each 28-in. pipe contained a bellows (expansion joint).

One of the reactors developed a crack and had to be removed. (The crack was the result of a process modification; see Section 2.6b.) It was replaced by a temporary 20-in. pipe, which had two bends in it, to allow for the difference in height. The existing bellows were left in position at both ends of the temporary pipe (Figure 2-5).

The design of the pipe and support left much to be desired. The pipe was not properly supported; it merely rested on scaffolding. Because there was a bellows at each end, it was free to rotate or “squirm” and did so when the pressure rose a little above the normal level. This caused the bellows to fail.

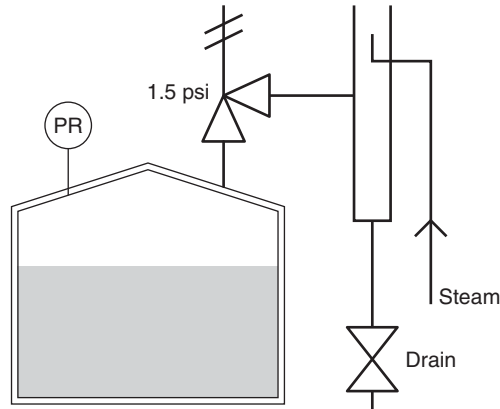
FIGURE 2-6 Liquid ethylene tank venting arrangements.

- (a)** A low-pressure refrigerated ethylene tank was provided with a relief valve set at a gauge pressure of about 1.5 psi (0.1 bar), which discharged to a vent stack. After the design had been completed, it was realized that cold gas coming out of the stack would, when the wind speed was low, drift down to ground level, where it might be ignited. The stack was too low to be used as a flarestack—the radiation at ground level would be too high—and was not strong enough to be extended. What could be done?

Someone suggested putting steam up the stack to disperse the cold vapor. This seemed a good idea, and the suggestion was adopted (Figure 2-6).

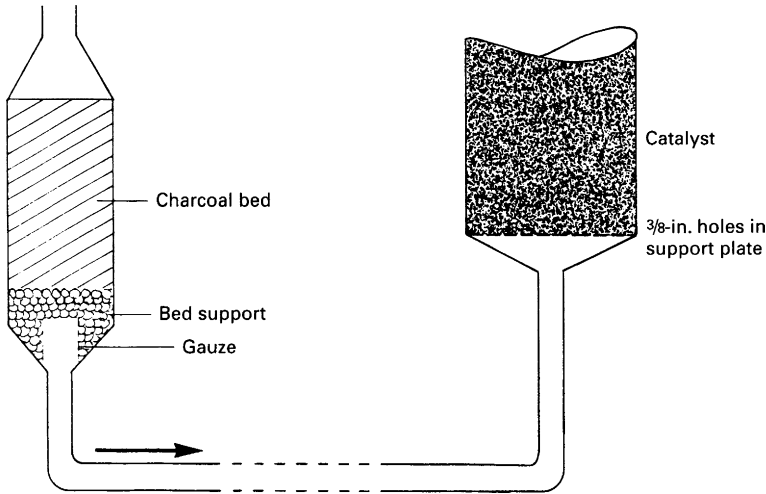
FIGURE 2-7 Hydrogen purification system.

The hydrogen came from another plant and was passed through a charcoal filter to remove traces of oil before it left the supplying plant. Changes of charcoal were infrequent, and the initial stock lasted several years. Reordering resulted in a finer charcoal being supplied and charged without the significance of the change being recognized. Over a long period, the new charcoal passed through its support into the line to the other plant. Small amounts of the charcoal partially clogged the  $\frac{3}{8}$ -in. (10 mm) distribution holes in the catalyst retaining plate (Figure 2-7). There was a big loss of production.

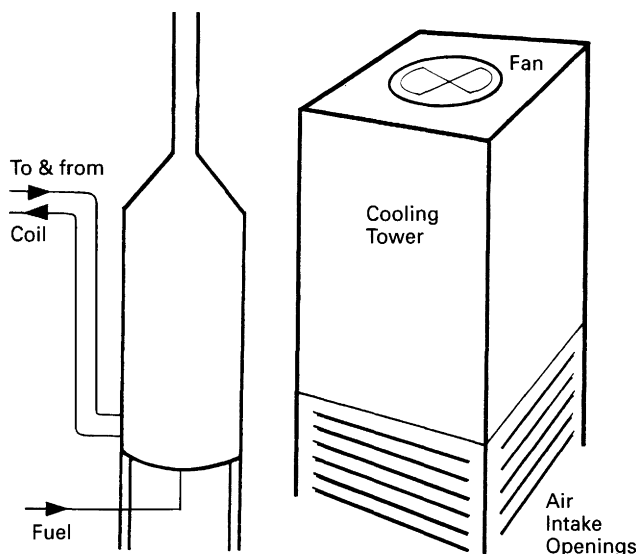
FIGURE 2-8 Gas entered the furnace when the cooling tower fan was switched off.

No one realized, when a site for the furnace was decided, that flammable vapors could come out of the cooling tower. Direct contact condensers are not common, but flammable vapors can appear in many cooling towers if there are leaks on water-cooled heat exchangers. After the incident, a combustible gas detector was mounted permanently between the furnace and the tower (Figure 2-8).

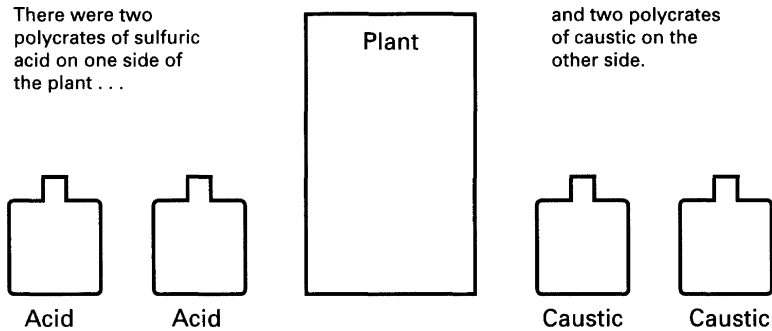
FIGURE 2-9 Original layout of acid and caustic containers.

- (a) A plant used sulfuric acid and caustic soda in small quantities, so the two substances were supplied in similar plastic containers called polycrates (Figure 2-9). While an operator was on his day off, someone decided it would be more convenient to have a polycrate of acid and a polycrate of alkali on each side (Figure 2-10). When the operator

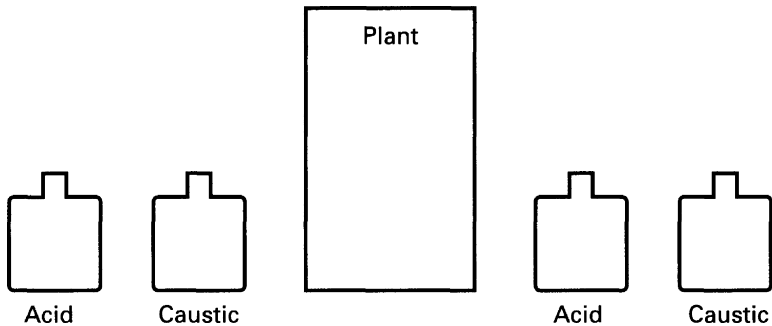
FIGURE 2-10 Modified layout of acid and caustic containers.

came back, no one told him about the change. Without checking the labels, he poured some excess acid into a caustic crate. There was a violent reaction, and the operator was sprayed in the face. Fortunately, he was wearing goggles.

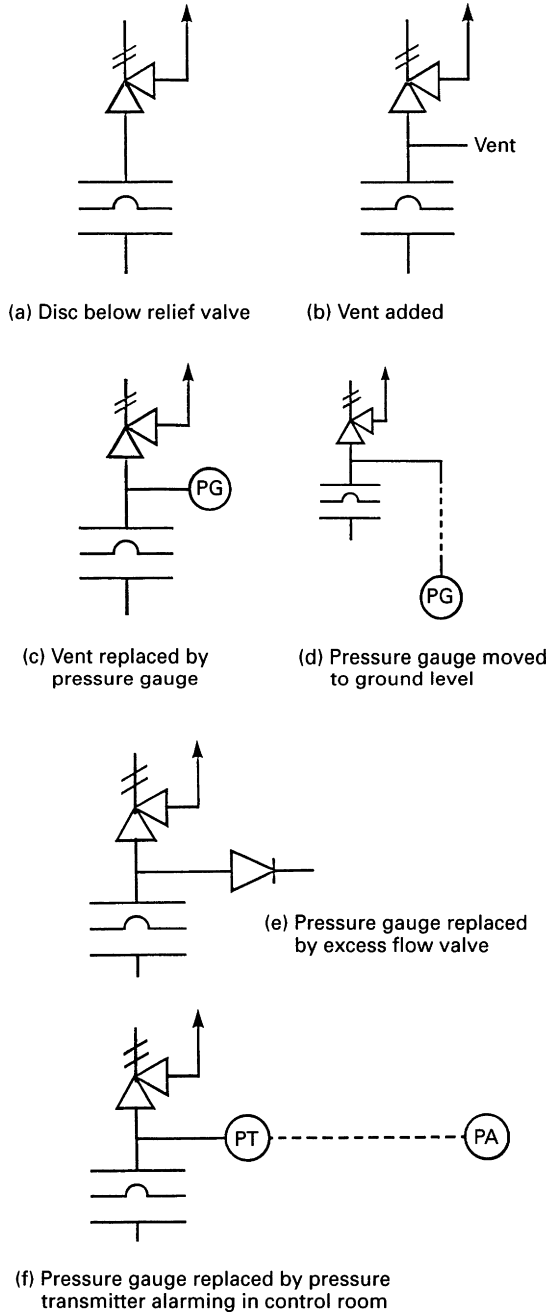
These long lengths of pipe got broken or kinked or liquid collected in them. Sometimes operators disconnected them so the pressure always read zero. The gauges and long lengths of pipe were therefore replaced by excess flow valves, which vent small leaks from pinholes but close if the rupture disc ruptures (Figure 2-11e).

Unfortunately, the excess flow valves were fitted with female threads, and many operators are trained to screw plugs into any open female threads they see. So some of the excess flow valves became plugged.

FIGURE 2-11 A modification chain—rupture discs below relief valves.

Pressure transmitters, alarming in the control room, were therefore fitted in place of the excess flow valves (Figure 2-11f). This was an expensive solution. Perhaps it would have been better to remove the rupture discs and prevent leaks to the atmosphere by taking more care over the machining and lapping of the relief valves.

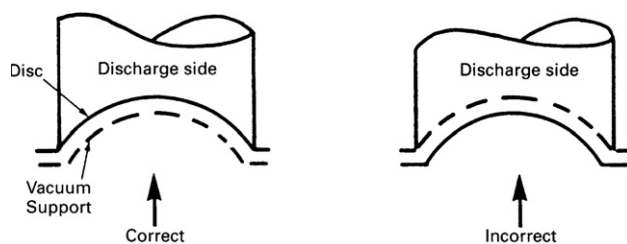
- (e) A runaway reaction occurred in a polymerization reactor. A rupture disc failed to burst. It had been fitted on the wrong side of the vacuum support, thus raising its bursting pressure from a gauge pressure of 150 psi (10 bar) to about 400 psi (27 bar) (Figures 3-1a and 3-1b).

The polymer escaped through some of the flanged joints, burying the reactor in a brown polymer that looked like molasses candy (treacle toffee). The reactor was fitted with class 150 flanges. If these are overpressured, the bolts will stretch, and the flanges will leak,

FIGURE 3-1a Arrangements of rupture disc and vacuum support.

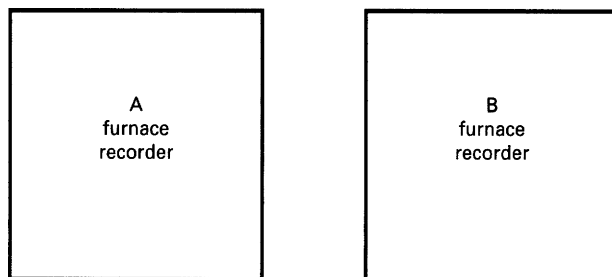
FIGURE 3-2 Layout of recorders on panel.

Two furnaces were each fitted with a temperature recorder controller and high-temperature trip. The two recorders were side by side on the instrument panel in the control room, with the recorder for A furnace on the left (Figure 3-2).

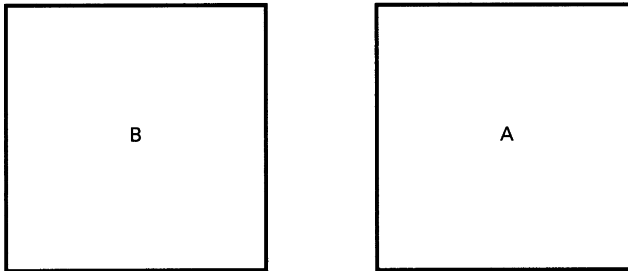
The mechanic, who had done the job many times before, took the cover off the back of B recorder, the one on the left behind the panel (Figure 3-3), and disconnected one of the leads. The effect was the same as if the recorder had registered a high temperature. The controller closed the fuel gas valve, shutting down the furnace and the rest of the plant.

FIGURE 3-3 Layout of recorders behind panel.

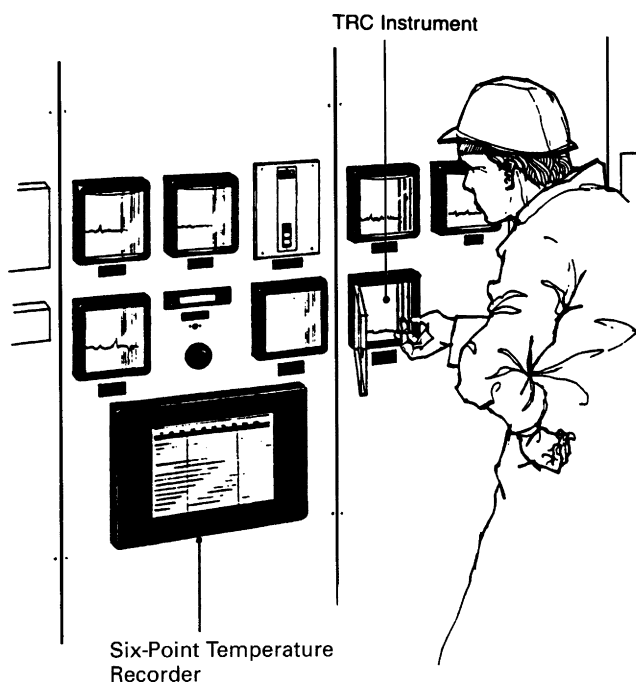
Unfortunately, there was a fault in the temperature recorder, and although the temperature actually rose, this was not indicated. The result was a runaway reaction. The rise in temperature was, however, indicated on a six-point temperature recorder at a lower level on the panel, but the operator did not notice this (Figure 3-4).

An interesting feature of this incident was that no one blamed the operator. The plant manager said he would probably have made the same mistake because the check instrument was at a low level (about 1 m above the floor) and because a change in one temperature on a six-point recorder in that position is not obvious unless you are actually looking for it. It is not the sort of thing you notice out of the corner of your eye.

FIGURE 3-4 Instruments below eye level may not be noticed.

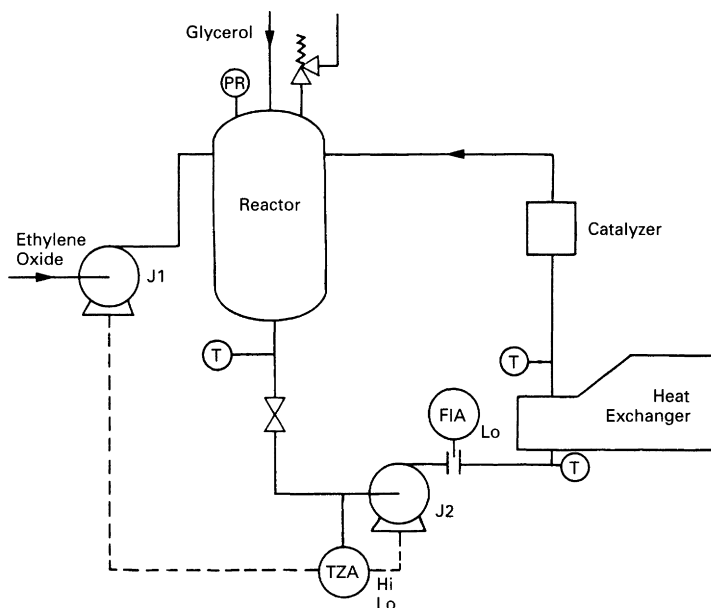
Figure 3-6 shows a batch reaction system. A batch of glycerol was placed in the reactor and circulated through a heat exchanger, which could act as both a heater and a cooler. Initially it was used as a heater, and when the temperature reached 115°C, ethylene oxide was added. The reaction was exothermic, and the exchanger was now used as a cooler.

FIGURE 3-6 Arrangements of reactor circulating system.

Despite these precautions, an explosion occurred. One day, when the ethylene oxide addition was started, the pressure in the reactor rose. This showed that the ethylene oxide was not reacting. The operator decided that perhaps the temperature point was reading low or perhaps a bit more heat was required to start the reaction, so he adjusted the trip setting and allowed the indicated temperature to rise to 200°C (390°F). Still the pressure did not fall.

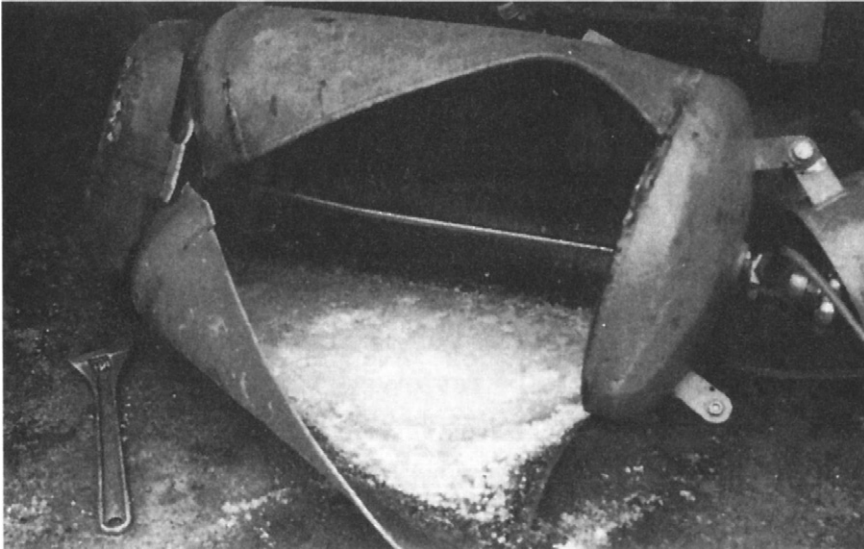
The regulator developed a fault and had to be changed. The gauge on the new one also had two scales. The inner one indicated 0 to 280 kg/cm<sup>2</sup> gauge (a kg/cm<sup>2</sup> is almost the same as a bar) in intervals of 10 kg/cm<sup>2</sup>; the outer one indicated psig. The inner one thus looked like the inner scale on the old gauge, so the operators set the pointer at three divisions on it. Long before the pressure reached two divisions, corresponding to a gauge pressure of 20 kg/cm<sup>2</sup> or 300 psi, the cylinder burst. Figure 4-3 shows the results. The estimated bursting pressure was 215 psig (15 kg/cm<sup>2</sup> gauge) [11].

**FIGURE 4-3** The result of pressurizing a cylinder to “two divisions” on a scale graduated in  $\text{kg}/\text{cm}^2$  instead of psi. (Photo courtesy of the Institution of Chemical Engineers.)

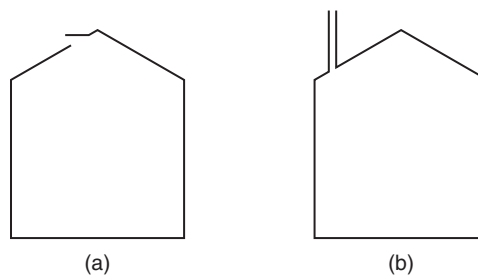
This overflow device should be fitted to the roof near the wall. If it is fitted near the center of the roof, the height of liquid above the top of the walls may exceed 8 in., and the tank may be overpressured (see Figure 5-2a).

Similarly, if the vent is designed to pass liquid, it should be fitted near the edge of the roof, and its top should not be more than 8 in. above the tops of the walls. Vessels have been overpressured because their vent pipes were too long (see Figure 5-2b). Tanks in which hydrogen may be evolved should be fitted with a vent at the highest point as well as an overflow (see Section 16.2).

FIGURE 5-2 A tank may be overpressured if the vent or overflow is more than 8 in. above the tops of the walls.

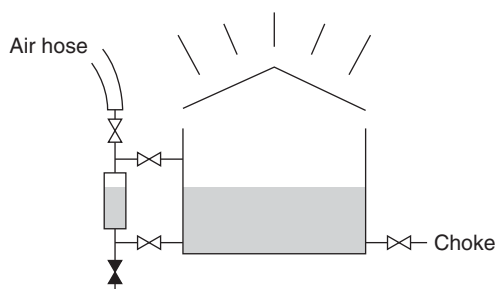
- (a) There was a choke on the exit line from a small tank. To try to clear the choke, the operator held a compressed air hose against the open end at the top of the level glass. The gauge pressure of the compressed air was 100 psi (7 bar), and the top of the tank was blown off (Figure 5-3).

FIGURE 5-3 Tank top blown off by compressed air.

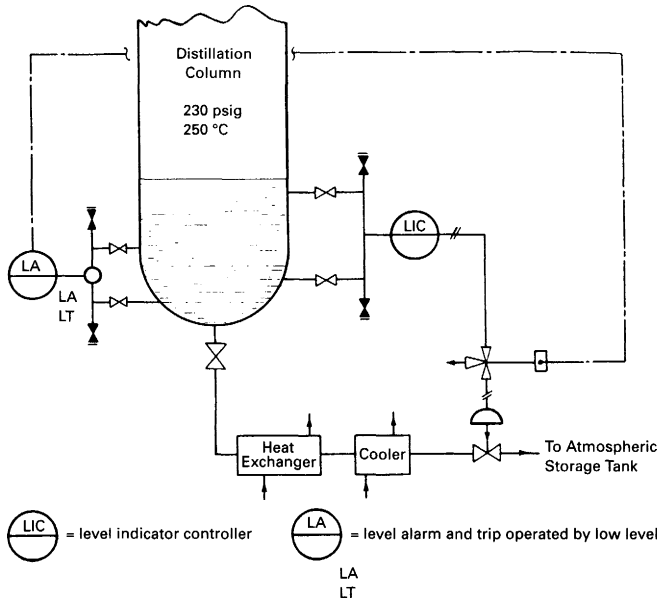
- (c) On other occasions, tanks have been ruptured because the failure of a level controller (e.g., on a high-pressure distillation column) allowed a gas stream to enter the tank via the bottoms transfer line (Figure 5-4). Pressure vessels have also been ruptured in this way (see Section 9.2.2d). The precautions necessary to prevent this from occurring are analyzed in detail in reference 1.

FIGURE 5-4 How failure of a level controller can overpressure a tank.

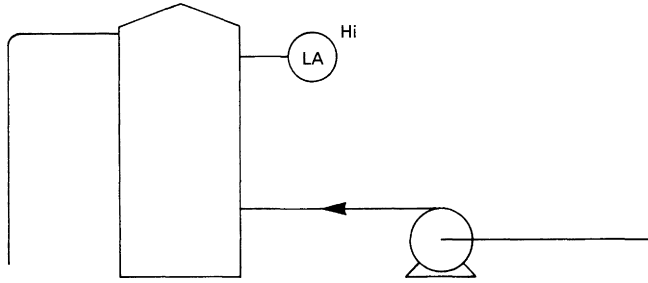
- (j)** Before emptying a tank truck, the driver propped the manhole lid open. It fell shut.
- (k)** A tank was fitted with an overflow, which came down to ground level. There was no other vent. When the tank was overfilled, the contents siphoned out (Figure 5-5). The tank should have been fitted with a vent on its roof, as well as the liquid overflow.

FIGURE 5-5 Overflow to ground level can cause a tank to collapse if there is no other vent.

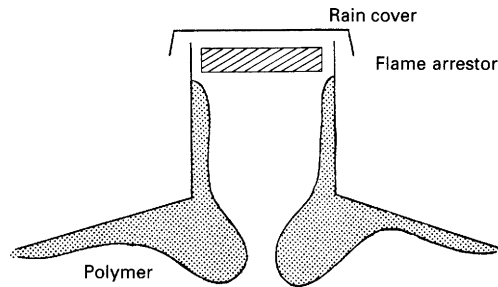
- (l)** A vent was almost blocked by polymer (Figure 5-6). The liquid in the tank was inhibited to prevent polymerization, but the vapor that condensed on the roof was not inhibited. The vent was inspected regularly, but the polymer was not noticed. Now a wooden rod is pushed through the vent to prove it is clear. (The other end of the rod should be enlarged so it cannot fall into the tank.)

FIGURE 5-6 Vent almost blocked by polymer.

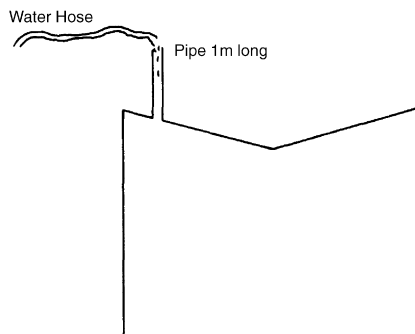
The need for such training is shown by the action taken following one of the incidents. Only the roof had been sucked in, and it was concave instead of convex. The engineer in charge decided to blow the tank back to the correct shape by water pressure. He gave instructions for this to be done. A few hours later, he went to see how the job was progressing. He found that the tank had been filled with water and that a hand-operated hydraulic

FIGURE 5-7 Method of restoring a tank with a concave roof to its original shape.

pump, normally used for pressure-testing pipework, was being connected to the tank. He had it removed, and he replaced the vent with a vertical pipe, 1 m long. He dribbled water into the pipe from a hose, and as he did so, the tank was restored to its original shape (Figure 5-7) to the amazement of onlookers. The static pressure of the water in the pipe was sufficient.

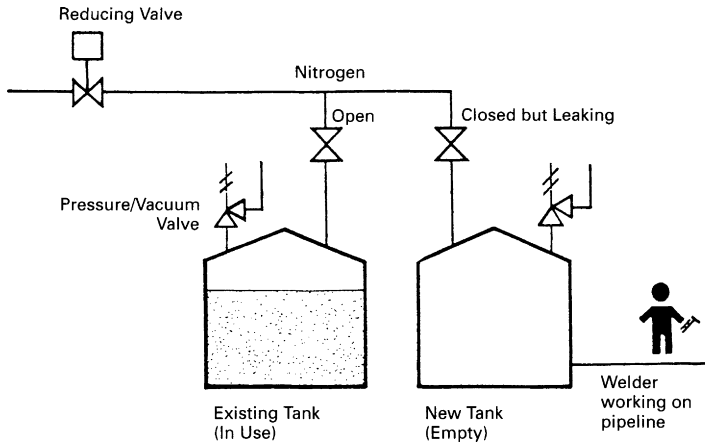
The new tank and an existing one were designed to be on balance with each other to save nitrogen (Figure 5-9), but the contractors did not understand this. The valve to the new tank was closed but leaking. Nitrogen and methanol vapor entered the tank, and a welder who was completing the inlet line to the tank ignited the vapor. The roof was blown right off. By great good fortune, it landed on a patch of empty ground just big enough to contain it (Figure 5-10).

FIGURE 5-9 If tanks are on balance, the nitrogen entering one tank is inevitably mixed with vapor.

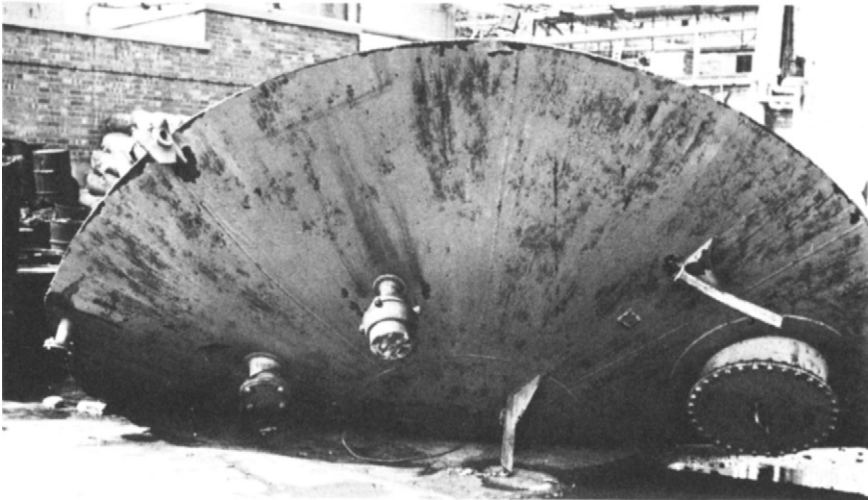
FIGURE 5-10 When an explosion occurred in a tank, the roof landed on an area just big enough to contain it.

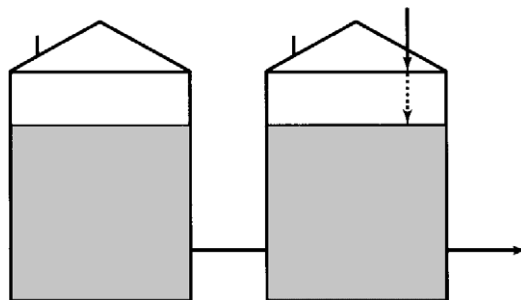
- (f) Paper mills use large quantities of water, and the water is usually recycled. Buffer storage is needed, and at one paper mill, it took the form of a 740-m<sup>3</sup> tank. Experience showed that this was insufficient, and another tank of the same size was installed alongside. To simplify installation, it was not connected in parallel with the original tank but on balance with it, as shown in Figure 5-13. A week after the new tank was brought into use, welders were completing the hand-rails on the roof when an explosion occurred in the tank. Two welders were killed, and the tank was blown 20 m into the air, landing on a nearby building.

Investigation showed that the explosion was due to hydrogen formed by anaerobic bacteria. In the original tank, the splashing of the inlet liquor aerated the water and prevented anaerobic conditions. This did not apply in the new tank [20].

**FIGURE 5-13** Extra buffer storage for water was provided by installing a second tank on balance with the first one. Lack of aeration allowed hydrogen-forming bacteria to grow, and an explosion occurred. (Reproduced with permission of the American Institute of Chemical Engineers. Copyright © 1995 AIChE. All rights reserved.)

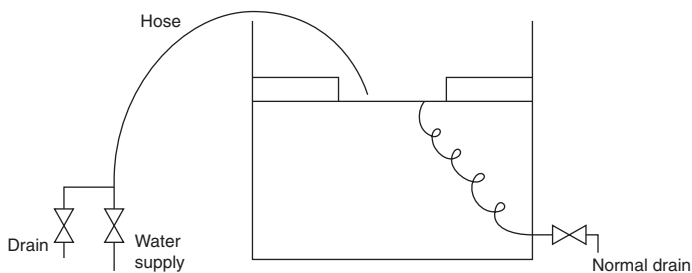
A choke occurred in the flexible pipe that drained the roof of a floating-roof tank. It was decided to drain rainwater off the roof with a hose. To prime the hose and establish a siphon, the hose was connected to the water supply. It was intended to open the valve on the water supply for just long enough to fill the hose. This valve would then be closed and the drain valve opened (Figure 5-14). However, the water valve was opened in error and left open, with the drain valve shut. Water flowed onto the floating roof, and it sank in 30 minutes (see also Section 18.8).

FIGURE 5-14 How to sink the roof of a floating-roof tank.

Temporary modifications should be examined with the same thoroughness as permanent ones (see Section 2.4).

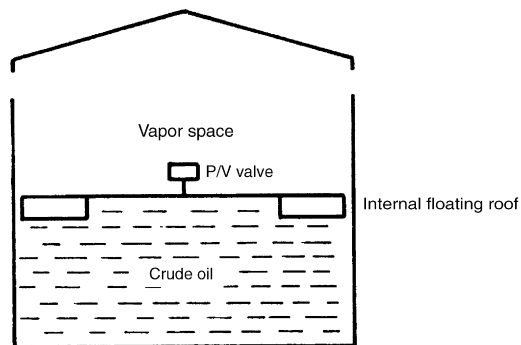
When the tank was refilled with warm crude oil at 37°C (100°F), vapor was pushed out into the space above the floating roof and then out into the atmosphere through vents on the fixed-roof tank (Figure 5-16). This vapor was ignited at a boiler house some distance away.

The fire flashed back to the storage tank, and the vapor burned as it came out of the vents. Pumping was therefore stopped. Vapor no longer came out of the vents, air got in, and a mild explosion occurred inside the fixed-roof tank. This forced the floating roof down like a piston, and some of the crude oil came up through the seal past the side of the floating roof and out of the vents on the fixed-roof tank. This oil caught fire, causing a number of pipeline joints to fail, and this caused further oil leakages. One small tank burst; fortunately, it had a weak seam roof. More than 50 fire appliances and 200 firefighters attended, and the fire was under control in a few hours.

FIGURE 5-16 Tank with internal floating roof.

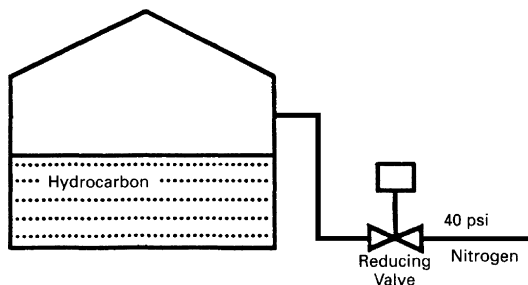
On one group of tanks, the reducing valve on the nitrogen supply was installed at ground level (Figure 5-17). Hydrocarbon vapor condensed in the vertical section of the line and effectively isolated the tank from the nitrogen blanketing.

FIGURE 5-17 Incorrect installation of nitrogen blanketing.

All safety equipment and systems should be scheduled for regular inspection and test. Nitrogen blanketing systems should be inspected at least weekly. It is not sufficient to check that the nitrogen is open to the tank. The atmosphere in the tank should be tested with a portable oxygen analyzer to make sure that the oxygen concentration is below 5%.

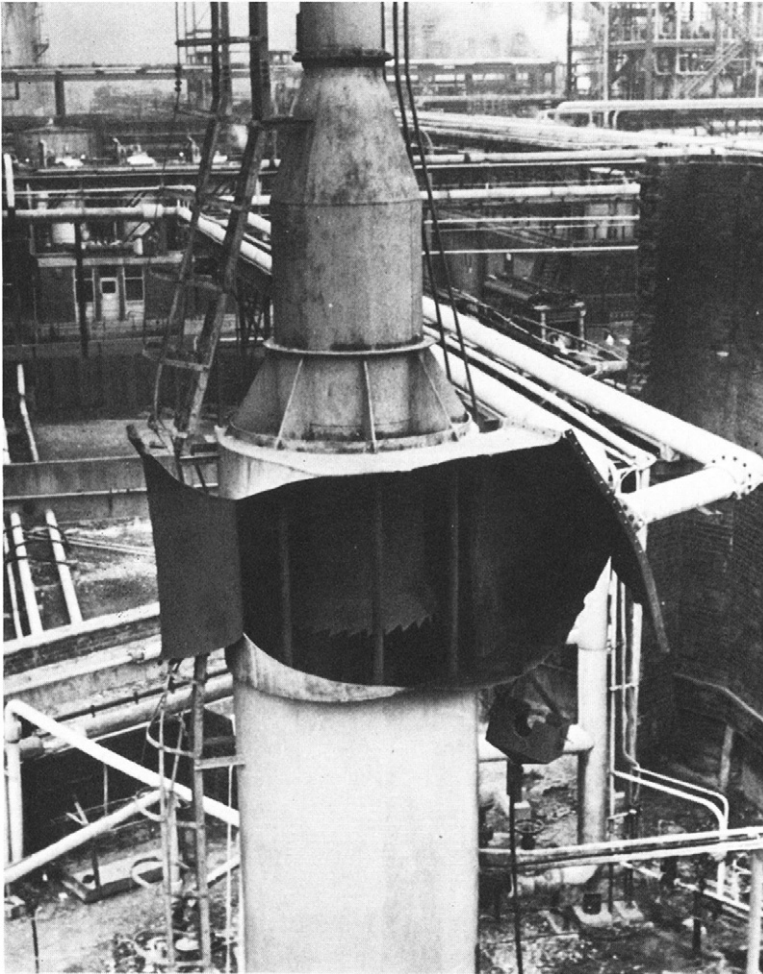
- (a)** Figure 6-1 shows the results of an explosion in a large flarestack. The stack was supposed to be purged with nitrogen. However, the flow was not measured and had been cut back almost to zero to save nitrogen. Air leaked in through the large bolted joint between unmachined surfaces. The flare had not been lit for some time. Shortly after it was relit, the explosion occurred—the next time some gas was put into the stack. The mixture of gas and air moved up the stack and the pilot flame ignited it.

FIGURE 6-1 Base of flarestack.

The following precautions should prevent similar incidents from happening again:

1. Stacks should be welded. They should not contain bolted joints between unmachined surfaces.

2. There should be a continuous flow of gas up every stack to prevent air diffusing down and to sweep away small leaks of air into the stack. The continuous flow of gas does not have to be nitrogen—a waste-gas stream is effective. But if gas is not being flared continuously, it is usual to keep nitrogen flowing at a linear velocity of 0.03 to 0.06 m/s (1.2 to 1.4 in/s). The flow of gas should be measured. A higher rate is required if hydrogen or hot condensable gases are being flared. If possible, hydrogen should be discharged through a separate vent stack and not mixed with other gases in a flarestack.
3. The atmosphere inside every stack should be monitored regularly, say daily, for oxygen content. Large stacks should be fitted with oxygen

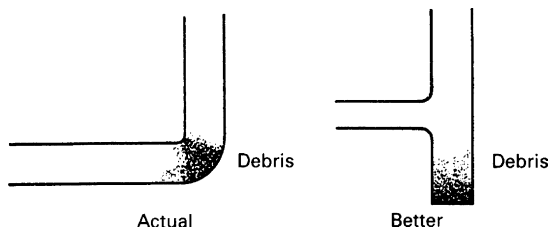
FIGURE 6-2 Flarestack after fall of debris.

- (b) The vent stack was replaced by a 14-in.-diameter flarestack with a supply of steam to a ring around the top of the stack. A few years later, this stack choked again, this time because of a deposit of refractory debris from the tip, cemented together by ice (as some condensate from the steam had found its way down the stack). Fortunately, in this case someone noticed the high pressure in the tank before any damage occurred. There was no boot at the bottom of the stack to collect debris (Figure 6-2). A boot was fitted [2].

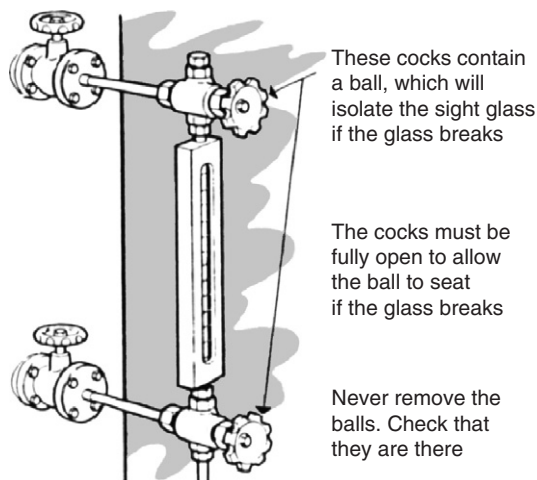
Level glasses and sight glasses (except magnetic types) should not be used on vessels containing flashing flammable or toxic liquids—that is, liquids under pressure above their normal boiling points. When level glasses are used, they should be fitted with ball check cocks, which prevent a massive leak if the glass breaks. Unfortunately, people who did not understand their purpose have sometimes removed the balls. The hand valves must be fully opened or the balls cannot operate (Figure 7-2).

FIGURE 7-2 Ball check cocks.

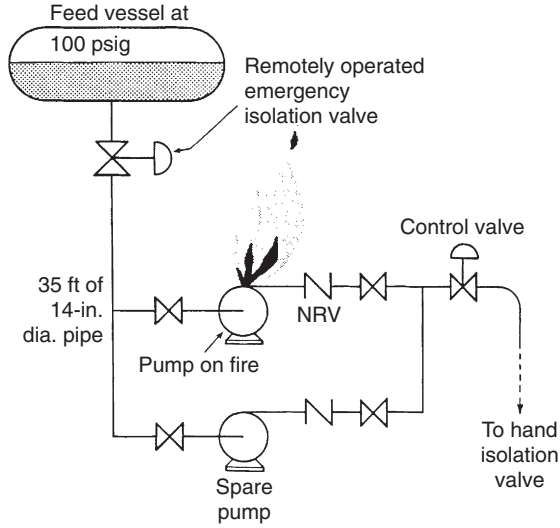
Backflow from the delivery side of the pump was prevented by a check (nonreturn) valve. In addition, a control valve and a hand valve well away from the fire were closed (Figure 7-5).

FIGURE 7-5 An emergency isolation valve stopped a fire.

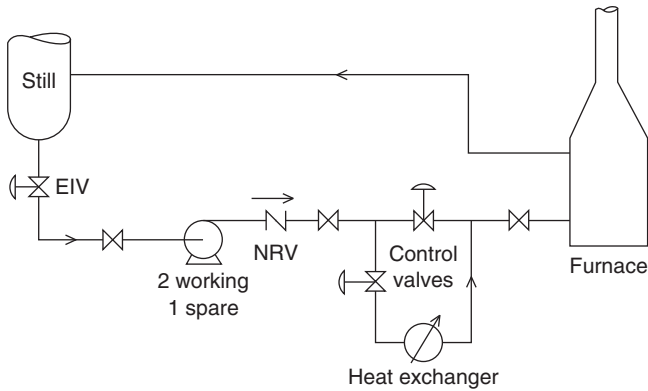
- (b)** The bearing on the feed pump to a furnace failed, causing a gland failure and a leak of hot oil. The oil caught fire, but an emergency isolation valve in the pump suction line was closed immediately, and the fire soon died out (Figure 7-6).

FIGURE 7-6 Another emergency isolation valve stopped a fire.

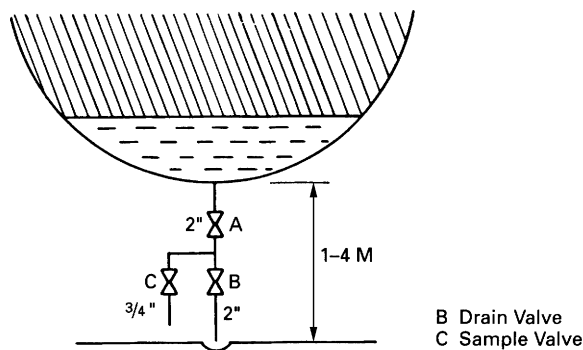
An operator had to drain water from a 1,200-m<sup>3</sup> spherical storage vessel nearly full of propane (Figure 8-1). He opened valves A and B. When traces of oil showed that the draining was nearly complete, he shut A and then cracked it to complete the draining. No flow came. He opened A fully. The choke—presumably hydrate, a compound of water and a light hydrocarbon with a melting point above 0°C (32°F)—cleared suddenly, and the operator and two others were splashed with liquid. The handle came off valve A, and they could not get it back on. Valve B was frozen and could not be moved. Access was poor because the drain valves were immediately below the tank, which was only 1.4 m (4.5 ft) above the ground.

FIGURE 8-1 Drain valves underneath propane tank at Feyzin.

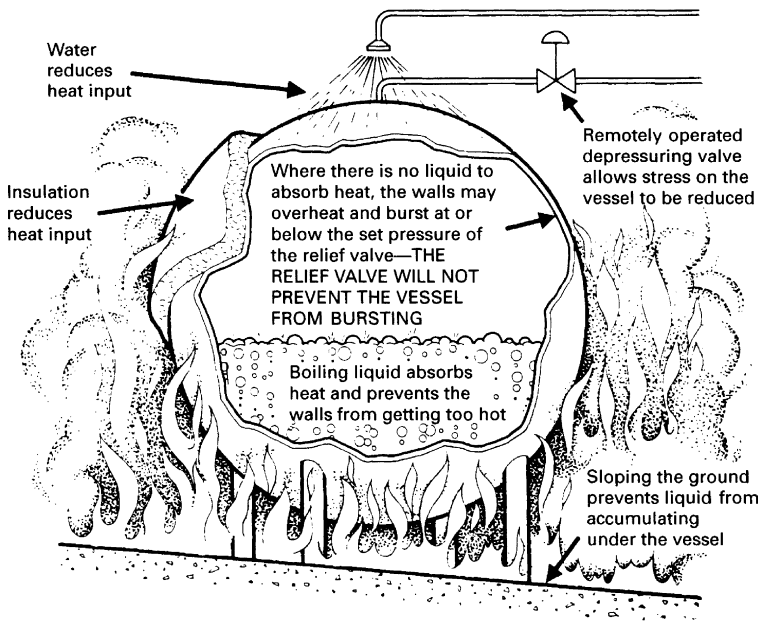
FIGURE 8-2 Methods of protecting a pressure vessel against fire.

- Slope the ground so that any spillage runs off to a collection pit.
- Fit an emergency depressuring valve so that the pressure in the vessel can be reduced to one-fifth of design in 10 minutes to reduce the strain on the metal [13]. The time can be increased to 30 minutes if the vessel is insulated and to one hour if, in addition, the ground is sloped.

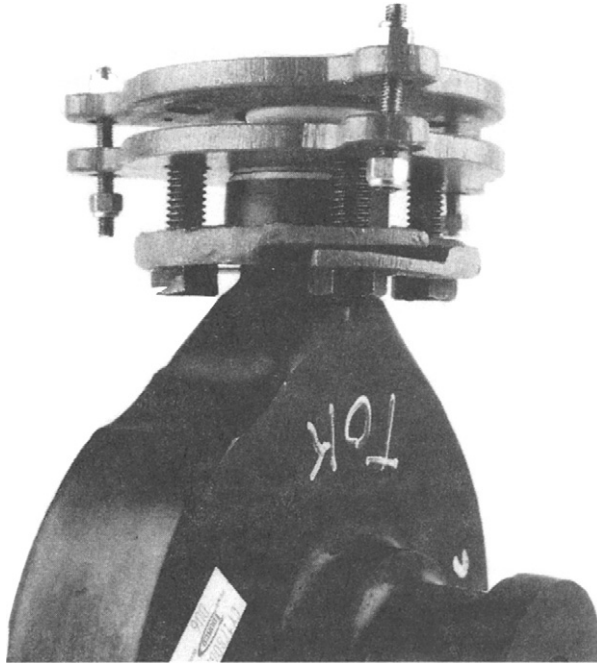
that it had to be rebuilt. Fortunately, no one was killed or injured. The leak started at a flange assembly on the delivery of a pump (Figure 8-3), probably the result of corrosion of the flanges but possibly caused by the failure of a plastic bellows. The official report [23] made the following points:

- The split flanges were badly corroded; their thickness was reduced, and the bolt holes were much enlarged. (Split flanges are not a good feature because they expose twice as much surface to the effects of corrosion.) There was no system for identifying critical items, the failure of which could have serious results, and registering them for regular inspection. Maintenance was on a breakdown basis, and there were no formal records that could be used to identify items needing regular inspection or replacement.

**FIGURE 8-3** Split flange assembly similar to one that leaked. (Photo courtesy of the UK Health and Safety Executive.)

- The leak could have been stopped as soon as it was detected if an emergency isolation valve (Section 7.2.1) had been fitted in the pump suction line. On the rebuilt plant, such valves were fitted on the pump suction lines, more combustible gas detectors and more extensive insulation were installed, plastic pump bodies were replaced by metal ones, and spillages were directed to collection pits. The plant
