Library of Congress Cataloging-in-Publication Data  
Kletz, Trevor A.

What went wrong? : case histories of process plant disasters and how they could have been avoided / Trevor Kletz. —5th ed.

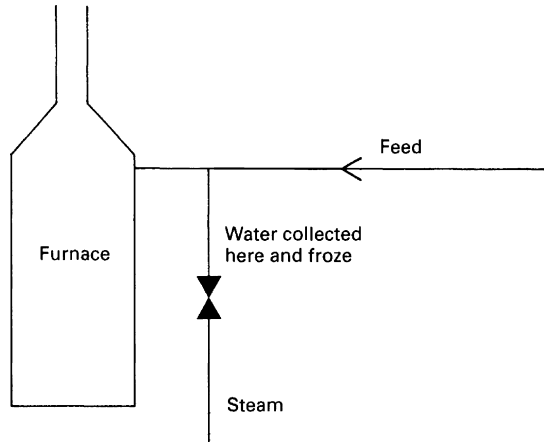
There are other sorts of dead-ends besides pipes that have been blanked. Rarely used valved branches are just as dangerous. The feed line to a furnace (Figure 9-1) was provided with a permanent steam connection for use during de-coking.

The connection was on the bottom of the feed line, and the steam valve was not close to the feed line. Water collected above the steam valve,

FIGURE 9-1 The steam connection to the furnace formed a dead-end.

froze during cold weather, and ruptured the line, allowing oil at a gauge pressure of 450 psi (30 bar) to escape. If dead-ends cannot be avoided, they should be connected to the *top* of the main pipeline (unless the liquid in the pipeline is denser than water).

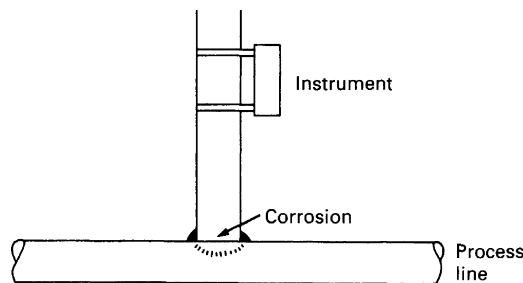
FIGURE 9-2 Water collected in the instrument support and corroded the process line.

An unusual—and unnecessary—dead-end was a length of 2-in. pipe welded onto a process line to provide a support for an instrument (Figure 9-2). Water collected in the support. Four years after it had been installed, the process line corroded through, and a leak of liquefied gas occurred.

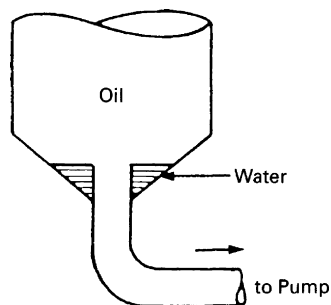
Another serious failure occurred because water in a dead-end was suddenly vaporized. A heavy oil was dried by heating it to 120°C (250°F) in a tank filled with steam coils. The oil was circulated while it was being dried. The suction line projected into the conical base of the tank, forming a dead-end, as shown in Figure 9-3.

FIGURE 9-3 Water in this dead-end was vaporized by oil.

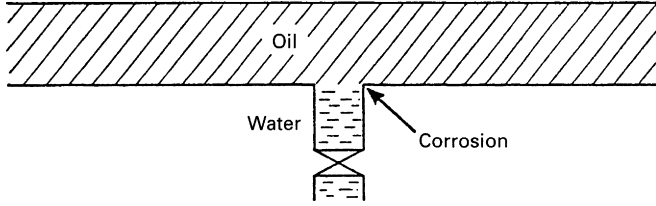
Water was injected into an oil stream using the simple arrangement shown in Figure 9-6. Corrosion occurred near the point shown, and the oil leak caught fire [5]. The rate of corrosion far exceeded the corrosion allowance of 0.05 in. per year.

FIGURE 9-6 Water injection—a poor arrangement.

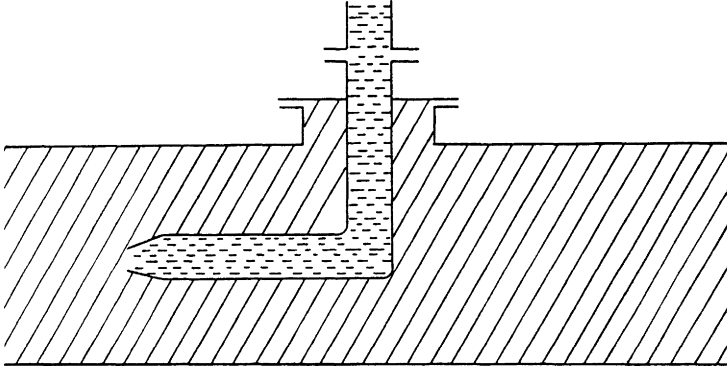
A better arrangement is shown in Figure 9-7. The dimensions are chosen so that the water injection pipe can be removed for inspection. However, this system is not foolproof. One system of this design was assembled with the injection pipe pointing upstream instead of downstream. This increased corrosion.

FIGURE 9-7 Water injection—a better arrangement.

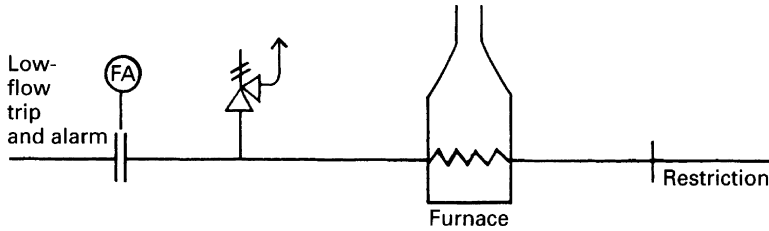
A furnace was protected by a relief valve on its inlet line (Figure 10-1). A restriction developed after the furnace. The relief valve lifted and took most of the flow. The flow through the furnace tubes fell to such a low level that they overheated and burst. The low-flow trip, which should have isolated the fuel supply to the furnace when the flow fell to a low value, could not do so because the flow through it was normal.

FIGURE 10-1 When the relief valve lifted, the flow through the furnace was reduced.

The relief valve should have been placed after the furnace or, if this was not possible, before the low-flow trip.

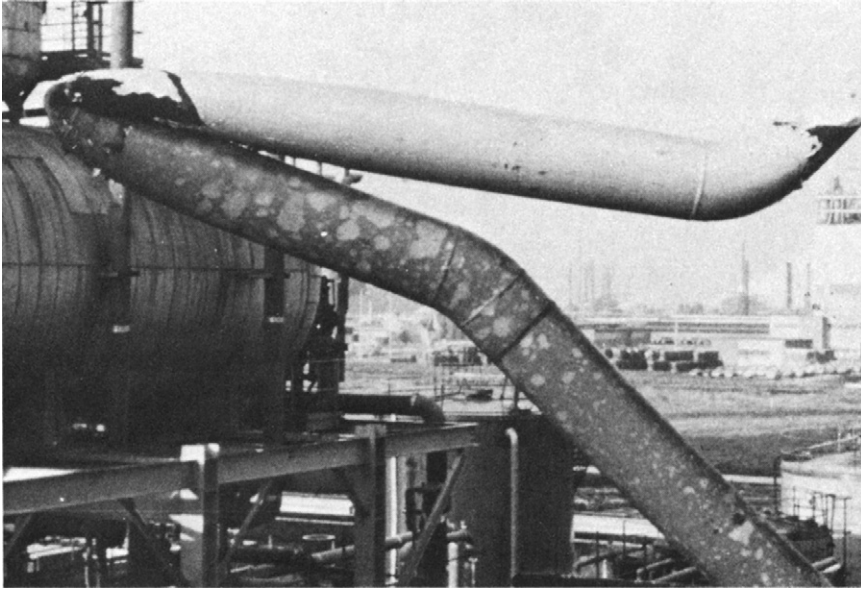
Figure 10-4 shows what happened to the tailpipe of a steam relief valve that was not adequately supported. The tailpipe was not provided with a drain hole (or if one was provided, it was too small), and the tailpipe filled with water. When the relief valve lifted, the water hit the curved top of the tailpipe with great force. Absence of a drain hole in a tailpipe also led to the incident described in Section 9.2.1g.

FIGURE 10-4 This relief-valve tailpipe was not adequately supported.

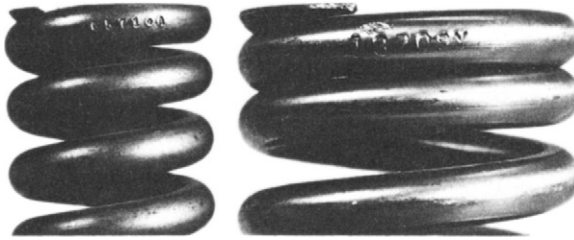
1. Identification numbers stamped on springs, thus weakening them (Figure 10-5).
2. The sides of springs ground down so that they fit.
3. Corroded springs.
4. A small spring put inside a corroded spring to maintain its strength. Sometimes the second spring was wound the same way as the first spring so that the two interlocked (Figure 10-6).
5. Use of washers to maintain spring strength.
6. Welding of springs to end caps (Figure 10-7).
7. Deliberate bending of the spindle to gag the valve (Figure 10-8).
8. Too many coils allowing little, if any, lift at set pressure (Figure 10-9).

FIGURE 10-5 Identification marks on body coils could lead to spring failure.

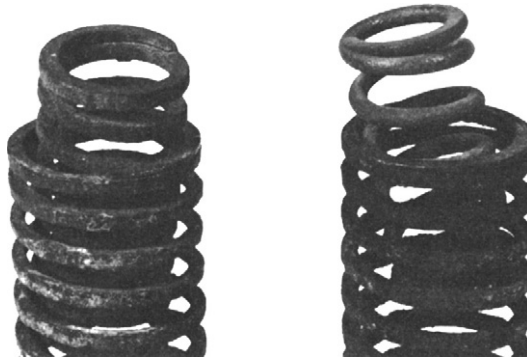
FIGURE 10-6 Use of additional inner springs of unknown quality in an attempt to obtain set pressure.

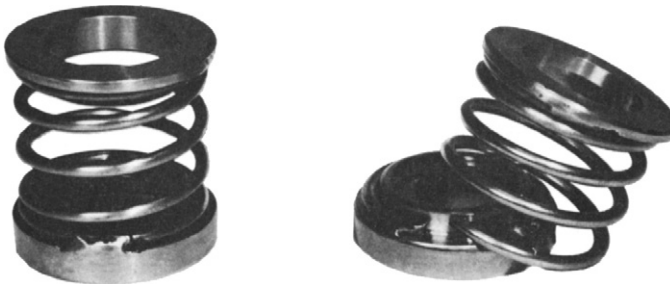
FIGURE 10-7 End caps welded to spring. Failure occurred at weld.

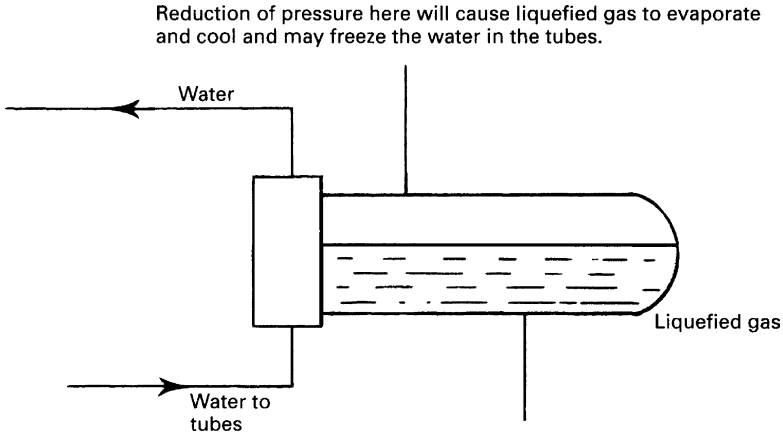
Figure 10-10 illustrates another incident. When a plant was shutting down, the flow of cooling water to the tubes of a heat exchanger was isolated. The propylene on the shell side got colder as its pressure fell. The water in the tubes froze, breaking seven bolts. The operators saw ice forming on the outside of the cooler but did not realize that this was hazardous and took no action. When the plant started up again, propylene entered the cooling-water system, and the pressure blew out a section of the 16-in. (400-mm) line. A furnace located 40 m (130 ft) away ignited the gas, and the fire caused serious damage.

FIGURE 10-10 Evaporative cooling.

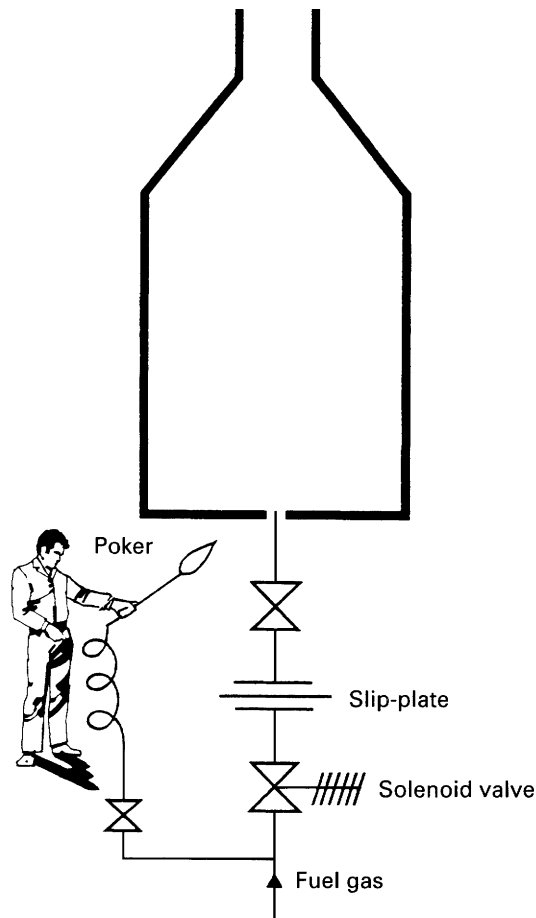
- (a)** A foreman tested the atmosphere inside a furnace (Figure 10-12) with a combustible gas detector. No gas was detected, so the slip-plate (blind) was removed, and two minutes later, a lighted poker

FIGURE 10-12 Lighting a furnace heated by fuel gas.

was inserted. An explosion occurred. The foreman and another man were hit by flying bricks, and the brickwork was badly damaged.

1. Test the atmosphere inside the furnace.
2. If you do not detect gas, light and then insert the poker (or switch on the electric igniter).
3. Remove the slip-plate (or connect the hose, drain the lute, or change over the double block and bleed valves). If the isolation valve is leaking, the poker or igniter will ignite the leaking fuel before it forms an explosive mixture. (The solenoid valve shown in Figure 10-12 should open automatically when the poker is inserted or the igniter is switched on. If it does not, it should be held open until the main burner is lit.)
4. Open the fuel-gas isolation valve.

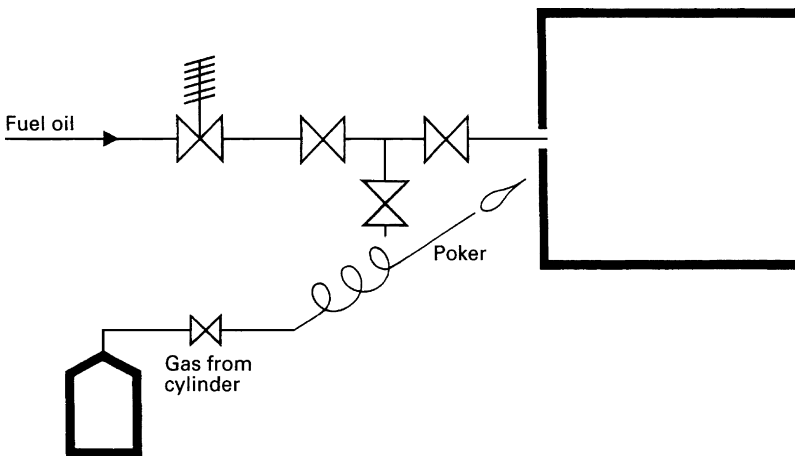
- (b)** A reduction in fuel oil pressure caused the burner in an oil-fired furnace to go out, and the flame failure device closed the solenoid valve in the fuel oil line (Figure 10-13). The operator closed the two hand-isolation valves and opened the bleed between them. (The group of three valves is equivalent to the slip-plate shown in Figure 10-12.) When the fuel oil pressure was restored, the foreman tested the atmosphere in the furnace with a combustible gas detector. No gas was detected, so he inserted a lighted poker. The fuel oil supply was

FIGURE 10-13 Lighting a furnace heated by heavy fuel oil.

1. Calculate the amount of oil between the solenoid valve and the burner.
2. Assume it all drains into the furnace and evaporates. Calculate the volume of the flammable mixture, assuming it is at the lower flammable limit, probably about 0.5% v/v. (If it forms a richer mixture, the volume will be less.)

3. Multiply by four to give a safety margin, and sweep out the furnace with this volume of air [11].

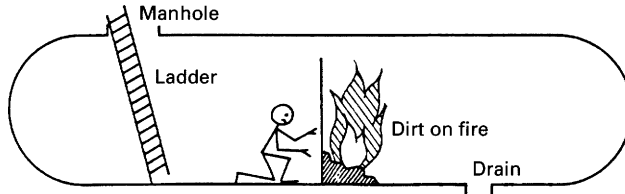
- (a)** A vessel was divided into two halves by a baffle, which had to be removed. The vessel was cleaned out, inspected, and a permit issued for a worker to enter the left-hand side of the vessel to burn out the baffle. It was impossible to see into the right-hand half. But because the left-hand half was clean and because no combustible gas could be detected, it was assumed that the other half was also clean (Figure 11-1). While

FIGURE 11-1 If part of a vessel cannot be seen, assume it is dirty.

the welder was in the vessel, some deposit in the right-hand half caught fire. The welder got out without serious injury but bruised himself in his haste.

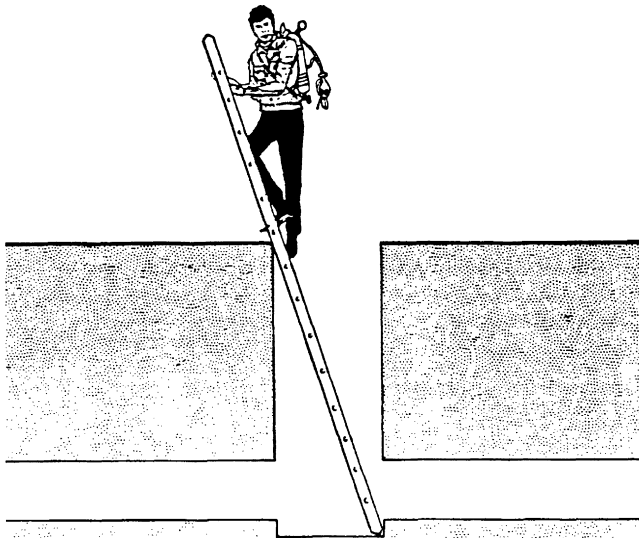
A man was standing on a ladder, ready to go down into a drain manhole to plug one of the inlet lines. The drain contained some hydrogen sulfide, so he had an air mask ready. But he had not yet put it on because he was well outside the manhole. His feet were at ground level (Figure 11-3). He was about to put on a safety harness when his two companions heard a shout and saw him sliding into the manhole. They were unable to catch him, and his body was recovered from the outfall. He had been

FIGURE 11-3 A man was overcome by fumes from the manhole.

overcome by hydrogen sulfide arising from the drains, although his face was 1.5m above ground level.

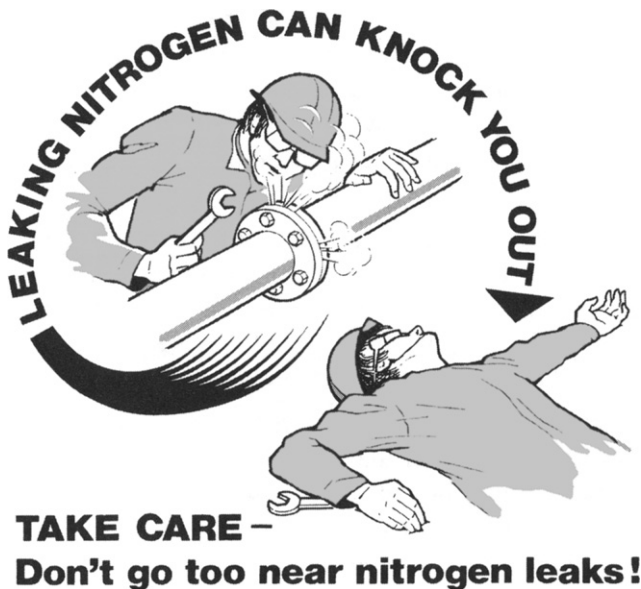
FIGURE 12-1

- (a) A member of a cleaning crew decided to recover a rope, which was half inside a vessel and was caught up on something inside. While kneeling down, trying to disentangle the rope, he was overcome by nitrogen. Afterward he admitted that if necessary, he would have entered the vessel.
- (b) On several occasions, people who were working on or near leaky joints on nitrogen lines have been affected. Although they knew nitrogen is harmful, they did not consider that the amount coming out of a leaky joint would harm them (Figure 12-1).

Two maintenance workers had just removed the cover from a man-hole near the top of a distillation column, which had been swept out with nitrogen, when one of them collapsed. The other pulled him free, and he soon recovered. The bottom manhole had already been removed, and it seems that a chimney effect caused nitrogen to come out of the upper manhole [23].

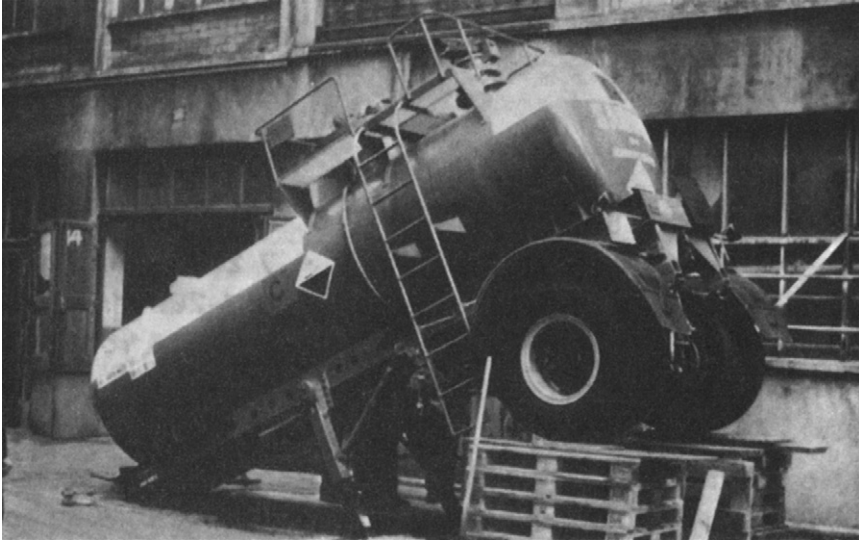
On several occasions, tank trailers have tipped up because the rear compartments were emptied first, as shown in Figure 13-1.

FIGURE 13-1 A tank trailer may tip up if the rear compartments are emptied first.

It is not always possible to keep the trailer connected to the truck's unit during loading/unloading. If it is not connected, the front compartments should be filled last and emptied first or a support put under the front of the trailer.

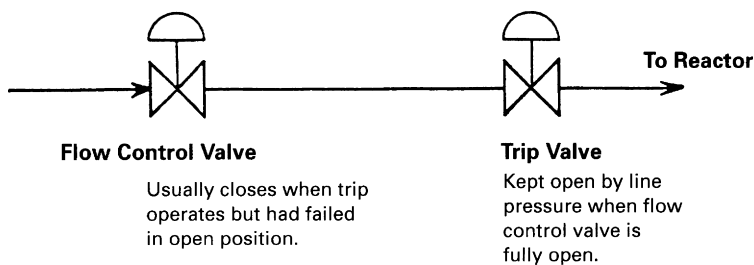
Investigation showed that the pressure drop through the trip valve—a globe valve—was so high that the valve could not close against it. There was a flow control valve in series with the trip valve (Figure 14-1), and the trip normally closed this valve as well. However, this valve failed in the open position—this was the reason for the high temperature in the reactor—and the full upstream pressure was applied to the trip valve.

FIGURE 14-1 When the control valve was open, the pressure prevented the trip valve from closing.

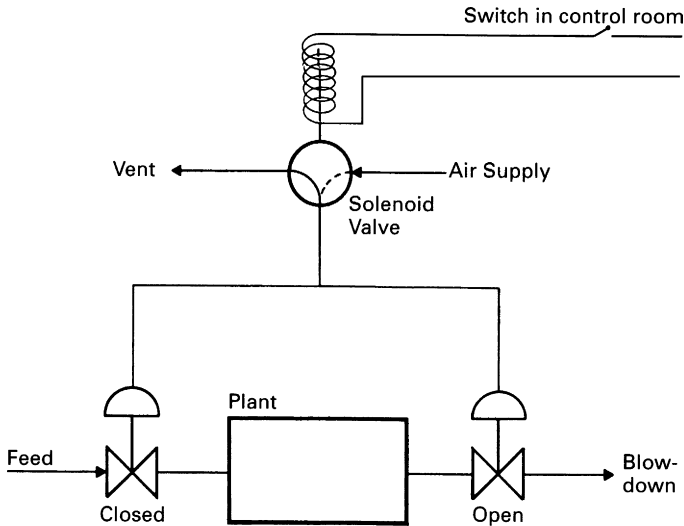
The switch operated a solenoid valve, which vented the compressed air line leading to valves in the feed and blowdown lines (Figure 14-3). The feed valve then closed, and the blowdown valve opened. This did not happen instantly because it took a minute or so for the air pressure to fall in the relatively long lines between the solenoid valve and the other valves.

FIGURE 14-3 An automatic system, which will take a minute or so to operate.

The operator expected the system to function as soon as he operated the switch. When it did not, he assumed it was faulty. Unfortunately, after operating the switch several times, he left it in its normal position.

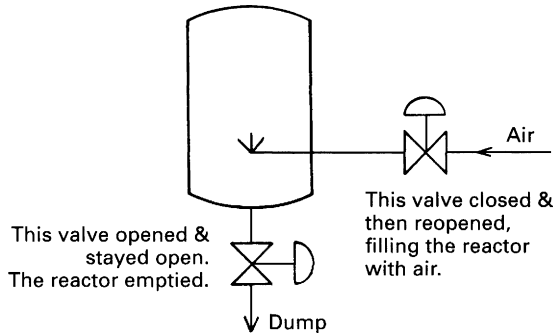
- (b)** A liquid-phase hydrocarbon oxidation plant was fitted with a high-temperature trip, which shut off the air and opened a drain valve that dumped the contents of the reactor in a safe place (Figure 14-4). If the air valve reopened after a dump, a flammable mixture could form in the reactor.

One day the temperature-measuring device gave a false indication of high temperature. The air valve closed, and the drain valve opened. The temperature indication fell, perhaps because the reactor was now empty. The drain valve stayed open, but the air valve reopened, and a flammable mixture was formed in the reactor. Fortunately, it did not ignite.

The air valve reopened because the solenoid valve in the instrument air line leading to the air valve would not stay in the tripped position. It should have been fitted with a latch.

FIGURE 14-4 When the air valve reopened after a dump, a flammable mixture formed in the reactor.

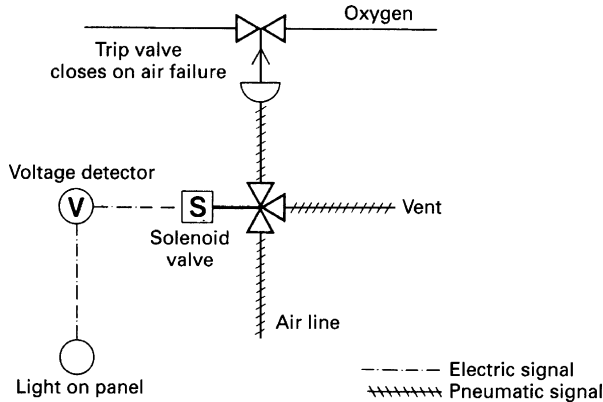
An ethylene oxide plant tripped, and a light on the panel told the operator that the oxygen valve had closed. Because the plant was going to be restarted immediately, he did not close the hand-operated isolation valve as well. Before the plant could be restarted, an explosion occurred. The oxygen valve had not closed, and oxygen continued to enter the plant (Figure 14-5).

Actually the air was not vented. A wasp's nest choked the 1-in. vent line on the air supply. Whenever possible, we should measure directly

FIGURE 14-5 The light shows that the solenoid is de-energized, not that the oxygen flow has stopped.

what we need to know and not some other parameter from which it can be inferred [1].

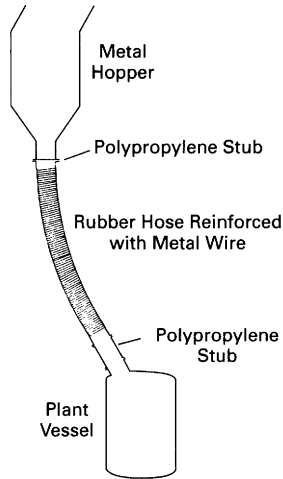
A powder was emptied down a metal duct into a plant vessel. The duct was replaced by a rubber hose, as shown in Figure 15-2. The flow of powder down the hose caused a charge to collect on it. Although the hose was reinforced with metal wire and was therefore conducting,

**FIGURE 15-2** The flow of powder caused a static charge to collect on the insulated hose.

it was connected to the plant at each end by short polypropylene pipes that were nonconducting. A charge therefore accumulated on the hose, a spark occurred, the dust exploded, and a man was killed.

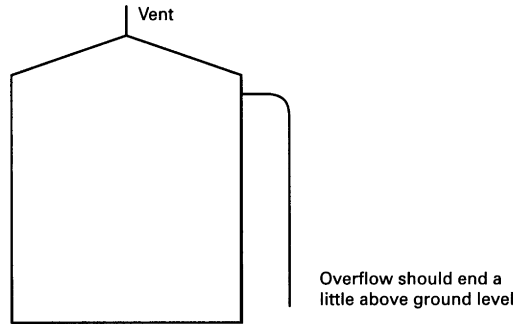
**FIGURE 16-1** Acid tanks should be fitted with a high-point vent, as well as an overflow, so that hydrogen can escape.

The tank should have been fitted with a vent at the highest point, as shown in Figure 16-1.

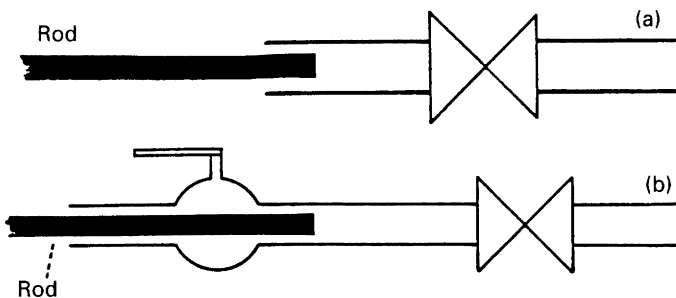
- (a)** A man was rodding out a choked  $\frac{1}{4}$ -in. line leading to an instrument (Figure 17-1a). When he had cleared the choke, he found that the valve would not close and he could not stop the flow of flammable liquid. Part of the unit had to be shut down.

FIGURE 17-1 The wrong (a) and right (b) ways of clearing a choked line.

Rodding out *narrow bore* lines is sometimes necessary. But before doing so, a ball valve or cock should be fitted on the end (Figure 17-1b). It is then possible to isolate the flow when the choke has been cleared, even if the original valve will not close.

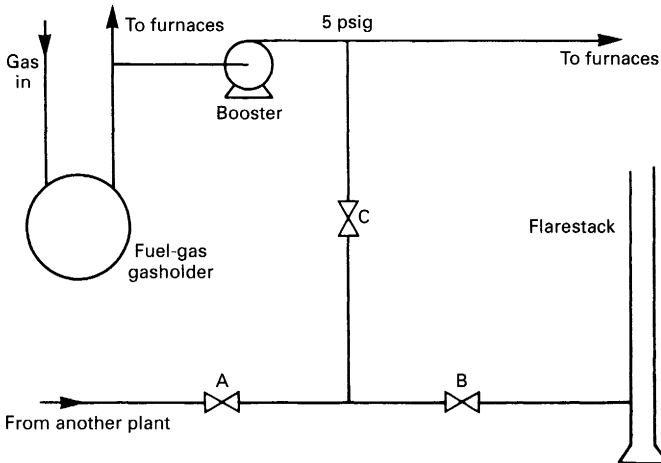
The flarestack shown in Figure 17-3 was used to dispose of surplus fuel gas, which was delivered from the gasholder by a booster through valves C and B. Valve C was normally left open because valve B was more accessible.

One day the operator responsible for the gasholder saw that it had started to fall. He therefore imported some gas from another unit. Nevertheless, a half-hour later the gasholder was sucked in.

Another flarestack at a different plant had to be taken out of service for repair. An operator at this plant therefore locked open valves A and B so that he could use the "gasholder flarestack." He had done this before, though not recently, and some changes had been made since he last used the flarestack. He did not realize that his action would result in the gasholder emptying itself through valves C and B. He told three other men what he was going to do, but he did not tell the gasholder operator. He did not know that this man was concerned.

FIGURE 17-3 Different operators controlled valve B.

Responsibility for each item of equipment should be clearly defined at the supervisor, foreman, and operator levels, and only the people responsible for each item should operate it. If different teams are allowed to operate the same equipment, then sooner or later an incident will occur.

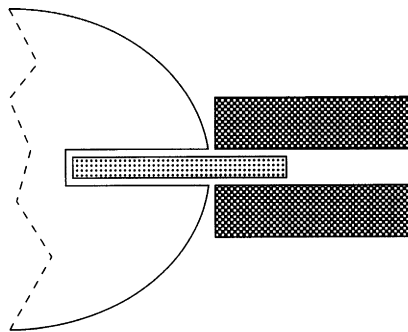
A vessel was fitted with a simple mechanical interlock: a horizontal pin fitted into a slot in the vessel lid; the lid could not be moved sideways until the pin was withdrawn (Figure 17-4). A solenoid controlled movement of the pin. The solenoid could not be activated and the pin withdrawn until various measurements, including the temperature and level of the liquid in the vessel, were within specified ranges.

Nevertheless the lid was moved, although the measurements were not correct. Several possible explanations were considered:

1. The pin might have been seized inside the solenoid. Unfortunately, the operator, believing this to be the case, had squirted a lubricant into the solenoid chamber before any investigation could be carried out. A vertical pin would have been less likely to stick.
2. The operator, believing that all measurements were correct, might have assumed that the system was faulty and inserted a thin strip of metal into the end of the slot and moved the pin back into the solenoid. He denies doing this but admits that he did not check the temperature and level readings to make sure they were correct before trying to move the lid.

FIGURE 17-4 A simple mechanical interlock: the lid could not be moved until the pin was withdrawn from the slot.

In the original design, the pin fitted into a hole, but the hole was changed to a slot so the operator could see the position of the pin. At the time no one realized that this made it possible for someone to move the pin by hand, another example of the unseen results of a plant modification. To prevent this, a sheet of transparent plastic could have been used to cover the slot.

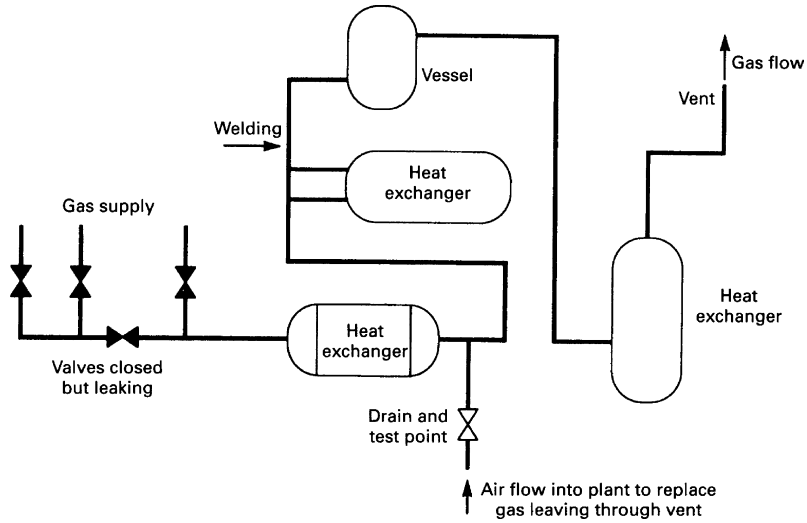
- (b)** A hydrogen line, about 12-in. diameter, had to be repaired by welding. The hydrogen supply was isolated by closing three valves in parallel (one of which was duplicated) (Figure 17-5). The line was purged with nitrogen and was tested at a drain point before welding started, to confirm that no hydrogen was present. When the welder struck his arc, an explosion occurred, and he was injured. The investigation showed that two of the isolation valves were leaking. It also showed why the hydrogen was not detected at the drain point: the drain point was at a low level, and air was drawn through it into the plant to replace gas leaving through a vent. The source of ignition was sparking, which occurred because the welding return lead was not securely connected to the plant (another familiar problem) [13].

FIGURE 17-5 A simplified diagram of a plant, showing why hydrogen gas was not detected at the drain point. (Reproduced with permission of the American Institute of Chemical Engineers. Copyright © 1995 AIChE. All rights reserved.)

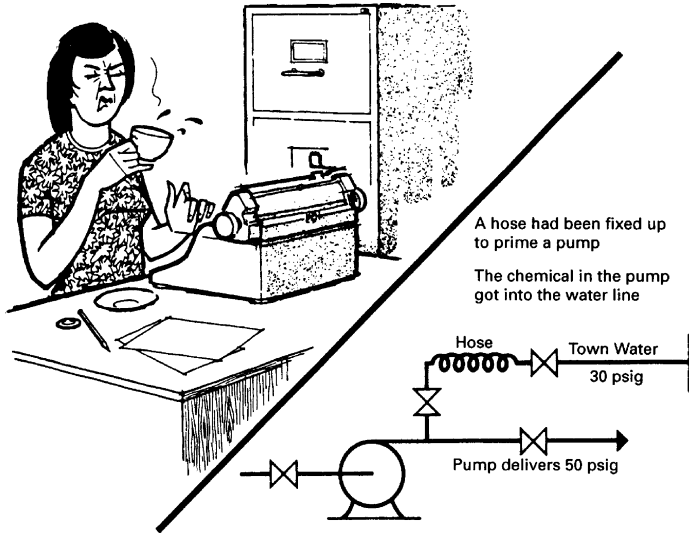
FIGURE 18-3 Never connect town water to process equipment.

Another incident is illustrated in Figure 18-3. Town water should never be directly connected to process lines by a hose [19] or permanent connections. A break tank should be provided.

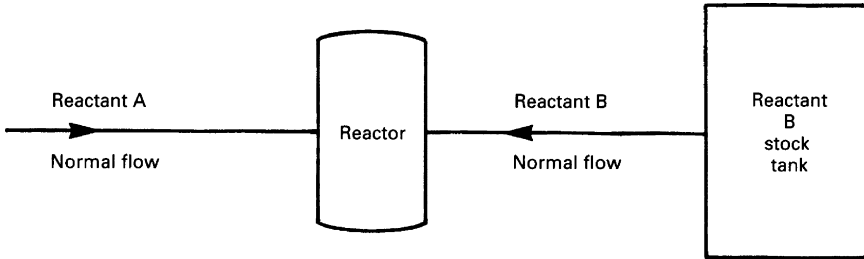
The most serious incidents resulting from reverse flow have occurred when reactant A (Figure 18-5) has passed from the reactor up the reactant B feed line and reacted violently with B.

FIGURE 18-5 Reverse flow of A occurred from the reactor into the B stock tank.

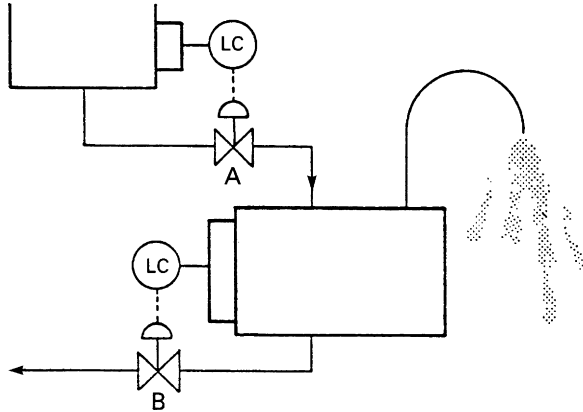
- (a)** Figure 18-6 shows part of an old unit. Valve A could pass a higher rate than valve B. Inevitably, in the end the lower tank overflowed.
- (b)** Raw material was fed to a unit from two stock tanks, A and B. Tank A was usually used; tank B was used infrequently. The raw material was pumped to a head tank from which excess flowed back, as shown in Figure 18-7. The system was in use for several years before the inevitable happened. Tank B was in use; tank A was full, and the flow from the head tank caused it to overflow.
- (c)** A funnel was installed below a sample point so that excess liquid was not wasted but returned to the process (Figure 18-8). What will happen if a sample is taken while the vessel is being drained?

FIGURE 18-6 Valve A could pass a higher rate than valve B, thus making a spillage inevitable.

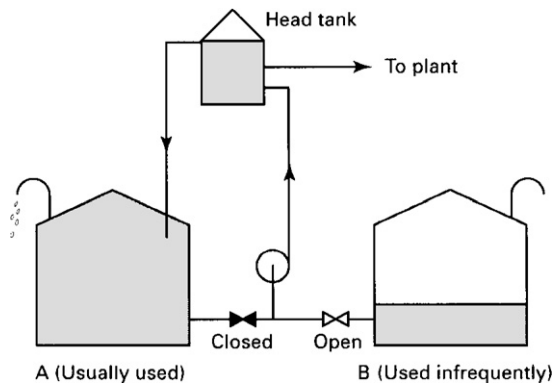
FIGURE 18-7 If A is full and suction is taken from B, A will overflow.

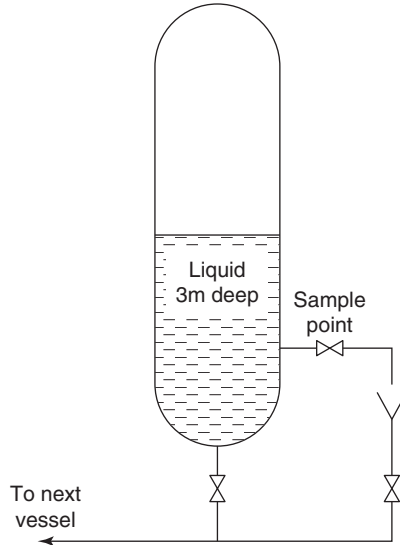
FIGURE 18-8 What will happen if the vessel is drained while a sample is being taken?

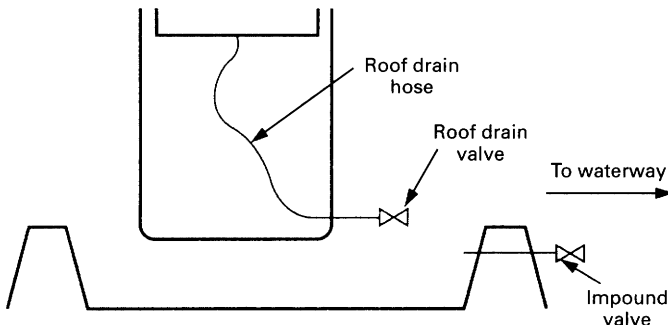
- (a) Figure 18-9 shows a floating-roof tank located in a dike. Rainwater can be drained from the roof into the dike and from the dike into a waterway. The team members are considering whether any substance other than water can get into the waterway. For this to occur, there would have to be a hole in the hose, and both valves would have to be left open. An inexperienced team may decide that a triple failure is so improbable that there is no need to consider it further.

**FIGURE 18-9** Liquid other than rainwater can reach the waterway only if there is a hole in the hose and both valves are left open. This is not as unlikely as it seems at first sight. (Used with permission from *Hydrocarbon Processing*, Apr. 1992. Copyright © 1992 Gulf Publishing Co. All rights reserved.)

Someone with knowledge of the practicalities of plant operation would realize that during prolonged rain the operators may leave both drain valves open, whatever the instructions say, to avoid frequent visits to the tank. Any hole in the hose will then contaminate the waterway with oil [20].

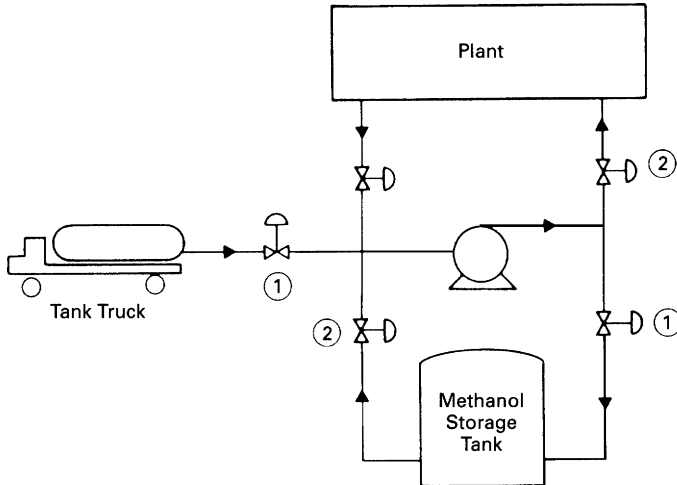
A pump and various pipelines were used for three different duties: for transferring methanol from a tank truck to storage, for charging it to the plant, and for moving recovered methanol back from the plant (Figure 20-1). A computer set the various valves and monitored their positions.

FIGURE 20-1 A pump and lines, controlled by a computer, were used for several different jobs. The pump could also be started and stopped locally. (1) Valves open for first job; others closed. (2) Valves open for second job; others closed.

A thorough Hazop probably would have revealed that this error could have occurred. The control system could have been modified, or better still, separate lines could have been installed for the various different movements, thus greatly reducing the opportunities for error. The incident shows how easily errors in complex systems can be overlooked if the system is not thoroughly analyzed. In addition, it illustrates the paradox that we are willing to spend money on complexity but are less willing to spend it on simplicity [4]. Yet the simpler solution, independent lines (actually installed after the spillage), makes errors less likely and may not be more expensive if lifetime costs are considered. Control systems need regular testing and maintenance, which roughly doubles their lifetime

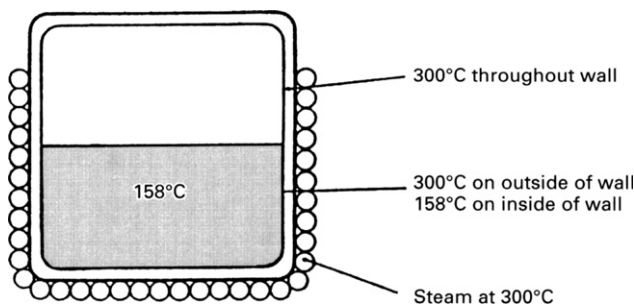
A reactor containing an uncompleted batch of 2,4,5-trichlorophenol (TCP) was left for the weekend. Its temperature was 158°C (316°F), well below the temperature at which a runaway reaction can start (believed at the time to be 230°C [645°F] but possibly as low as 185°C [365°F]). The reaction was carried out under vacuum, and the reactor was heated by an external steam coil supplied with exhaust steam from a turbine at 190°C (374°F) and a gauge pressure of 12 bar (Figure 21-1). The turbine was on reduced load, as various other plants were also shutting down for the weekend (as required by Italian law), and the temperature of the steam rose to about 300°C (570°F). The temperature of the bulk liquid could not

FIGURE 21-1 The Seveso reactor.

get much above 158°C (316°F) because of its heat capacity, and so below the liquid level there was a temperature gradient through the walls of the reactor, 300°C (570°F) on the outside, 158°C (316°F) on the inside. Above the liquid level, the walls were at 300°C (570°F) right through.

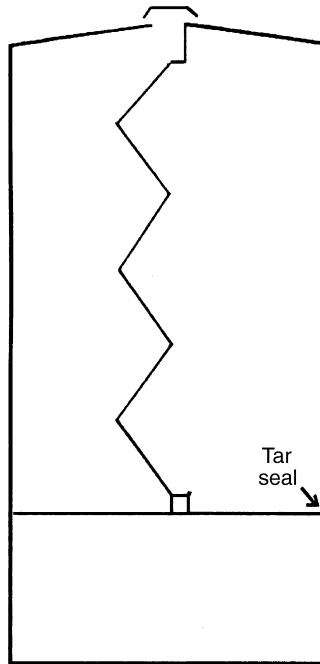
At a guess, the volume of the gasholder was several thousand  $\text{m}^3$  and its height was  $\approx 3 \times$  its diameter. To get inside it, we had to go up a staircase onto the roof, through an opening in the center, and then down a Jacob's ladder, a folding ladder, onto the disc. As Figure 24-2 shows, during half the descent we were clinging to the wrong side of the sloping ladder. Fortunately, the gasholder was nearly empty and the angle of the ladder was not too great.

FIGURE 24-2 Diagram of dry gasholder showing Jacob's ladder.

atmosphere above the disc in the gasholder was not tested before we entered and there was no entry permit and no standby man, although the foreman mentioned that strictly speaking there should have been one (this was many years ago). The whole experience was eerie, and I have never forgotten it.

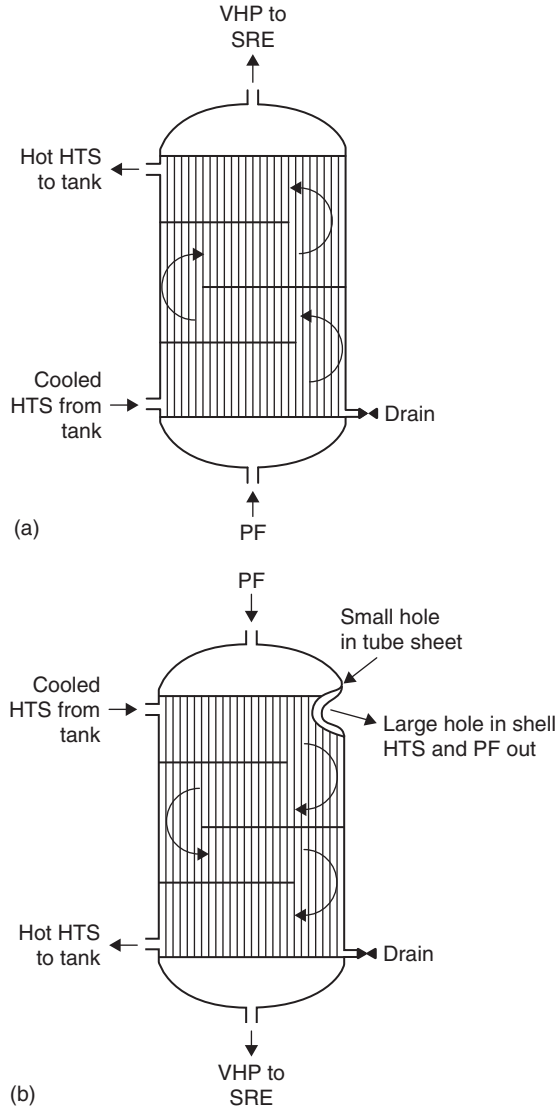
Figure 25-1a shows the original design of a reactor. Hot feed gas (PF [preheated feed]) was passed upward through catalyst tubes 3 m (10 ft) long. The heat of reaction was removed by circulating a molten salt (HTS [heat transfer salt]) through the shell. Note that the flow of this liquid was also upward.

The hot exit gases were cooled in a waste heat boiler. During a review of the model, the contractors pointed out that the boiler required an expensive structure to support it. They could avoid this cost, they said, by reversing both flows through the reactor, as shown in Figure 25-1b, and putting the boiler at ground level. This was agreed.

The change in design was made without following the company's normal procedure for control of change. Reversing the flow seemed

**FIGURE 25-1** (a) Original design of reactor. (b) Reversing the flow allowed a gas bubble to be trapped below the top tubesheet and led to overheating of the tops of the tubes. PF = preheated feed; HTS = heat transfer salt; VHP = very hot product gases; and SRE = steam raising exchanger. From reference 10. (Reprinted with the permission of the Institution of Chemical Engineers.)

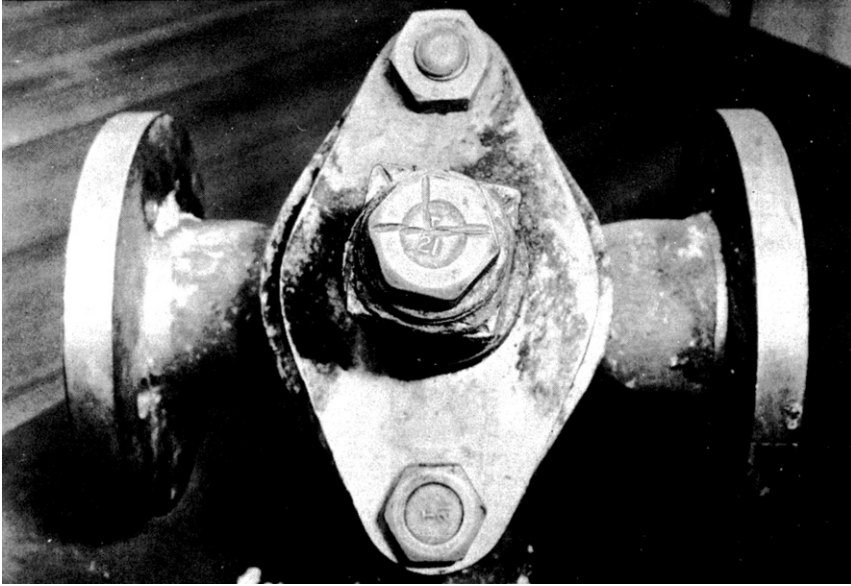
Figure 25-3 shows a three-way cock in which the top of the central bolt has been marked to show the position of the cock. This was presumably done because the marks on the plug itself are hard to see. They are just faintly visible in the photograph.

Originally the marks on the bolt corresponded to those on the plug. At some time, two washers were placed underneath the bolt. It could no longer be screwed right in and the marks no longer corresponded.

**FIGURE 25-3** The central bolt was marked to show the position of the cock. When two washers were inserted under the bolt, it could not be screwed down as far as before and the marks no longer corresponded with the position of the cock.

Most of the operators on the unit set the cock according to the marks on the bolt. Ultimately, this led to misdirection of a process stream, formation of an explosive byproduct, and an explosion.

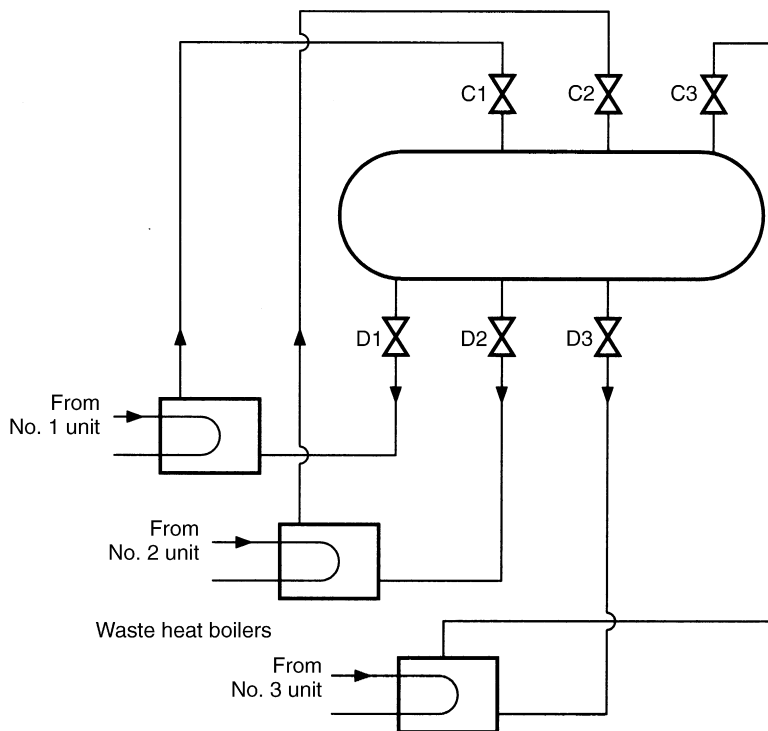
Figure 27-2 shows a similar situation. To save cost, three waste heat boilers shared a common steam drum. Each boiler had to be taken off

**FIGURE 27-2** Note the positions of isolation valves on the common steam drum. (Reprinted with the permission of the Institution of Chemical Engineers.)

line from time to time for cleaning. On two occasions, the wrong valve was closed (D3 instead of D2) and an online boiler was starved of water and overheated. The chance of an error was increased by the lack of labeling and the arrangement of the valves—D3 was below C2. On the first occasion the damage was serious. High temperature alarms were then installed on the boilers. On the second occasion they prevented serious damage but some tubes still had to be changed. A series of interlocks were then installed so that a unit had to be shut down before a key could be removed; this key was needed to isolate the corresponding valves on the steam drum.

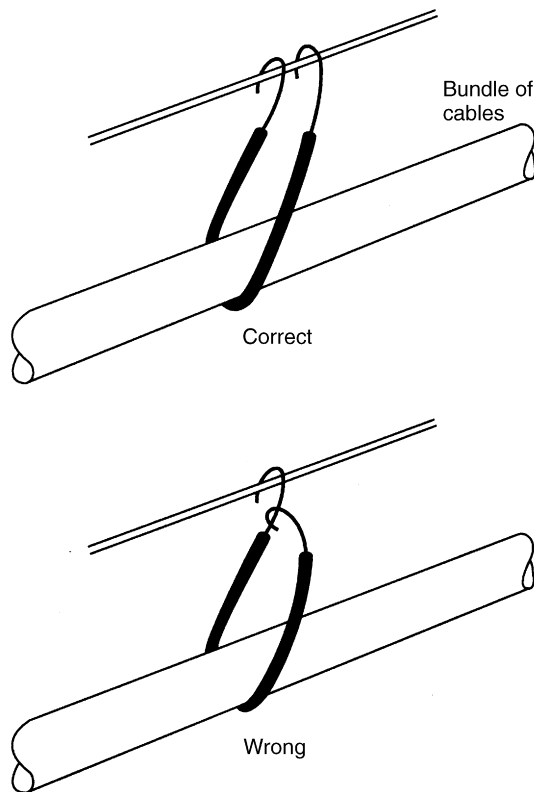
A bundle of electric cables was supported by cable hangers. The hooks on the ends of the cable hangers were curved over the top of a metal strip (Figure 27-3, *top*). The electric cables had to be lowered to the ground to provide access to whatever lay behind them and then replaced. They were put back as shown in the second part of Figure 27-3. This increased the load on the upper hooks. One failed, thereby increasing the load on the adjacent ones and then they also failed. Altogether, a 60-m (200-ft) length of cables fell down [2].

FIGURE 27-3 Different ways of supporting a bundle of cables. (Reprinted with the permission of the Institution of Chemical Engineers.)

Many people would fail to see this hazard. Training is impracticable if, as is probably the case, many years will pass before the job has to be done again. The best solution is to use cable hangers strong enough to carry the weight even if they are used incorrectly.

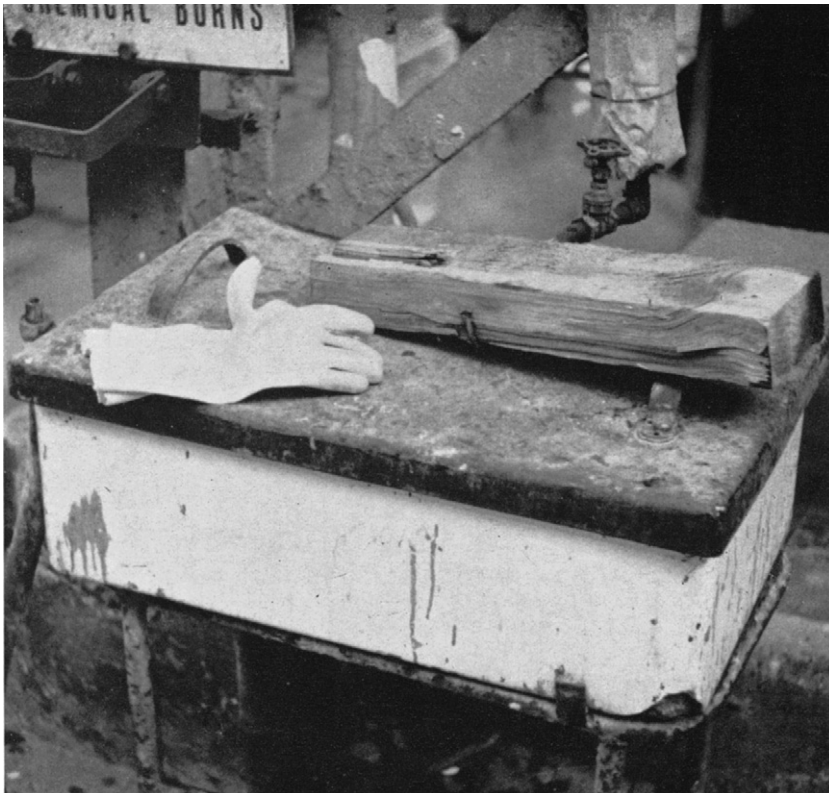
Washbasins filled with water were installed at a plant so that anyone splashed with a corrosive chemical could wash it off immediately. The basins were covered to keep the water clean, but people used the covers as tables (Figure 27-4a). Figure 27-4b shows the action taken, and Figure 27-4c shows a better solution.

FIGURE 27-4 (a) The cover over the washbasin was used as a table. (b) The solution. (c) A better solution.

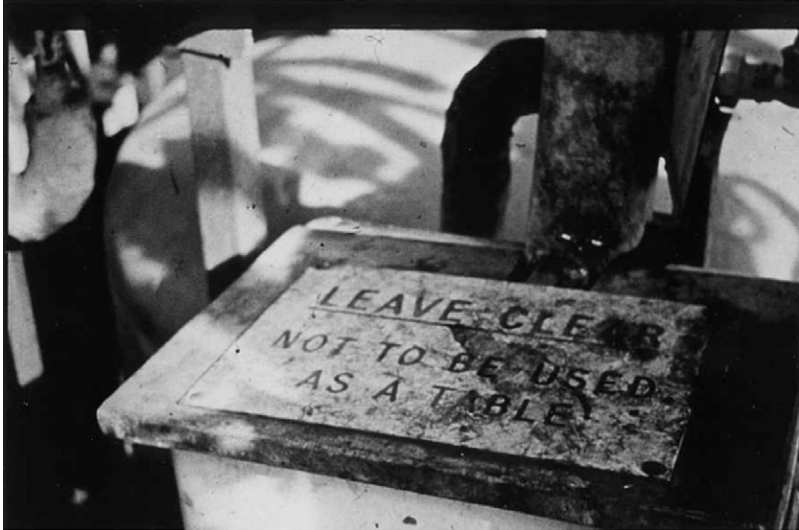
(b)

Perhaps there is something wrong with our educational system or company culture when educated and professionally trained people take the action shown in Figure 27-4b.

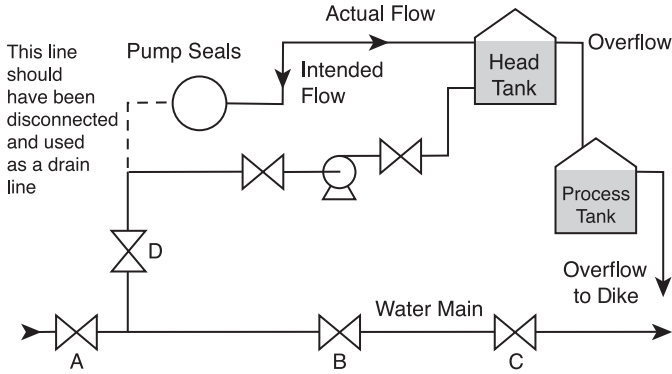
Figure 29-1 shows the layout of the relevant pipework on an experimental unit that was used intermittently. In the original design, the pump

**FIGURE 29-1** When the unit was modified, the contractors forgot to disconnect the dotted pipeline. As a result, water flowed in the opposite direction to that intended and into the head tank.

seals were supplied with water via valve D. However, the pressure in the main varied and therefore, to provide a more consistent supply, a small head tank was installed and the old supply line to the pump seals was then used as the drain line. During construction, the need to disconnect it from the water main was overlooked and it remained connected. Perhaps the designers of the modification failed to tell the construction team that the line should have been disconnected, or perhaps they were told but failed to do so. Either way, nobody checked the job thoroughly (if at all) after completion and the company's procedure for the control of modifications was ignored, as the plant was only an experimental one.

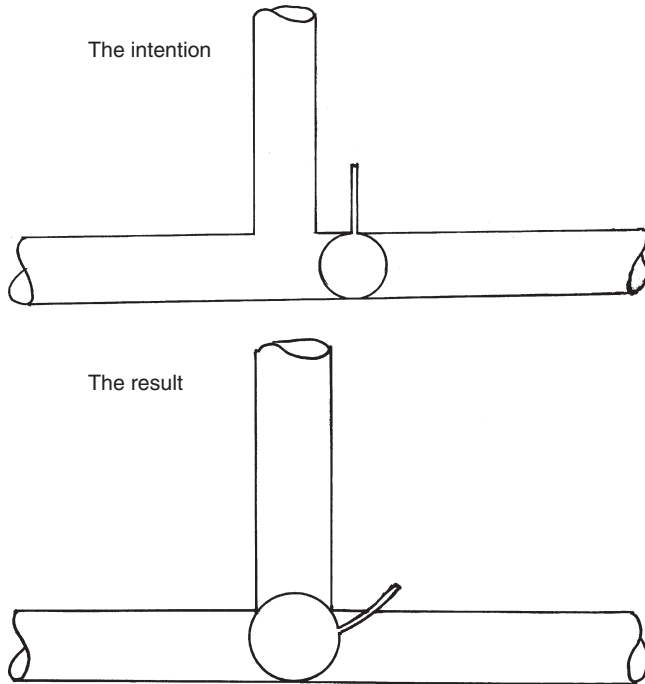
FIGURE 31-1 An inflatable stopper with a rigid stem was wanted, but a *similar* one was fitted instead.

the contractor was told to drill a hole in the main duct and push an inflatable rubber balloon through it. This is a standard item of equipment that had been used successfully on previous occasions. The drawing specified “[manufacturer’s name] inflatable pipeline stopper or similar.” This manufacturer’s stopper is fitted with a metal inflation tube that ensures that the balloon remains in position beneath the insertion hole. The contractor instead used a balloon fitted with a flexible tube. The inflated balloon moved a little way down the duct and blocked the bypass line (see Figure 31-1). Ventilation flow stopped. The operators in the control room had been warned that changing over to the bypass line might cause the low flow alarm to operate, and therefore they ignored it. Some time elapsed before they realized what had happened.

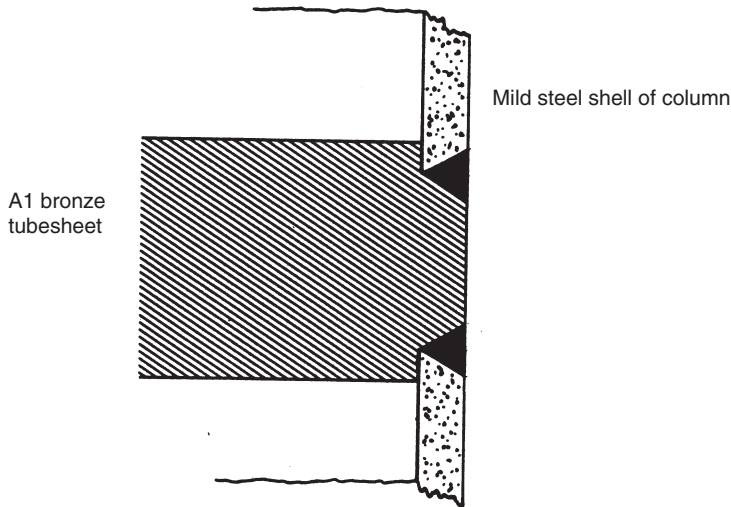
FIGURE 32-2 No one at the plant was aware of this unusual method of construction.

An unusual method of construction produced another hidden hazard. A steel fractionation column was fitted with an internal condenser that had an aluminum-bronze tubesheet. It had the same diameter as the vessel but was welded to it in an unusual way, as shown in Figure 32-2. One of the welds cracked in service, and flammable vapor escaped. Fortunately, it did not ignite.

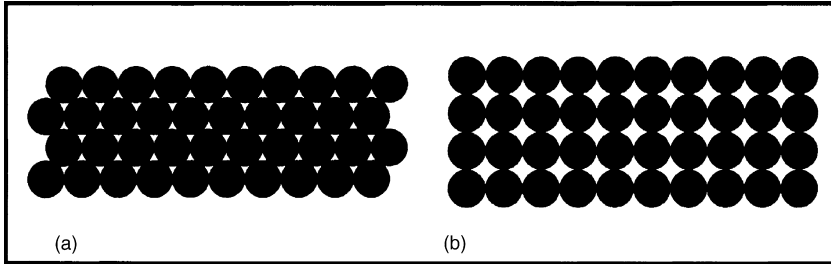
**FIGURE 32-3** (a) Close packing of uncharged spheres. (b) Open packing of charged spheres.

showed that this amount of powder would fit into the bags, nevertheless it backed up into the machine and caused it to stall. It had to be stripped down and cleaned before packing could continue.

Experiments showed that rapid filling of the powder lowered the bulk density by 10% as charges of static electricity on the particles pushed them farther apart. Instead of being closely packed as in Figure 32-3a, they were more openly packed as shown in Figure 32-3b. As the output of the plant was large, a machine for eliminating the static charge was designed and installed [13].
