Library of Congress Cataloging-in-Publication Data  
Kletz, Trevor A.

What went wrong? : case histories of process plant disasters and how they could have been avoided / Trevor Kletz. —5th ed.

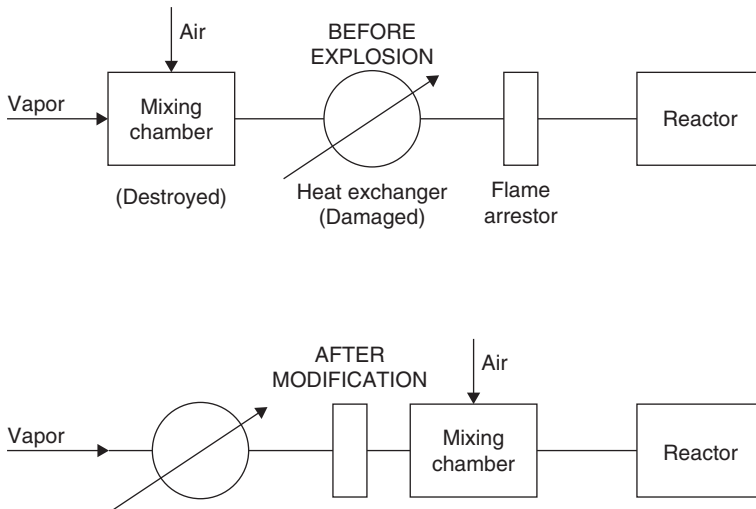
1. A vaporizer for the raw material
2. A mixing chamber where it was mixed with air
3. A heat exchanger to heat the mixture
4. A flame arrestor
5. A tubular reactor (see Figure 32-4)

The reactor operated in the explosive range but below the auto-ignition temperature. The designers realized that hot spots might form in the reactor and ignite the reaction mixture, so they strengthened the reactor and provided explosion vents. The flame arrestor was installed to prevent the explosion passing back into the heat exchanger. There was no need, they decided, to strengthen or vent the vaporizer, mixer, or heat exchanger as there was no source of ignition in them, or so they thought.

After a two-year operation, an explosion demolished the mixer and damaged the heat exchanger. The probable source of ignition was an

FIGURE 32-4 Layout of equipment in vapor phase oxidation unit before and after explosion in reactor.

unlikely one. The vaporizer had to be cleaned from time to time. Various agents had been used including acids, which had attacked the vaporizer and deposited a mixture of metal and organic residues in the mixer. These oxidized and became hot enough to ignite the flammable mixture of reactant vapor and air in the mixer.

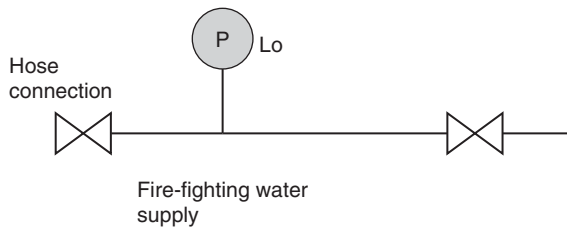
The pressure of a water supply was normally high enough for it to be used for firefighting. If the supply pressure fell, a low-pressure alarm sounded and an alternative supply of water was then made available. When someone isolated the water supply in error, the trapped pressure in the line prevented the alarm from operating. The instrumentation could do what it was asked to do—detect a low pressure—but not what its designers wanted it to do—that is, detect that the water supply was unavailable (see Figure 33-1).

**FIGURE 33-1** When the valve on the right was closed, the low-pressure arm became ineffective.

As often happens, something else was wrong as well: the valve in the water line should have been locked open but was not. Valves that are locked open for safety reasons should be listed and checked periodically to make sure that they are still locked. They are part of a protective system.

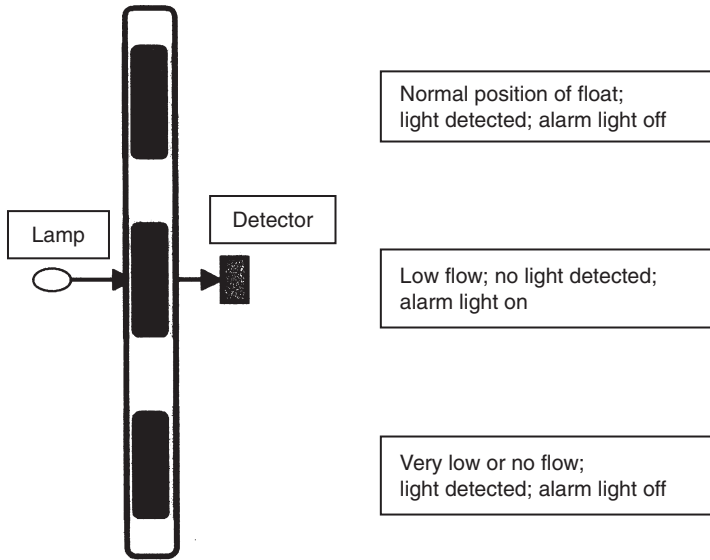
The design had limitations. If the flow diminished only slightly, the light beam remained broken and the alarm light stayed on after the alarm bell was silenced. However, if the flow fell substantially or stopped completely, the float dropped farther, the light beam was no longer broken, and the alarm light went out (Figure 33-2a). One day when the flow actually failed, the operator canceled the alarm, but with no light to remind him he was distracted by other problems and forgot that the gas flow had stopped. Several hours passed before this was discovered.

**FIGURE 33-2** (a) Original design of rotameter low-flow alarm. (b) Revised design of rotameter low-flow alarm.

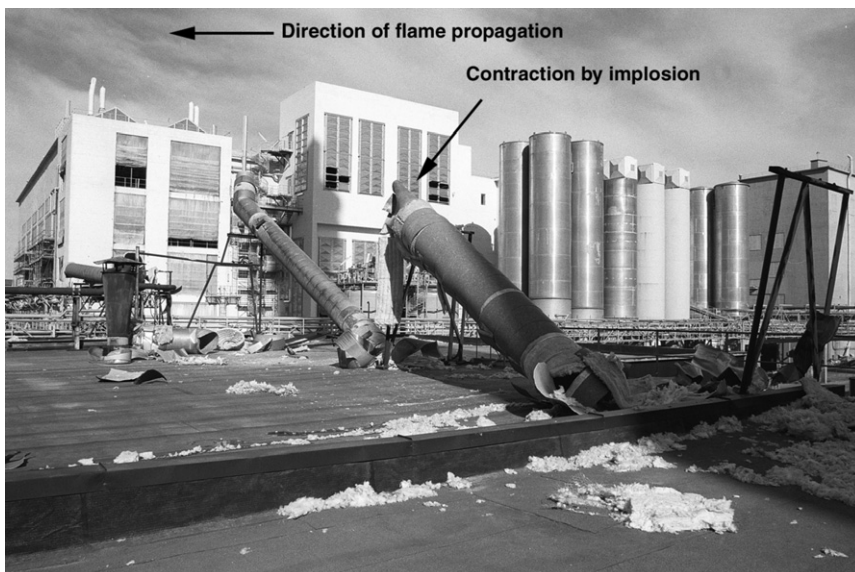
During shutdowns, the ammonia plant was swept out with nitrogen, which contaminated the carbon dioxide. Nitrogen has twice the thermal conductivity of hydrogen, so the hydrogen measurements were ignored until the nitrogen had been swept out of the pipeline. You have already guessed what happened: air got into the transfer line during this period and an explosion occurred; 850 m (2,800 ft) of the pipeline was destroyed (Figure 33-3).

**FIGURE 33-3** The result of hydrogen and air entering a pipeline. From reference 1. (Reprinted with the permission of the American Institute of Chemical Engineers.)

instead of nitrogen for sweeping out the ammonia plant. The source of ignition may have been heat from cutting a bolt.

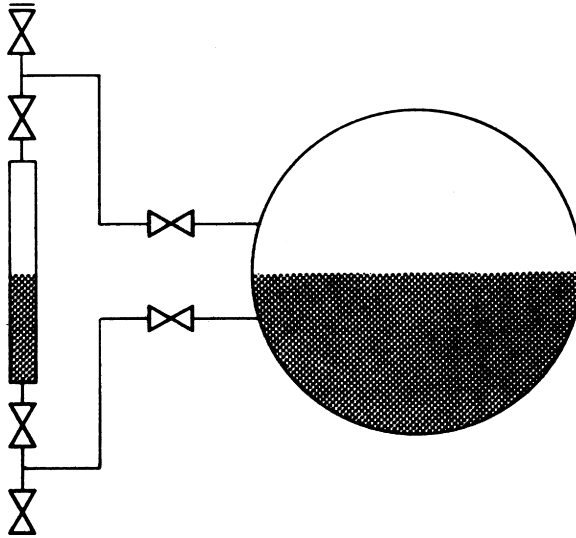
A sight-glass 1.2 m (4 ft) long was connected to vessel branches 0.6 m (2 ft) apart as shown in Figure 33-4. It will indicate the correct level only when the liquid in the vessel is between the two branches. If the liquid level is below the lower branch, the liquid in the sight-glass is isolated and its level cannot fall. If the liquid level is above the upper branch, vapor will be trapped in the upper part of the sight-glass. As the level rises, this vapor will be compressed. If any noncondensable gas is present, the

FIGURE 33-4 A level glass with a limited range. From *Chemical Engineering Progress*, July 1980. (Reprinted with the permission of the American Institute of Chemical Engineers.)

pressure in the sight-glass will rise and the level in the sight-glass will be depressed below the level in the vessel.

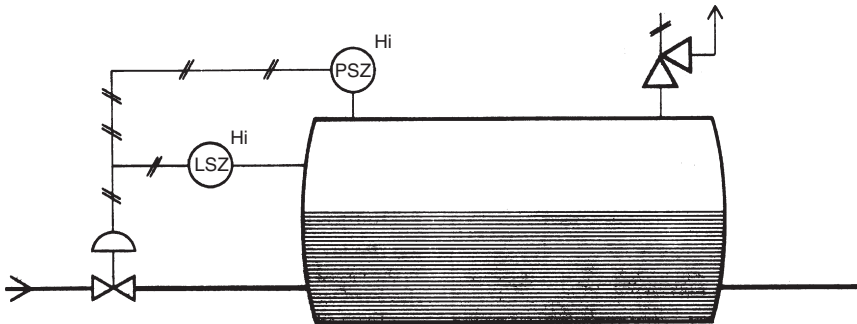
**FIGURE 33-6** The designer of this system seemed unaware of the difference between vapors and noncondensable gases. From *Chemical Engineering Progress*, July 1980. (Reprinted with the permission of the Institution of Chemical Engineers.)

petroleum gas (LPG) is fitted with a level controller (not shown) and, in addition, a high-level trip to isolate the inlet line if the level gets too high (Figure 33-6). The high-level trip might fail; the relief valve will then lift and discharge liquid to the atmosphere so a high-pressure trip is installed as well.

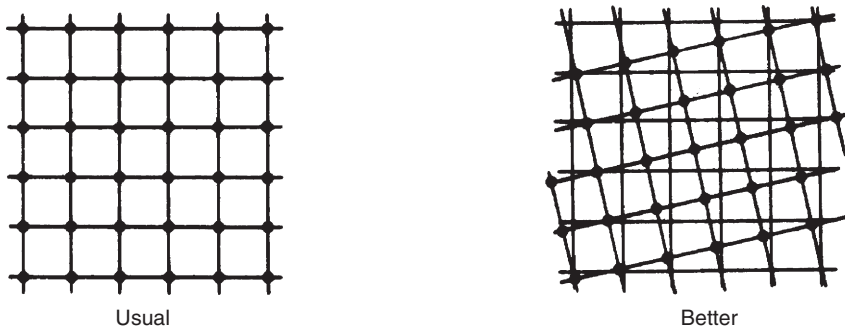
If tests are being carried out on a vessel, they are often made on the points of a grid. Lines of weakness (such as welds) may then be missed.

**FIGURE 33-8** If test points are on a grid, it should be tilted so that no lines of weakness are missed.

The grid should be tilted so that the test points are not all above or below each other (Figure 33-8).

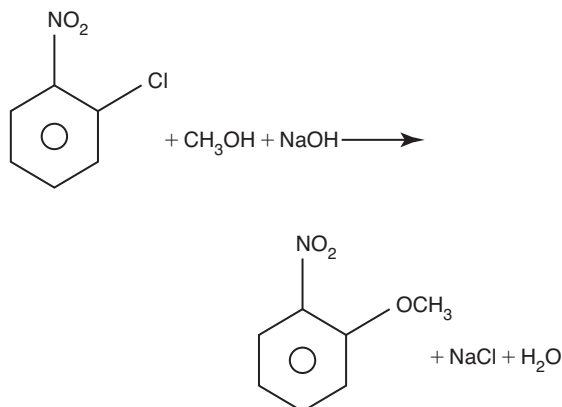
One day, after replacing the manway cover (step 3), the operator forgot to switch the stirrer back on. There was no mixing, and the caustic soda plus methanol (added in step 5) formed a separate layer. No reaction occurred,

FIGURE 35-1 Late mixing of this reaction led to a leak that covered 75 acres.

and the operator had to apply heat instead of cooling to the jacket to maintain the temperature at 80°C (175°F). When the operator realized that the stirrer was not running, he switched it on. A very rapid reaction occurred, the temperature rose to at least 160°C (320°F), and the pressure rose to 16 bar gauge (230 psig). Most of the contents of the reactor, 10 tons of liquid, were discharged through the relief valve and a yellow deposit was distributed over 300,000 m<sup>2</sup> (75 acres) of a builtup area, a suburb of Frankfurt, Germany.

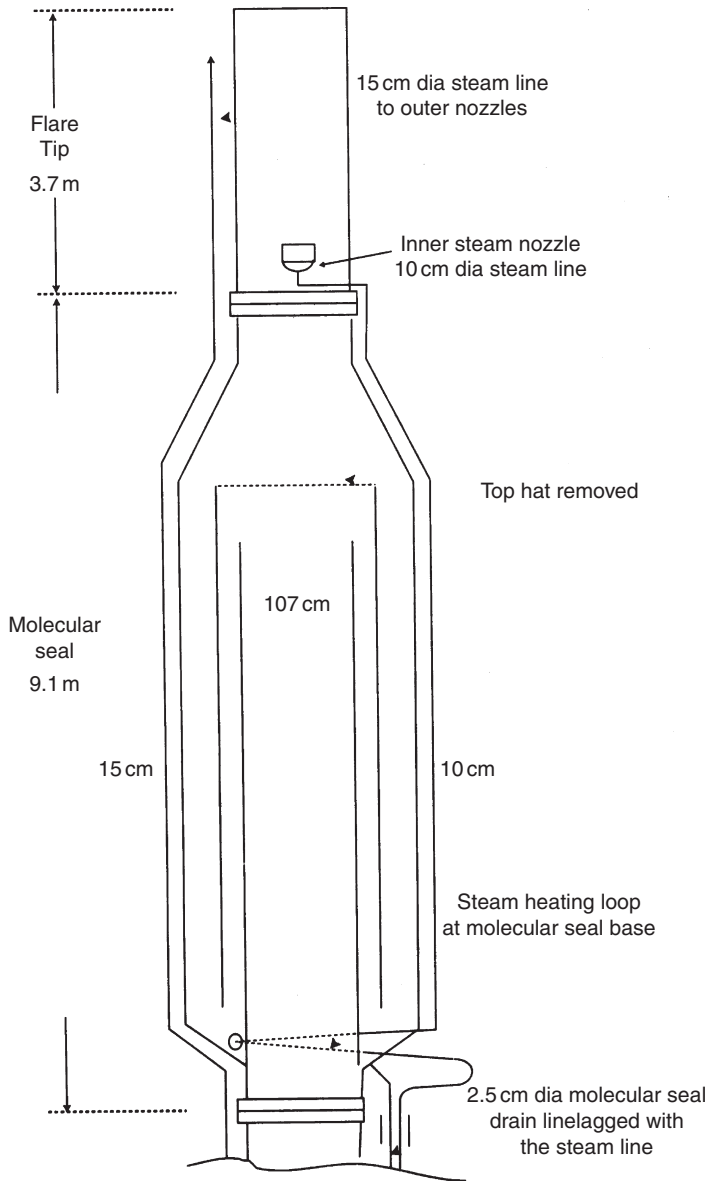
Many explosions have occurred in flarestacks because a normally continuous flow of gas failed or fell to a very low level and air diffused down the stack, forming an explosive mixture (see Chapter 6). To reduce such diffusion, many companies have installed molecular seals: the gas leaving the stack and any air diffusing down follow a labyrinthine path, as shown in Figure 36-2. However, these seals have disadvantages. Carbon from incompletely burned gas can fall into the bottom of the seal and block the flow. Ideally, material discharged from a relief valve should follow a simple and straightforward path without any equipment that might obstruct the flow. For this reason, some companies have had second thoughts and removed the top of the molecular seal, called the “top hat,” as shown by the dotted line in Figure 36-2. This effectively neutralizes the seal but leaves the rest of it in position. On one plant, a steam nozzle was added inside the stack to cool the tip and to reduce smoke formation. Some of the steam condensed and flowed down the drain line into the knock-out drum. In the stack shown in Figure 36-2, the drain line was insulated with the steam line to prevent freezing.

Unfortunately, the drain line had only a 1-in. diameter. It became partially blocked with carbon and a pool of water formed in the bottom of the molecular seal. It filled the outer rings of the seal and overflowed into the inner pipe. Some of it froze when unusually large quantities of cold gas had to be flared during cold weather, partially choking the inner pipe. Finally, there was a rumbling noise and bits of ice and a stream of water were blown out of the stack. The flame was extinguished. Similar

**FIGURE 36-2** The top of a flarestack fitted with a "top hat." From reference 6. (Reprinted with the permission of the Institution of Chemical Engineers.)

incidents have occurred on other plants. On one plant, a narrow stack was completely blocked by ice when steam was injected inside it (see Sections 2.5 and 6.2). It is doubtful if a 107-cm (42-in.) diameter stack could be completely blocked in this way. Nevertheless, the report [6]

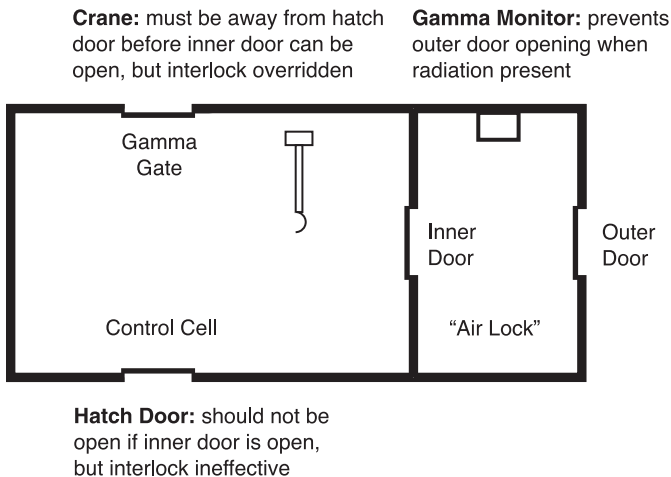
This incident was the result of too much complexity in design and operations. Unfortunately, this makes the following account rather complex. Please persevere; it contains some messages of wider applicability than you might think at first glance.

FIGURE 36-3 An overly complex system of interlocks to prevent both doors being open at the same time, unless maintenance is in progress.

was brought into the cell through a hole in the floor (the hatch door) and removed after cleaning through a hole in the ceiling (the gamma gate). Cleaning and other operations were carried out by remote control. No one was allowed in the cell when radioactive equipment was present but people could enter the cell at other times to maintain the cleaning equipment. They entered through double doors that acted as an air lock. A key exchange system—only one key could be withdrawn at a time—ensured that only one door could be open at a time.

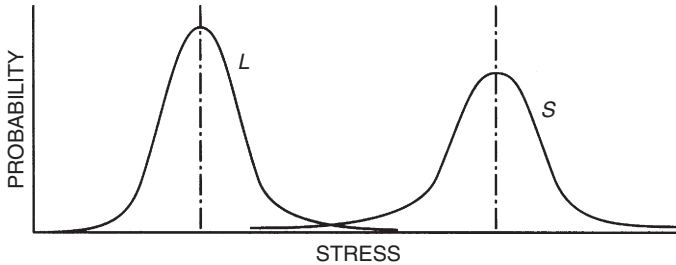
As described in Section 25.3.2, in 2000 a railway accident at Hatfield, United Kingdom, killed four people and drew attention to a literal interface problem. The immediate cause was a cracked rail, but the underlying cause was that British Railways had been privatized and split into a hundred companies. Responsibility for the rails and the wheels now lay with different organizations. To quote the head of the railways' safety organization, "Both sides of the wheel/rail interface may be operating

**FIGURE 37-1** Overlapping distributions of load (L) and strength (S). (Reprinted with permission of the Institution of Chemical Engineers.)

within their respective safety based Standards, but the combined effect of barely acceptable wheel on barely acceptable rails is unacceptable” [14].

Figure 37-1 may make this clearer. In any system, the strength and the load vary to some extent from their design values, and there is inevitably a small overlap between the two asymptotes. Its area is a measure of the probability that the load will exceed the strength and the system will fail, not necessarily immediately but in the long run. Normally, this probability is negligible. In the case of the railways, the wear on the wheel increases the load and cracks in the rail decrease the strength. Both were just within specification, and the overlap was too large. This led to rolling contact fatigue of the track (also called gauge corner cracking), the train crash, and the consequent upheaval while hundreds of miles of faulty rail were replaced.
