# BOILER SYSTEM FAILURES

## *Analysis & Diagnostics Manual*

### EXAMPLES OF ISSUES IN SPECIFIC BOILER SYSTEM COMPONENTS

Metallurgy  
Volume 2.0 | Boiler Systems

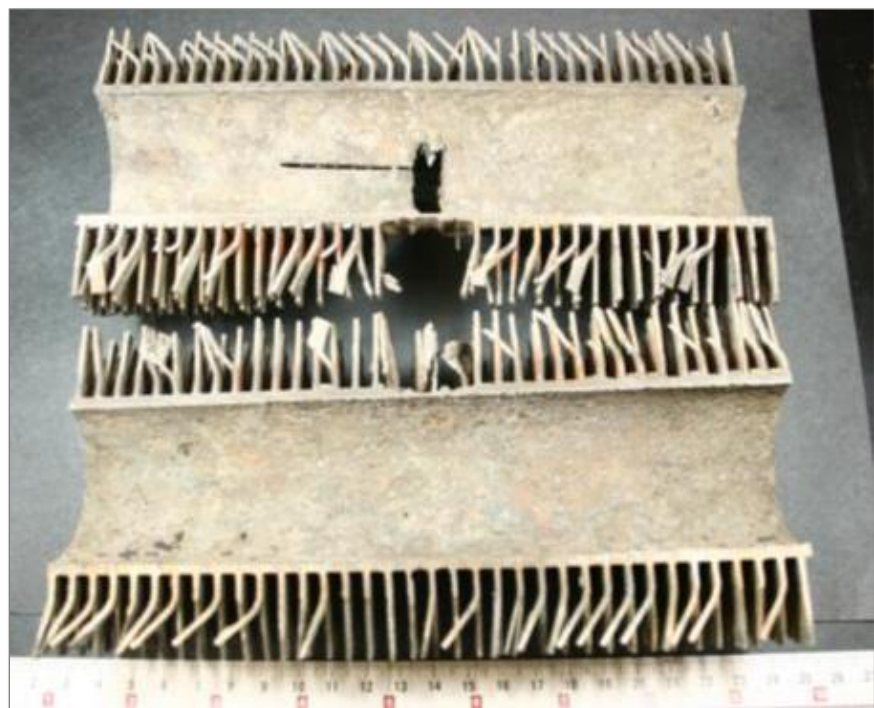
After cleaning with inhibited HCL

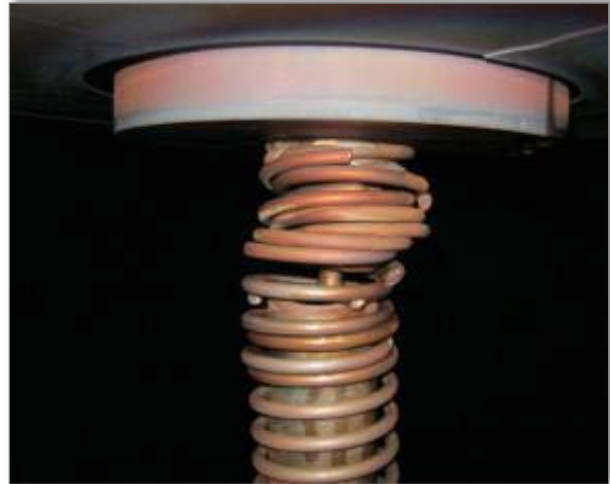
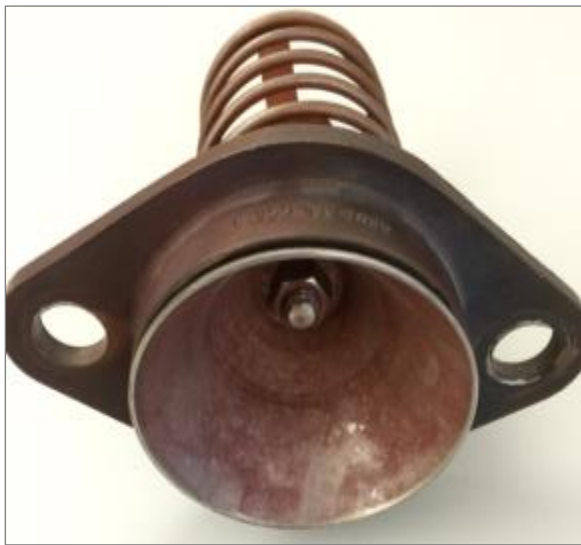
Normal deaerator spray valve bell

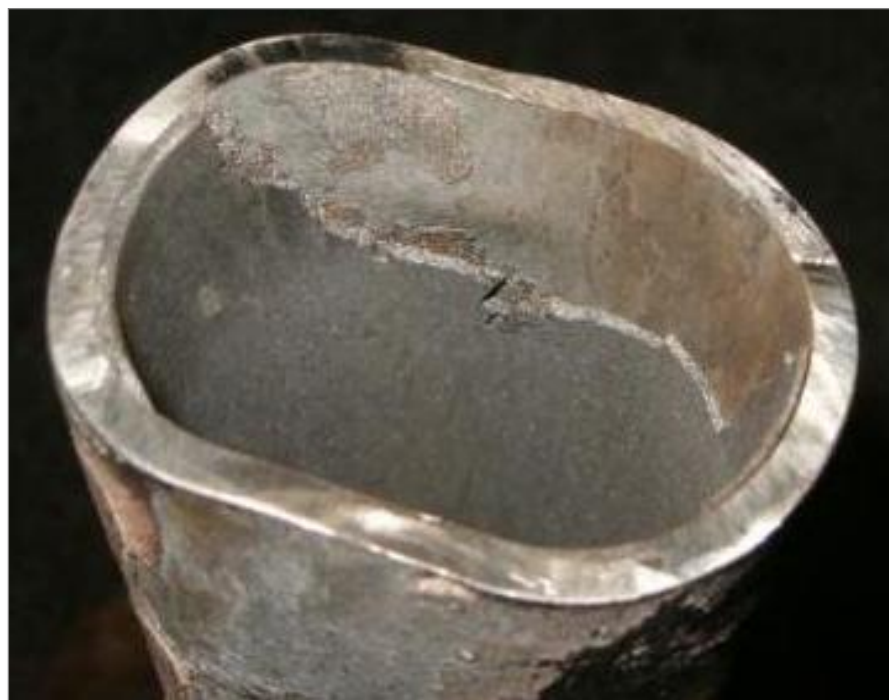
Heavy magnetite formation in a superheater tube
